# **FINAL INVESTIGATION REPORT**

**SERIOUS INCIDENT OF M/S AIRBORNE AVIATION**  
**CESSNA-152 AIRCRAFT REG NO. AP-BJW AT**  
**MANDI BHAOUDDIN ON 5<sup>TH</sup> MARCH, 2018**

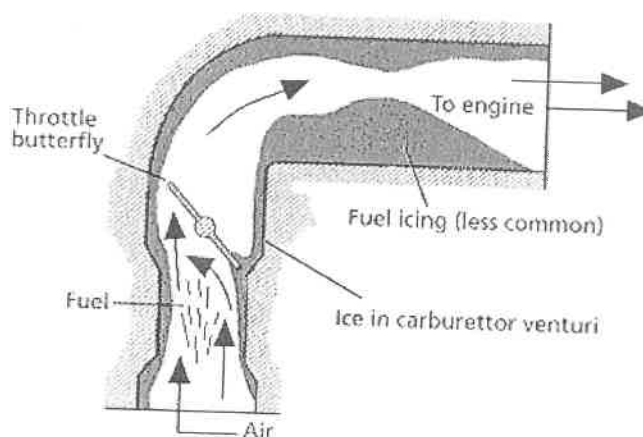
- 2.1.12.1. **Carburettor Icing.** The most common type of induction system icing is carburettor icing which is caused by a combination of the sudden temperature drop due to fuel vaporisation and the reduction in pressure at the carburettor venturi. The temperature reduction may be as much as 20°- 30° C and results in moisture in the induction air forming ice. The ice gradually builds up, constricting the venturi, and by upsetting the fuel/air ratio causes a progressive decrease in engine power. Engines which have a conventional float-type carburettor, as in this case are more prone to this type of icing.

### BUILD UP OF ICING IN INDUCTION SYSTEM

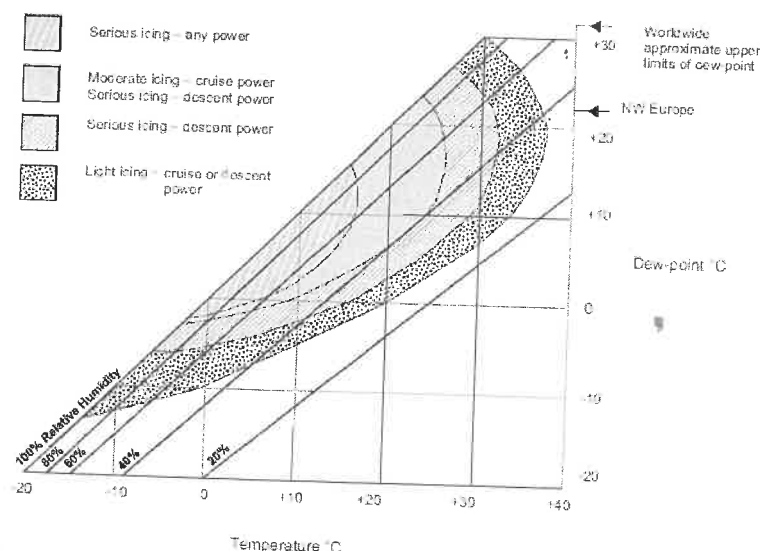
- 2.1.13. **Atmospheric Conditions.** At cruise power, icing can occur at 20°C with a relative humidity of 60% or more. Ice accumulation is less on cold, dry winter days than on warm, humid summer days because the water vapor content of the air is lower. Thus, where high relative humidity and ambient temperatures of between -10°C and +25°C are common, pilots must be constantly alert to the possibility of icing and should take the necessary steps to prevent it.

### CARBURETOR ICING IN FREE AIR
