# **FINAL INVESTIGATION REPORT**

**ACCIDENT OF M/S SHAHEEN AIR FLYING TRAINING  
SCHOOL CESSNA-162 AIRCRAFT, REG # AP-ZBQ ON  
24<sup>TH</sup> FEBRUARY, 2017 AT FAISALABAD**

### ACCIDENT OF M/S SHAHEEN AIR FLYING TRAINING SCHOOL CESSNA-162 AIRCRAFT, REG # AP-ZBQ ON 24<sup>TH</sup> FEBRUARY, 2017 AT FAISALABAD

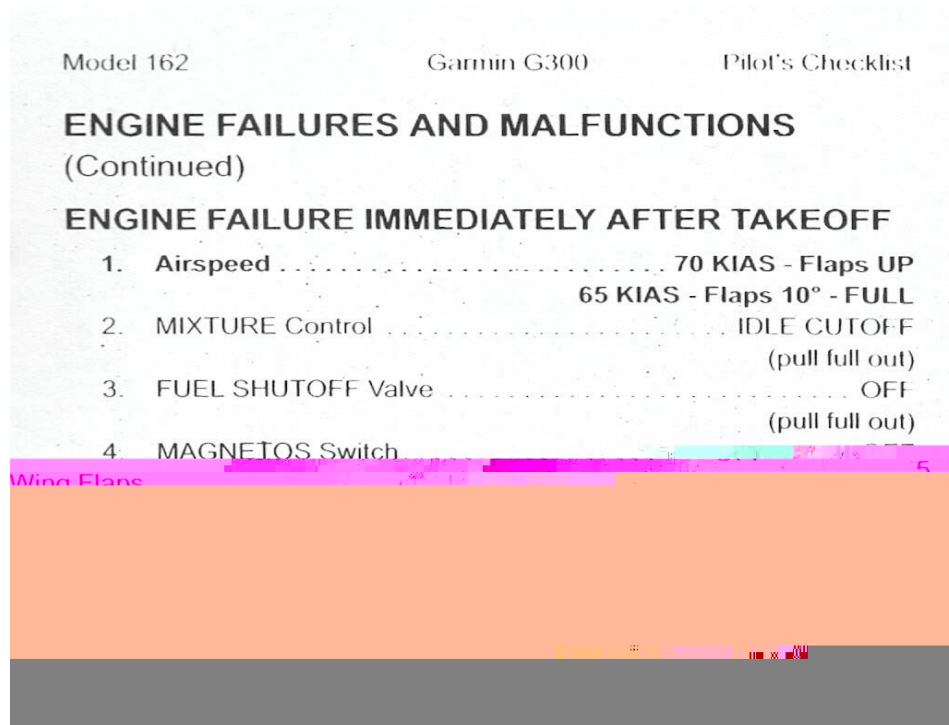
- 2.1.20 The SAFTS pilot checklist emergency procedures page E-5 describes procedure for Engine Failure and Malfunctions of Cessna – 162 aircraft. The procedure for engine failure immediately after takeoff, as the case under discussion, necessitated maintenance of 70 kts IAS and landing straight ahead while carrying out the safety checks (mixture control, fuel shutoff valve, magnetos switch, master switch – all OFF) inside the cockpit. The relevant procedure is also appended below :-

3.1.19 The SAFTS pilot checklist emergency procedures page E-5 describes procedure for Engine Failure and Malfunctions of Cessna – 162 aircraft. The procedure for engine failure immediately after takeoff, as the case under discussion, necessitated maintenance of 70 kts IAS and landing straight ahead while carrying out the safety checks (mixture control, fuel shutoff valve, magnetos switch, master switch – all OFF) inside the cockpit. This procedure was not followed.

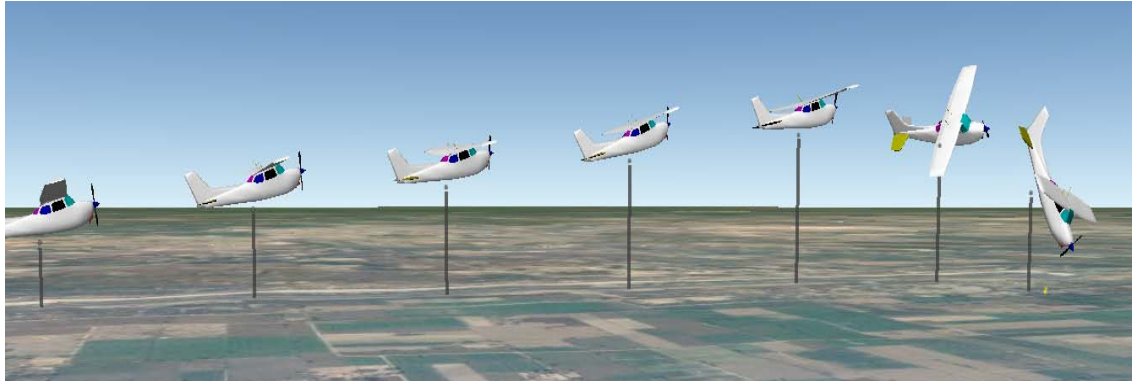
- 2.1.18 During this abnormal engine behaviour the aircraft was initially observed to gradually pitch down along with a little roll of 3 to 4 degree left. When the engine developed sudden and sharp drop in its parameters, the aircraft was observed to reverse its roll from left to right side all the time increasing to 87 degree and nose pitch down to 43 degree and beyond.

2.1.22 The aircraft attitude / flight path during entire emergency situation is pictorially depicted below :-

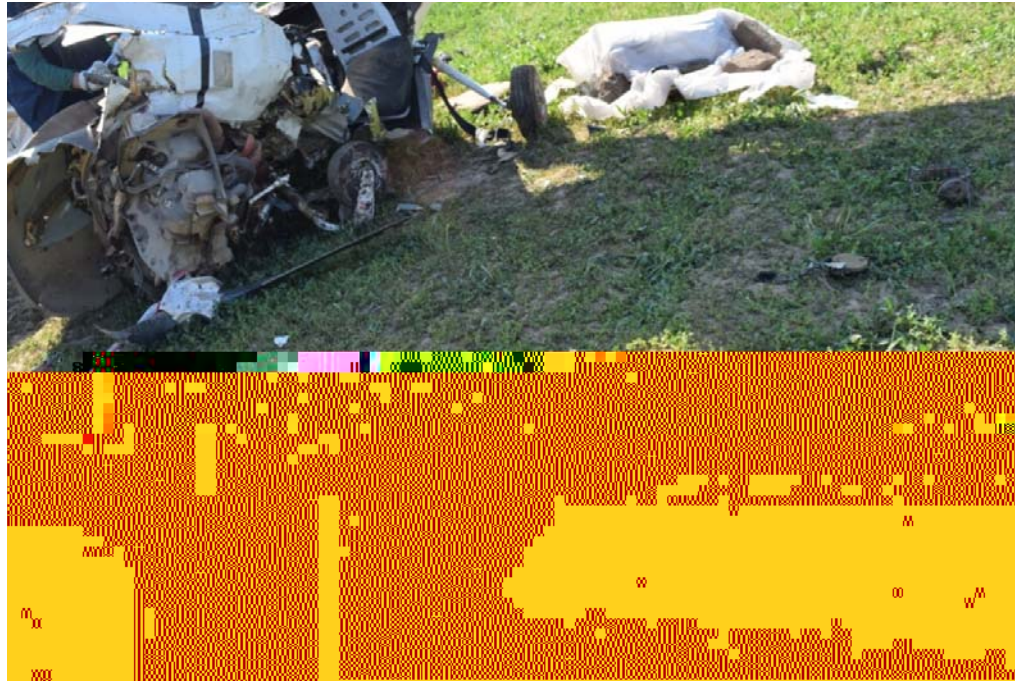
2.2.3 **Structural Integrity of the Aircraft / Flight Controls.** Entire wreckage of the aircraft was confined to a limited area and all four corners of the aircraft were well accounted. Since, it was a short duration lift off, the entire track of the aircraft was scanned for any lost structure prior to the crash site, however, nothing was found. Moreover, the flight parameters analysis also revealed nothing un-usual that could have been recorded especially due to an in-advertant loss of any lift generating or flight control surfaces etc. Therefore, crash of the aircraft due lost structural integrity has been ruled out. All primary and secondary flight surfaces were intact. Left aileron was detached and lying under the left wing, however, it was due to aircraft impact with the ground. Rest of the left wing and left flap was intact.

*Fig. Detached Left Aileron lying under the Wing*

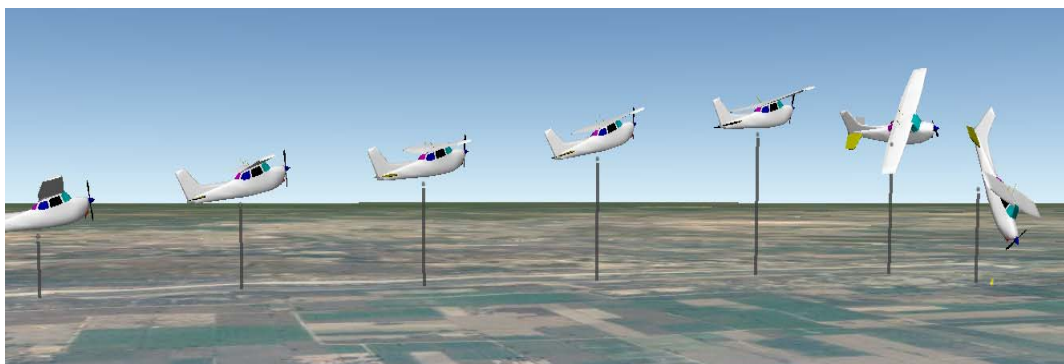
3.1.17 During this abnormal engine behaviour the aircraft was initially observed to gradually pitch down along with a little roll of 3 to 4 degree left. When the engine developed sudden and sharp drop in its parameters, the aircraft was observed to reverse its roll from left to right side all the time increasing to 87 degree and nose pitch down to 43 degree and beyond. There was no communication between aircraft and ATC during entire this event till aircraft impacted ground.

3.1.21 The aircraft attitude / flight path during entire emergency situation is pictorially depicted below :-
