**AIRCRAFT INCIDENT INVESTIGATION REPORT**  
**(DIS-ORIENTATION)**

**M/S. AIR BLUE, AIRBUS – 320 FLIGHT NO. ED-405**  
**REG. NO. AP-BGV ON 10 AUGUST 2007**  
**AT**  
**JINNAH INTERNATIONAL AIRPORT**  
**KARACHI**

## **FINAL REPORT**

### **INCIDENT ON AIR BLUE A-320-231 (MSN-0443) AP-BGV FLIGHT NO. ED 405 ON 10<sup>th</sup> AUGUST 2007 AT JIAP, KARACHI (DIS-ORIENTATION)**

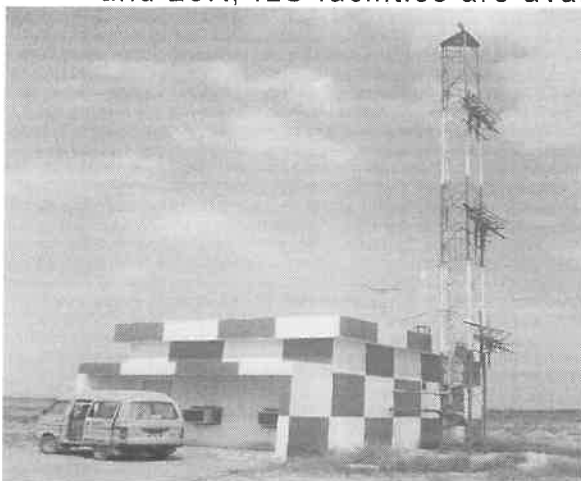
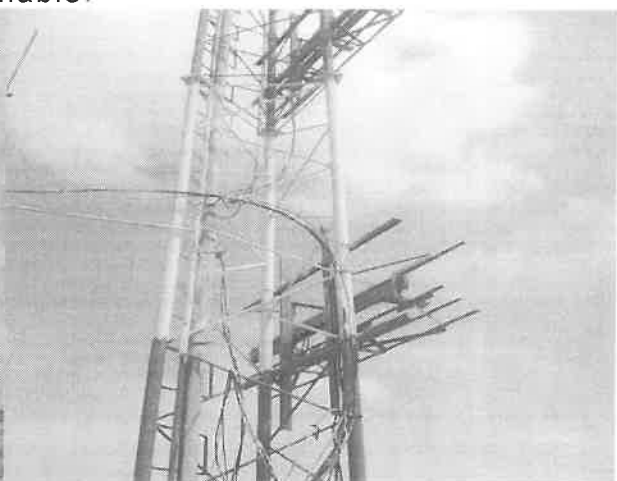
(Figure - A)

(Glide Slope 25L Hut/ Room)

2.3.2 The Glide Slope Room is equipped with Terminal Distance Measuring (TDM) equipment and DME (Model: Glide Slope Mark II Wilox USA installed since 1993), with 03 air conditioners (window type) to maintain the room temperature. Maintenance checks (including daily checks) are logged in the diary book (Communication Center/ transmitting station/ maintenance dairy book).

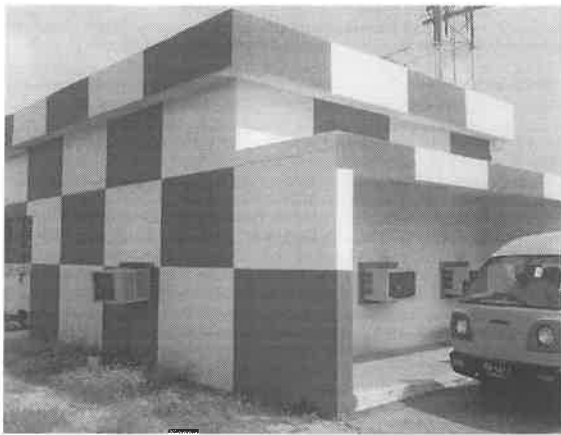
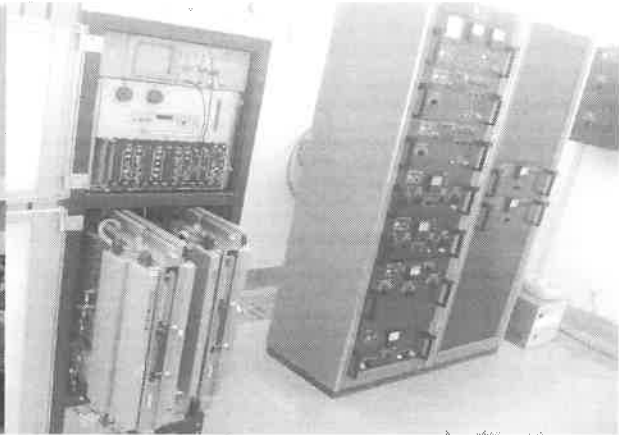
(Figure- C)

(Glide Slope 25L Hut/ Room)

"Glide slope reported off the air 1020 LT, reached and found its modulation lobe. Adjusted limits and wave shape observed on oscilloscope found OK, technically glide slope OK at 11:40 E but due to non availability of aircraft tower declared it serviceable at 12:06 LT".

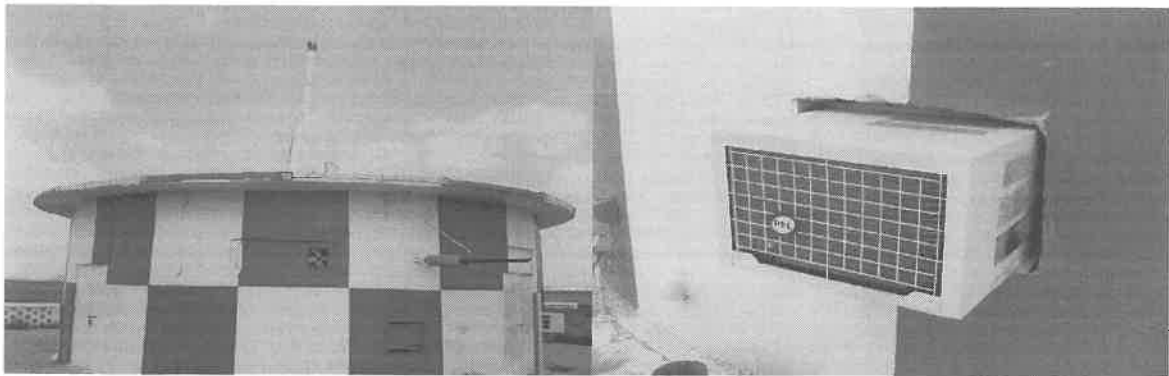
**(Figure- E)**

### **1. (VOR/ DME Hut/ Room)**

2.5 VOR/ DME Room is equipped with VOR (Model Wilcox 585B) and DME (Model Wilcox 956B), the unit is installed since 1983. On top of the room the antenna is installed. This antenna is built in single unit shape, transmitting both the systems frequencies. VOR antenna is covered with a radome.

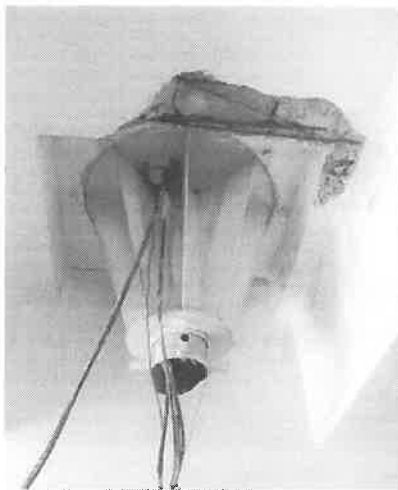
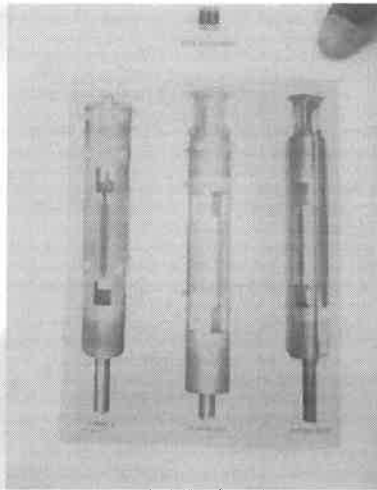
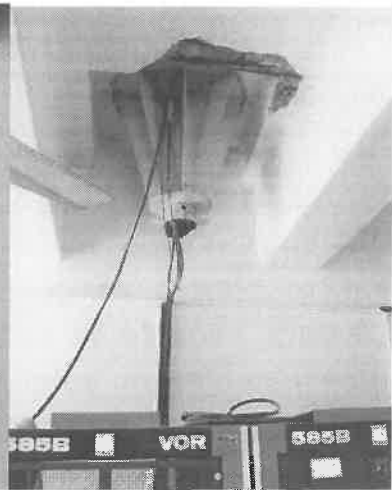
**(Figure-G)**

"(10:00LT to 18:00 LT) 'Visited VOR/ DME open the antenna system observed water in side and also checked both sides band cables found normal. However reflected power on green side band approximately 0.8 watt and forwarded 01.4 watt than put 02 bulbs on the antenna system and observed slow improvement".

**(VOR/ DME Antenna Installation - ceiling view)**

"12.08.2007 (10:30 pm) at 2230 visited VOR found improvement and reflected power is 0.6 watt."

"13.08.2007 (1000 LT) reached VOR and found that reflected power at side band one became zero and VOR is operating normal ground checks of both transmitters carried out and found satisfactory informed sr. manager Nav Aids".

5.1 Additional checks are to be introduced to visually inspect the Nav aids located at Karachi Airport to monitor their condition during rain / bad weather.

5.2 Appropriate NOTAM actions should be taken for erratic behavior of the Nav Aids to warn the operators in case water is observed to have seeped into the system.

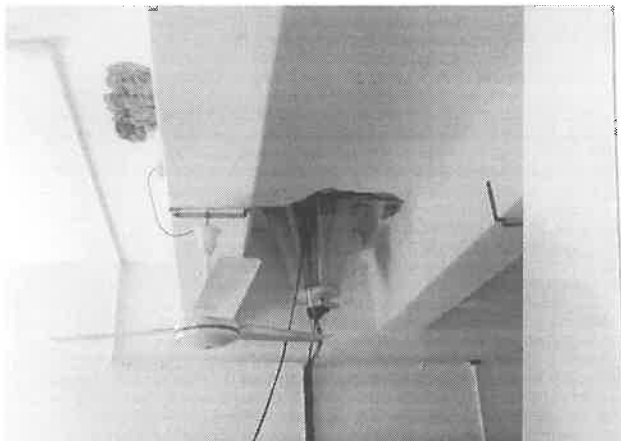
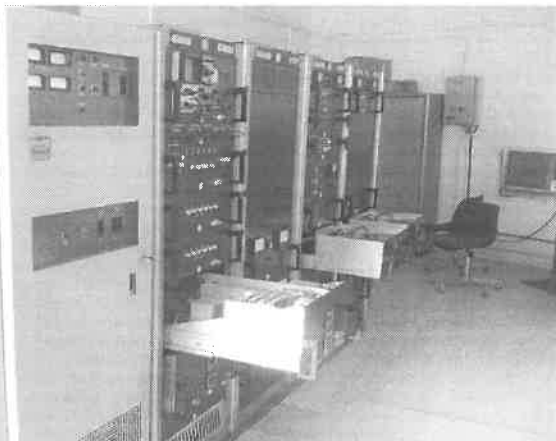
**(Figure-J)**

**(VOR/ DME Equipments and Antenna Installation)**

"11.08.2007 ECR reported that VOR is not getting by aircraft. Checked and found that VOR is working normal".

"12.08.2007 the matter became serious in nature.  
By 13.08.07 the system became normal".

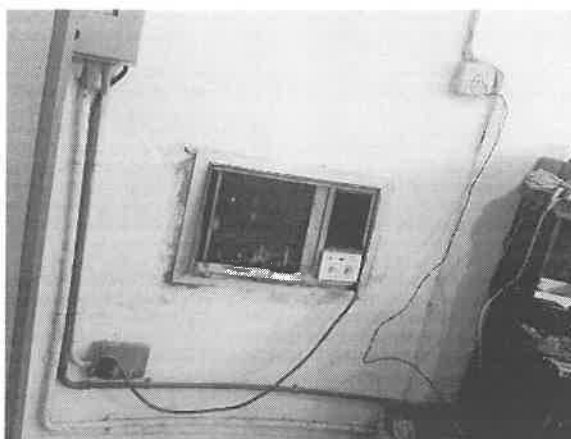
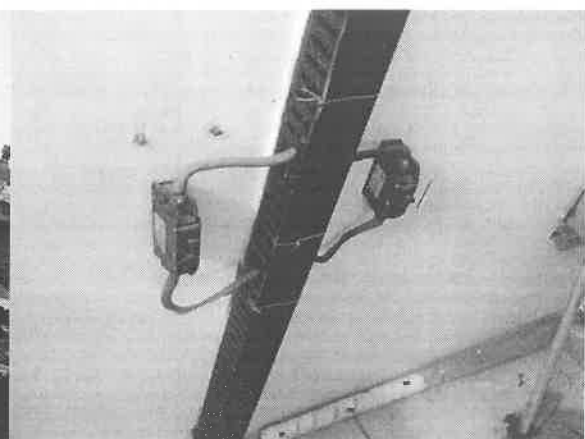
(Figure-L)

- a) Improper electrical installations and loose connection which may lead in arcing of electric or cause fire hazard situation (Refer **Figure 'L' and 'M'**).
- b) Improper Installation of Room Air conditioners (Window Type), several gaps/ openings in AC slot were noted and cause dust, pests and lizards etc in side the room, this may also effect for damaging of equipments.
