**PAKISTAN CIVIL AVIATION AUTHORITY**  
**(SAFETY INVESTIGATION BOARD)**

**FINAL REPORT**

**SERIOUS INCIDENT OF IN-FLIGHT FIRE (ENGINE NO 2) M/S PIAC**  
**FLIGHT NO. PK – 213, A310-308 AIRCRAFT, REG NO. AP-BEC,**  
**(SECTOR KHI – DXB) AT JIAP, KARACHI**  
**ON 06<sup>TH</sup> OCTOBER, 2013**

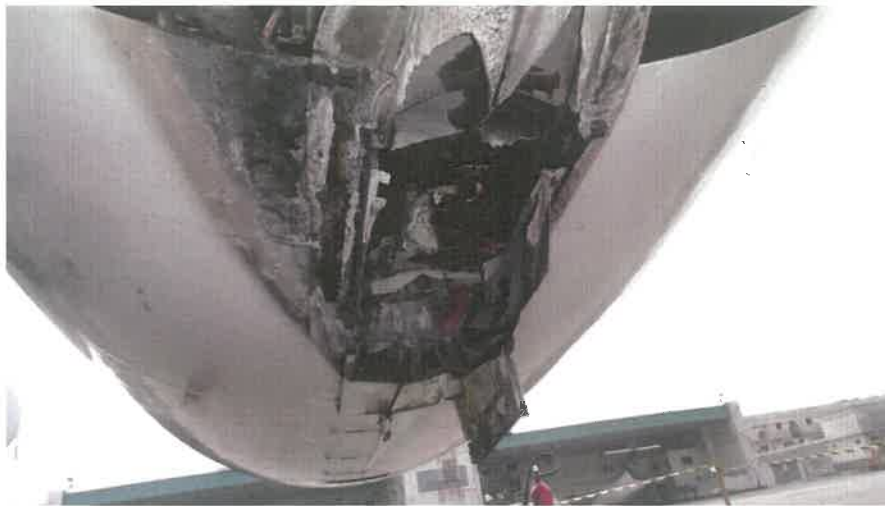
**Thrust reverser cowlings lower side damage from in-flight fire**

3.2.4 During post occurrence inspection, extensive fire damage effects were observed in under cowl nacelle area, lower half of Thrust Reverser and Core cowl of Engine No 2.

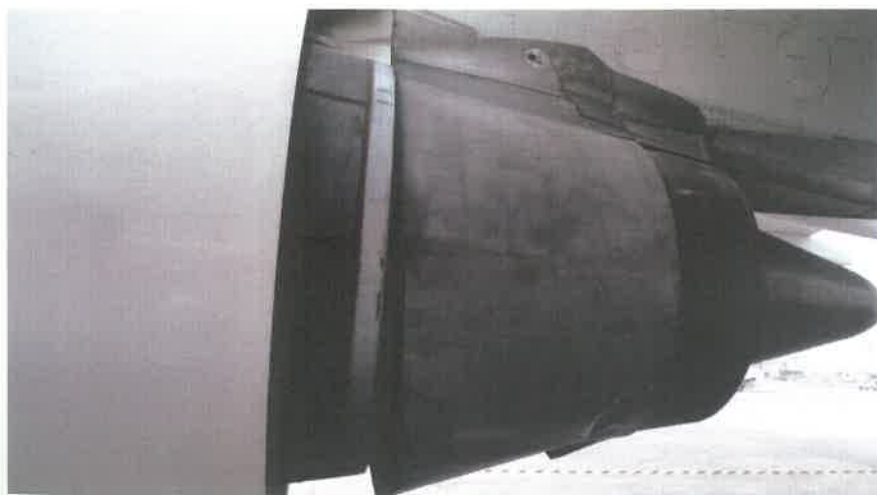
**Bursted and De-shaped Thrust reverser and Core cowl**

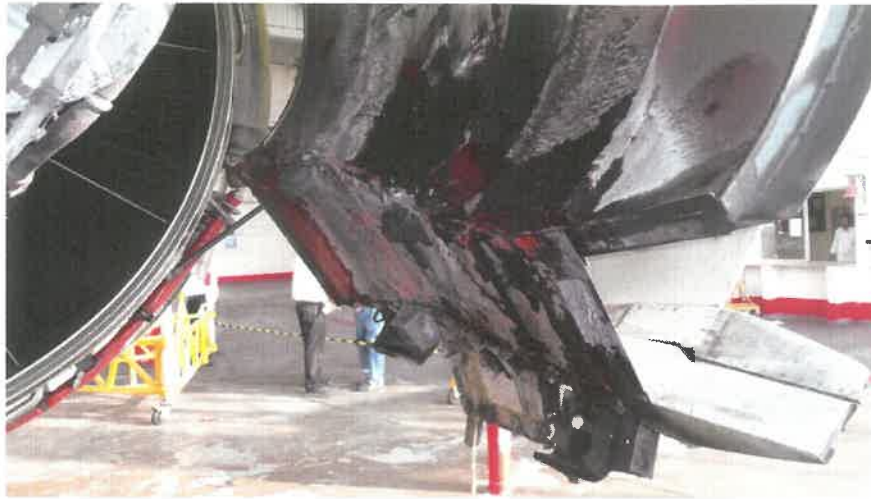
**Right Hand Thrust Reverser Cowl Damage**

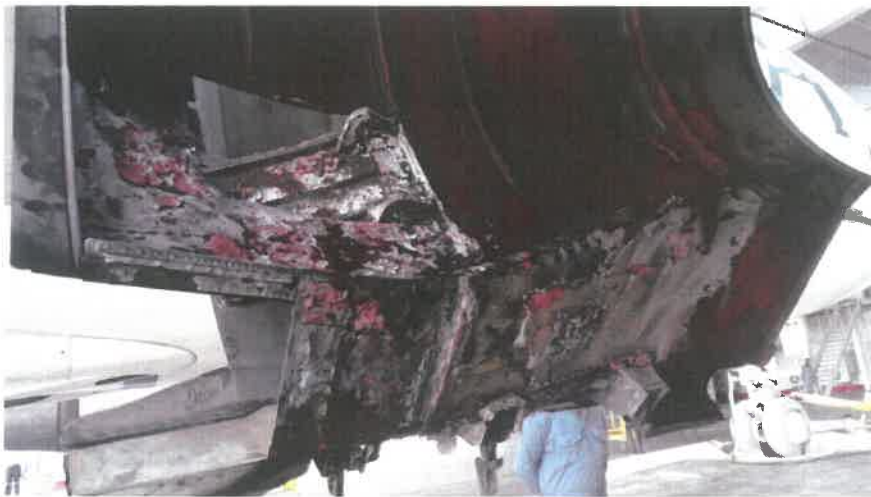
**Left Hand Thrust Reverser Cowl Damage**

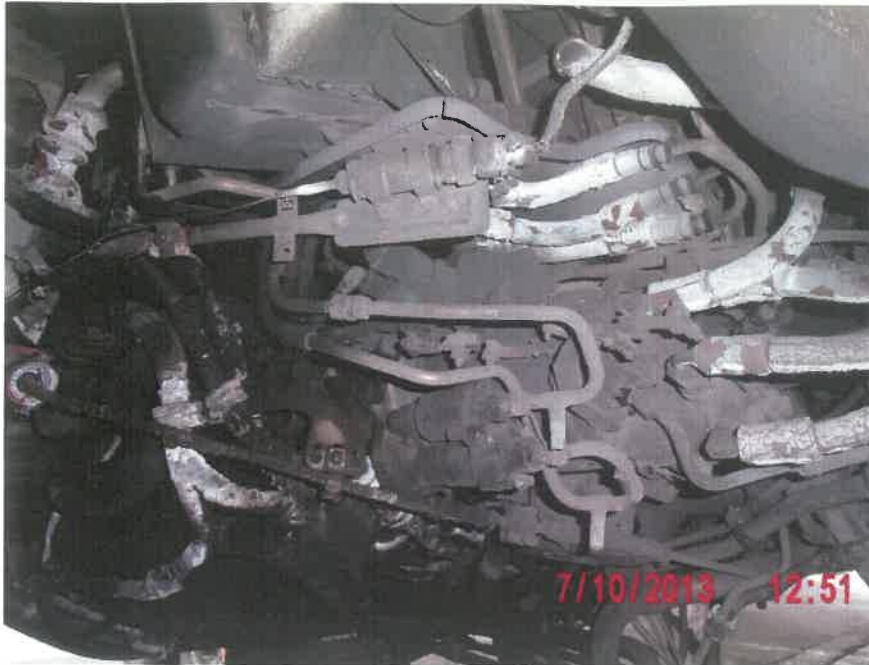
- 1.3.2 Some electrical and engine build up items around Main Engine Control (MEC) were found severely affected due to in-flight fire. The pictures of these damages are attached below:

Components on Lower Right Side of Engine around MEC

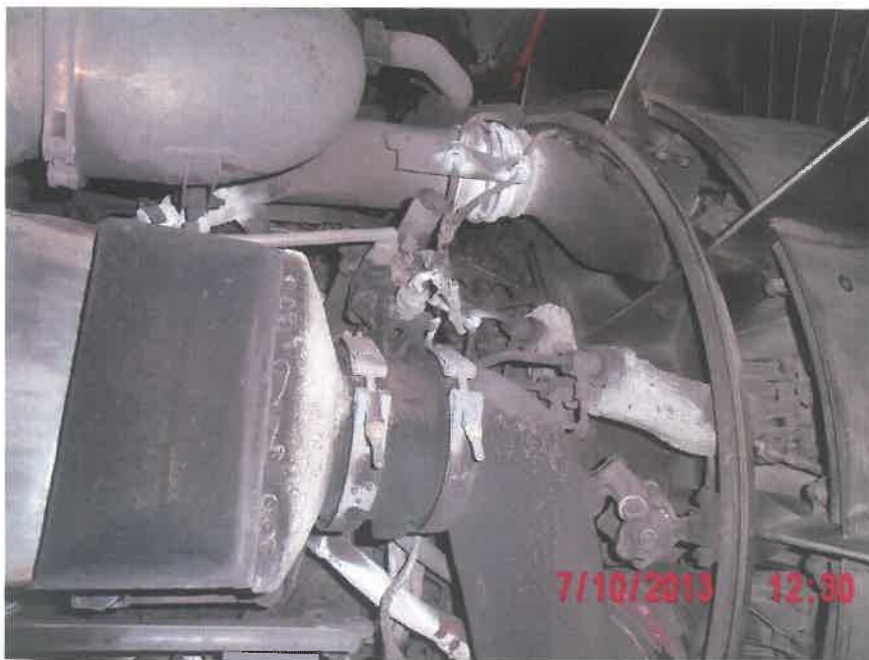
Components on Upper Right Side of Engine above MEC

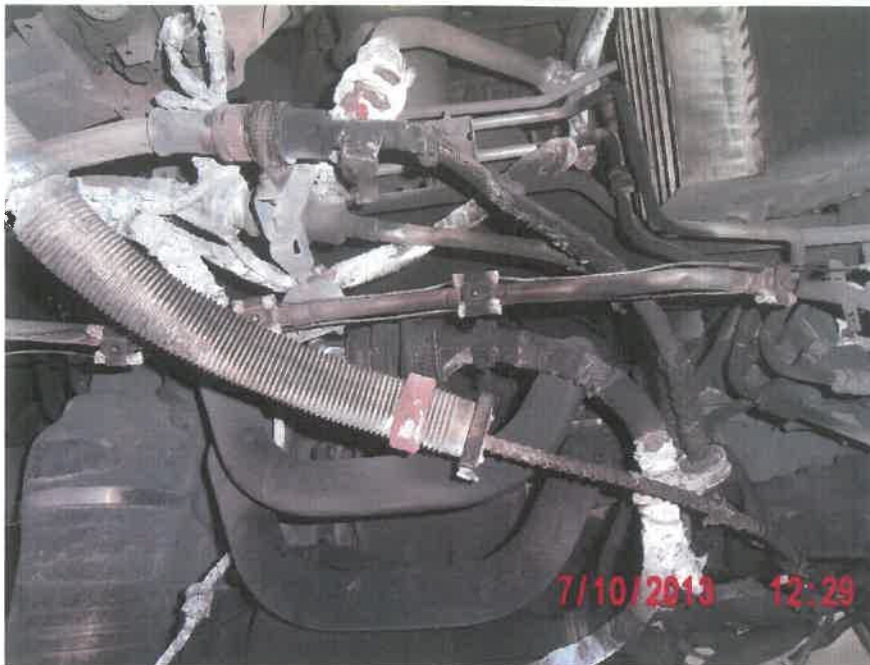
**Components Aft of MEC on Right Side of Engine**

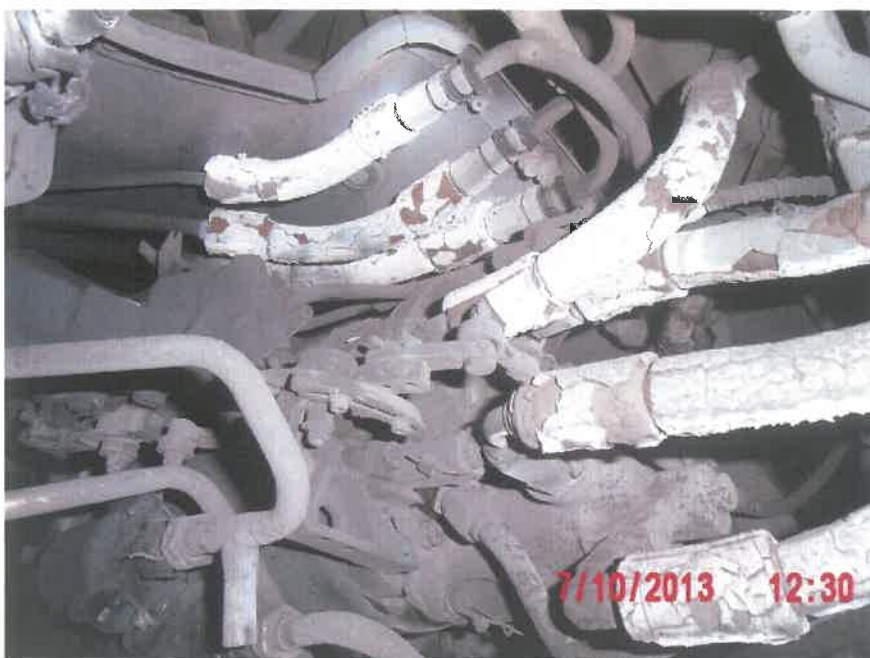
**Burnt Fuel Hoses on MEC**

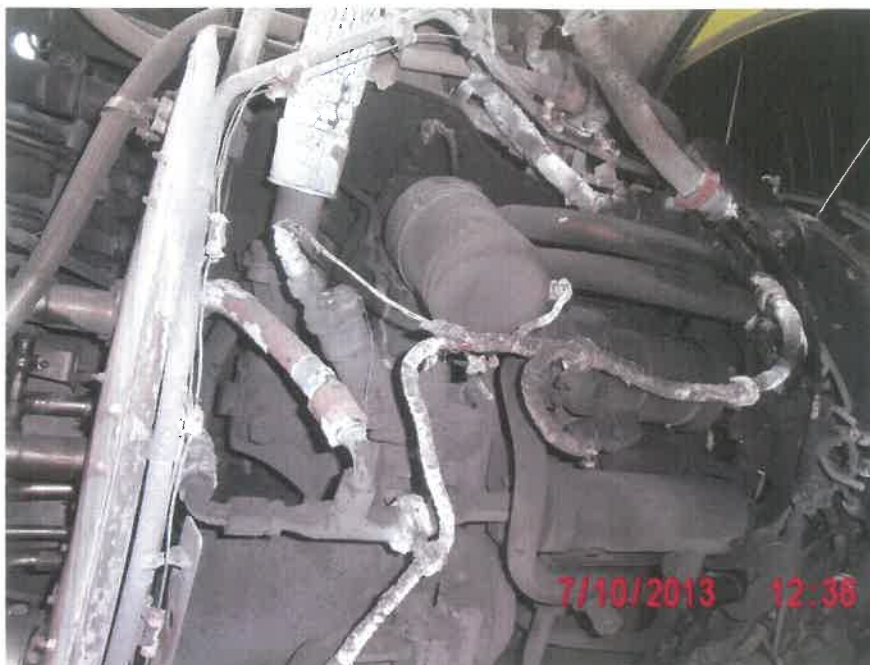
**Wiring Damaged by In-Flight Fire on Lower Right Side of Engine**

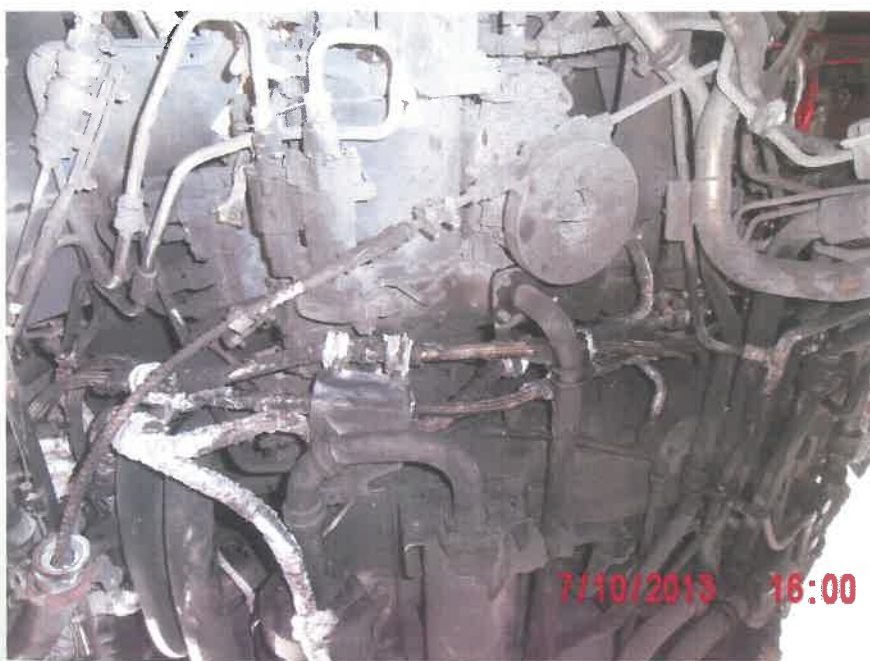
**Detailed View of Damages on Lower Side of Engine**

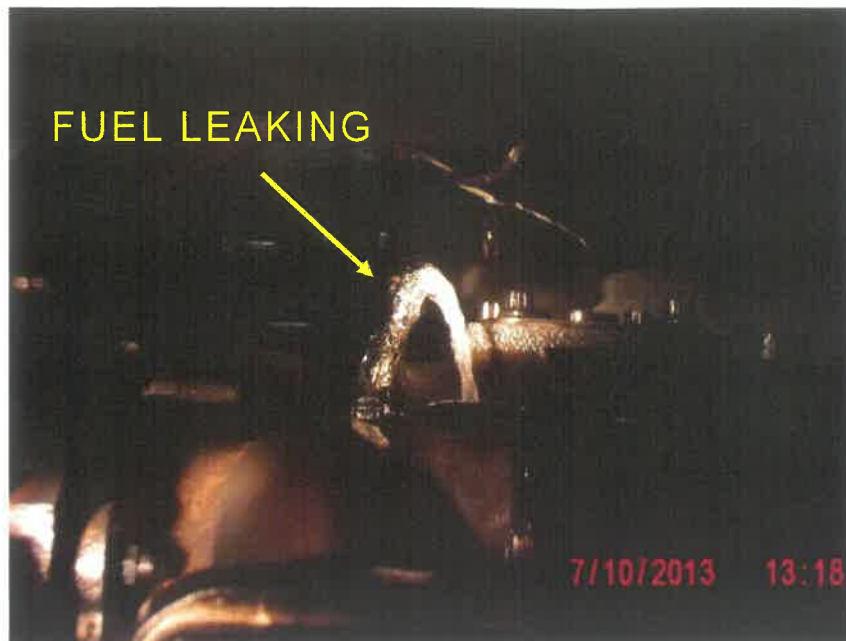
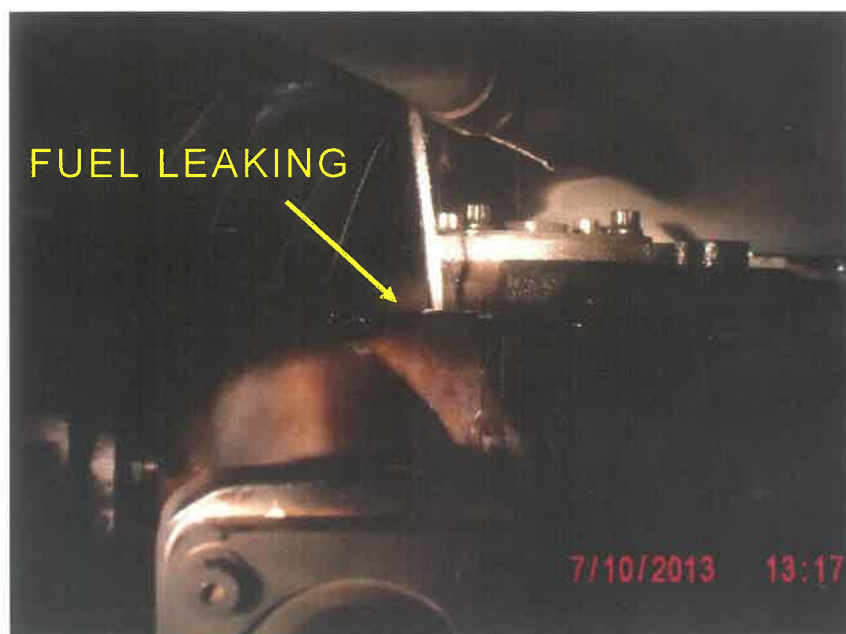
2.2.2.1 After the in-flight fire occurrence, during investigation when the Engine No. 2 Fire Handle was pushed "IN" without fuel booster pumps ON, fuel under gravity feeding was found leaking from top of MEC. Pictures attached below:

Fuel Leaking from Top of MEC Under Gravity

Fuel Leaking From top of MEC Under Gravity

3.2.5 During trouble shooting, when Fire Handle was pushed in to reset, heavy fuel leakage was observed from the top of MEC.

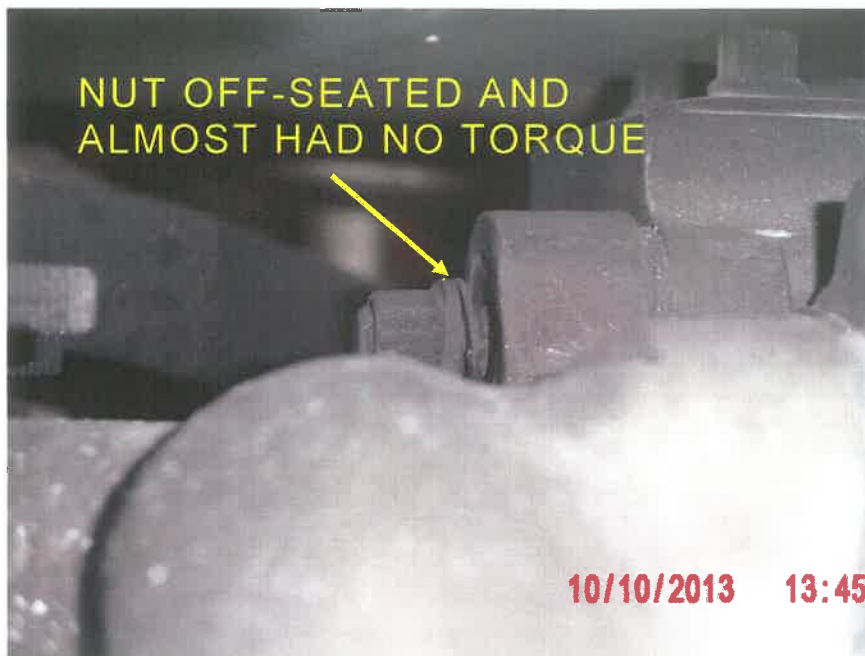
- 2.2.2.2 During detailed visual inspection, one top MEC mount Nut Part No. J1092P05 was observed "off seated" from its actual torqued position. The pictorial evidence is appended below:

**MEC Top Nut "Off Seated" from its Position**

3.2.8 One MEC mounting nut on top side was found off-seated (in zero torque condition); whereas, threads of its stud and nut were in satisfactory condition.

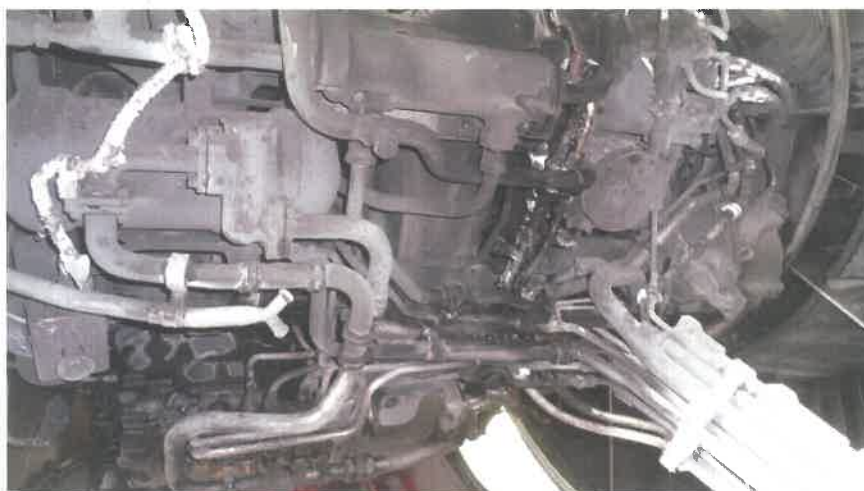
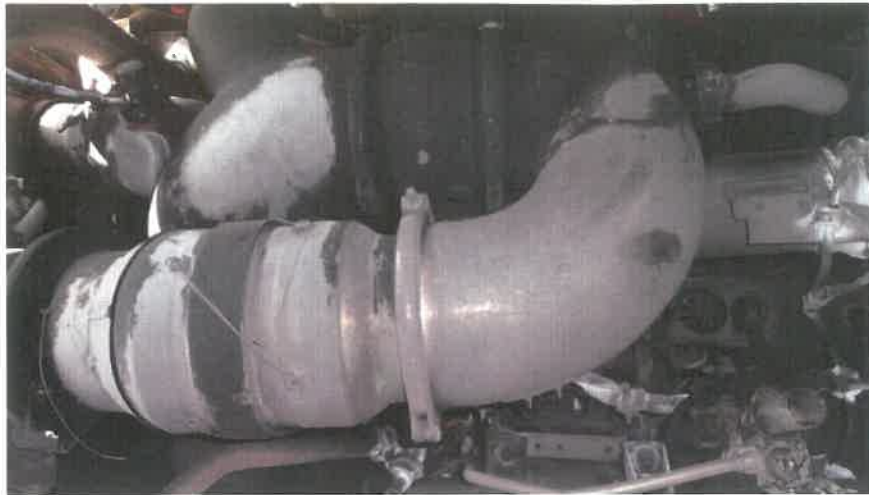
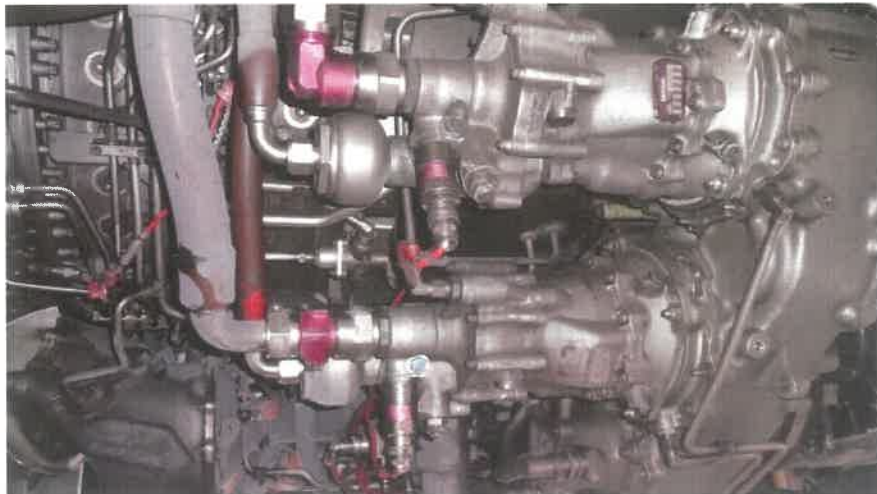
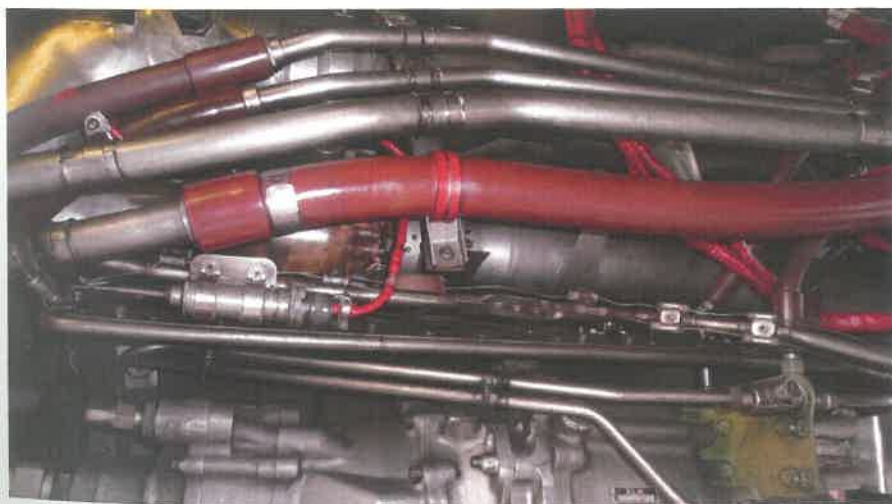
- 2.2.2.3 All engine build-up items, ducting, lines / hoses and engine accessories were found intact during detailed visual inspection.

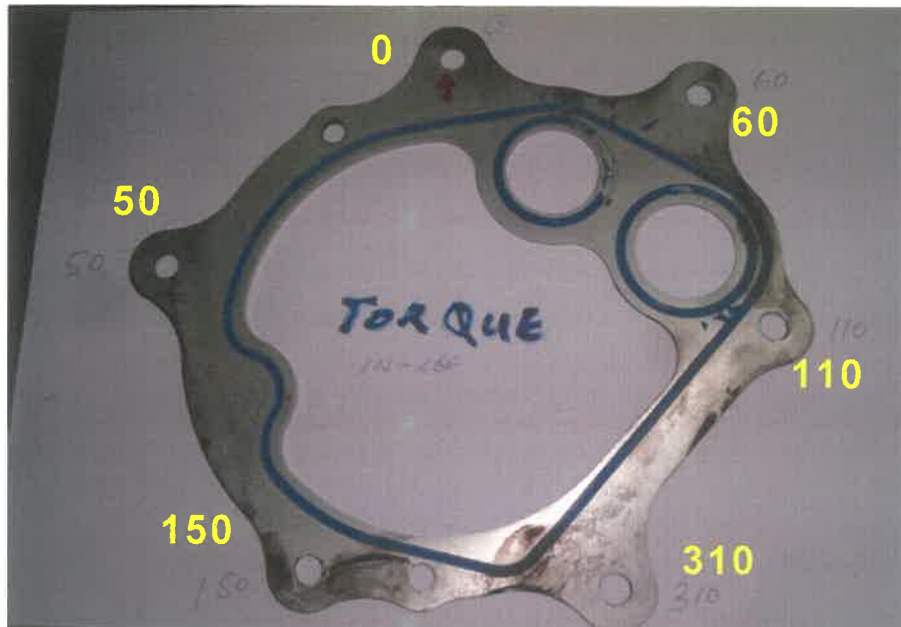
2.2.3.1 MEC Part No. 8061-889, Serial No. WYG55448, TSN/CSN: 41085/13785, of affected engine was removed in Power Plant Overhaul (PPOH) Shop for further examination. During removal of MEC, un-seated (opening) torques of MEC mount nuts were measured and recorded. The torque range as per Aircraft Maintenance Manual (AMM 73-21-01, Page 401, Refer Appendix "G") is 175 to 200 lbf in, whereas the measured un-seated torque values (Refer Appendix "H") were observed as 0, 60, 110, 310, 150 and 50 lbf in as shown below:

**Measured Un-seated\* Torque Values of MEC Mount Nuts**

3.2.7 Subsequent strip examination revealed improper torquing of MEC six mounting nuts.

3.2.19 The un-evenness of torque values, one missing washer, one over sized washer and one nut not tightened at all, resulted into unsymmetrical loading on the gasket and forced the rubber seal to rupture.

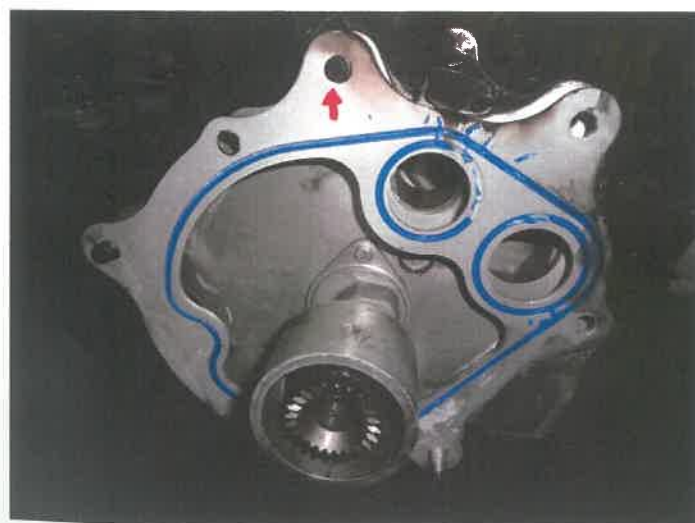
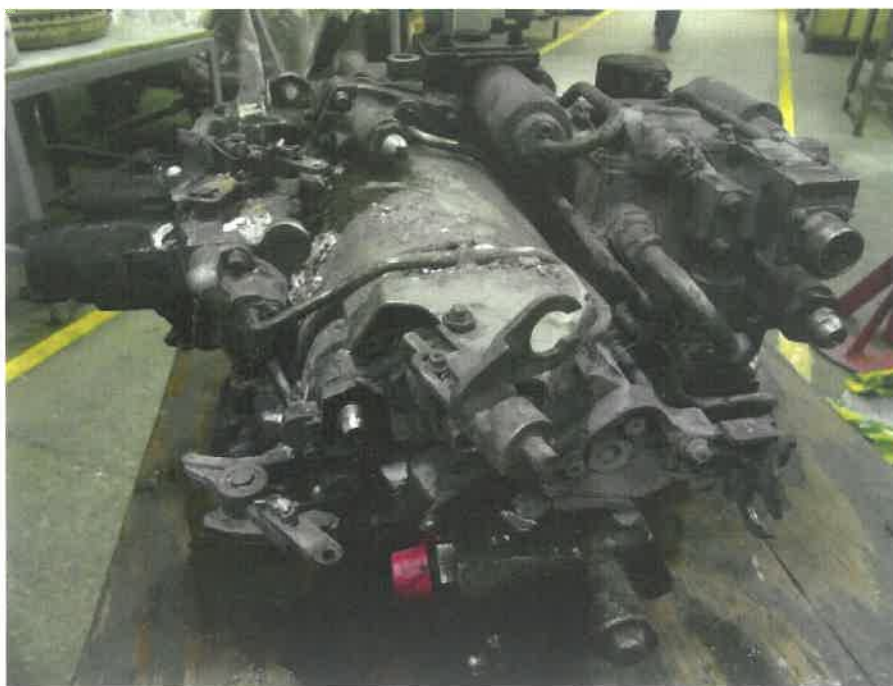
**Mishap Gasket and MEC**

**Removed Mishap MEC**

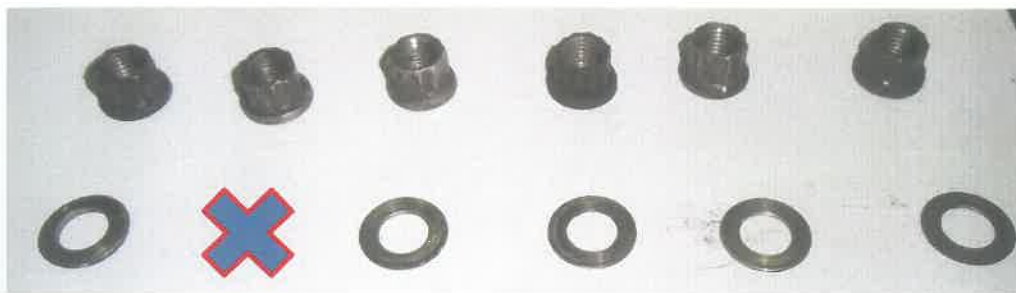
2.2.3.3 One MEC mount washer Part No. AN960C516L was observed missing during removal of MEC.

**One Washer Found Missing**

3.2.11 Out of six washers installed with these nuts, one was completely missing and another one was of more thickness than the specified limits.

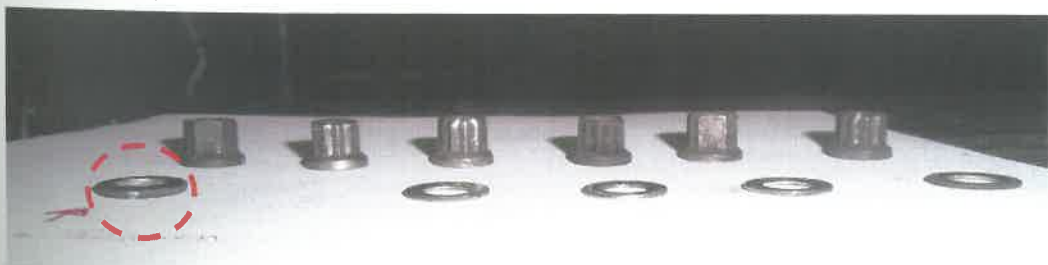
2.2.3.4 It was also observed that one out of five washers was of more thickness (0.057 inch against the standard thickness of 0.022 – 0.042 inch.), refer CF6-80C2 Airbus Engine Illustrated Parts (IPC 72-00-05 Fig. 25) Accessory Drive Module – Main Engine Control (**Refer** Appendix "I"). The remaining four washers were of correct thickness (0.029, 0.031, 0.028, 0.029 inch).

**One Washer of More Thickness**

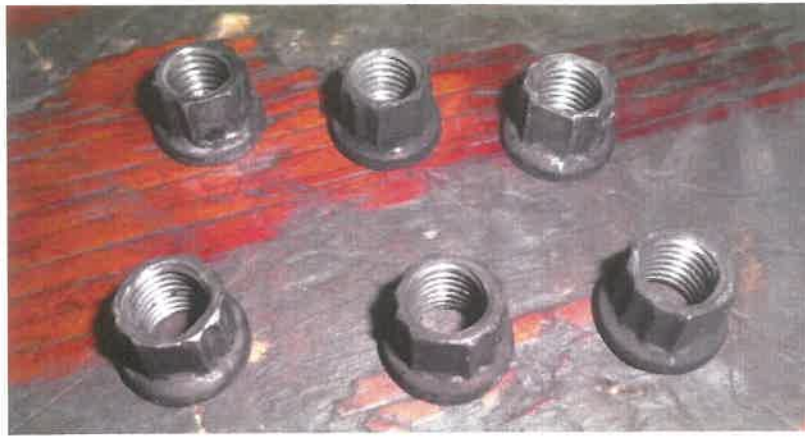
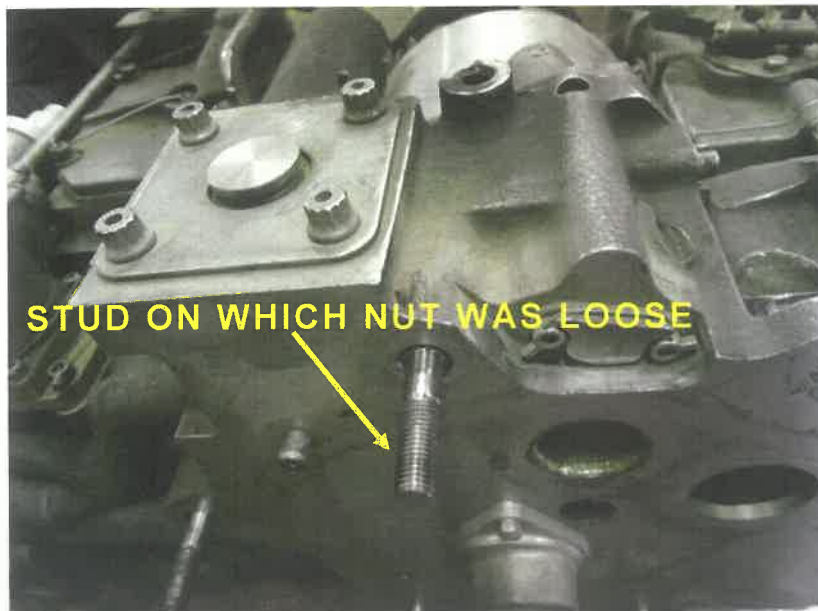
2.2.3.5 The conditions of Nuts Part No. J1092P05 and Studs Part No. MS51833A203-16 were also inspected and found normal.

**MEC Mounting Nuts Condition Normal**

**Condition of Stud Normal**

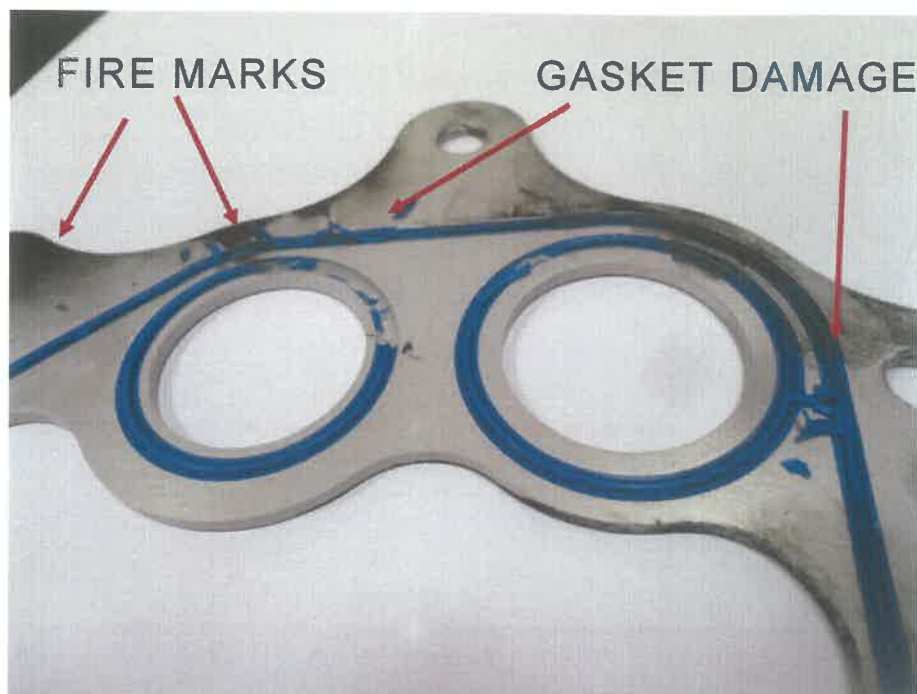
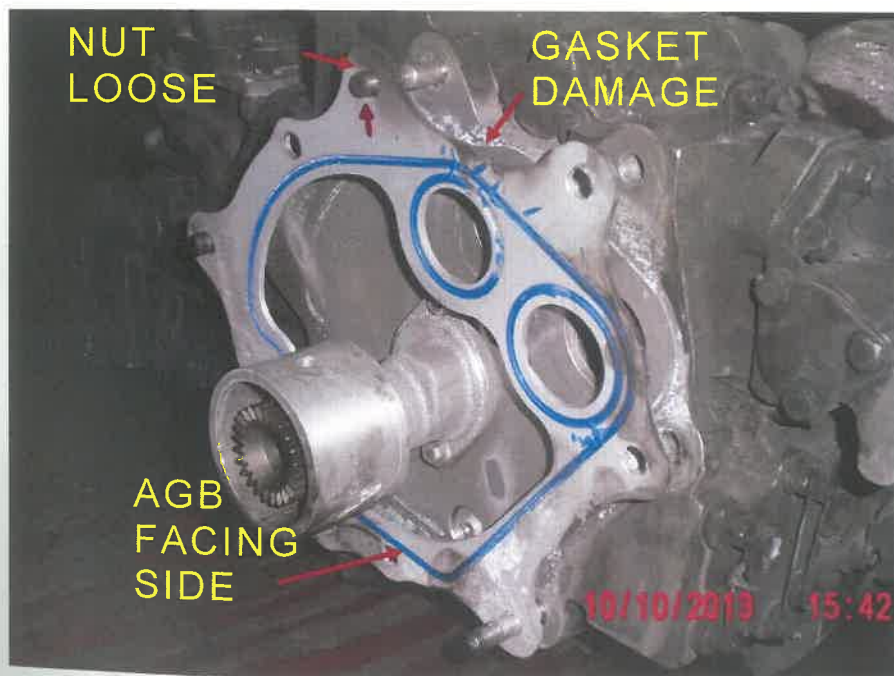
- 2.2.3.6 The Blue coloured Fluorocarbon (Viton) rubber seal of MEC gasket Part number 9378M27P01 (TSN/CSN: 56/15), was found damaged. Black soot marks indicating Fire were visible on the upper half of the gasket and on its side facing the Accessory Gear Box (AGB). MEC gasket thickness was checked on surface plate but due to erosion / damage of seal, it was not possible. MEC gasket was also found slightly bent (metal part) after removal.

MEC Gasket AGB Side Damage

Gasket along with MEC

2.2.4.1 From the above mentioned examination and analysis, it was observed that MEC gasket became un-serviceable due to the inadequate torques applied, use of improper sized washer and missing of one out of six washers during MEC replacement at Madina.

2.2.4.5 The mishap aircraft flew fifteen flights prior to the occurrence of Engine No 2 in-flight fire mainly due to the fact that the rubber seal embedded in the gasket did not give in initially. Subsequently due to the un-evenness of torque values, one missing washer and another oversized washer, and one nut not tightened at all resulted into unsymmetrical loading on the gasket and forcing the rubber seal to rupture. In the mishap flight, the ruptured rubber

seal could not withstand the fuel feeding into the MEC under pressure and heavy fuel leakage started from it. The accumulated and vaporized fuel caught fire when it came in contact with the hot area resulting into intense in-flight fire.

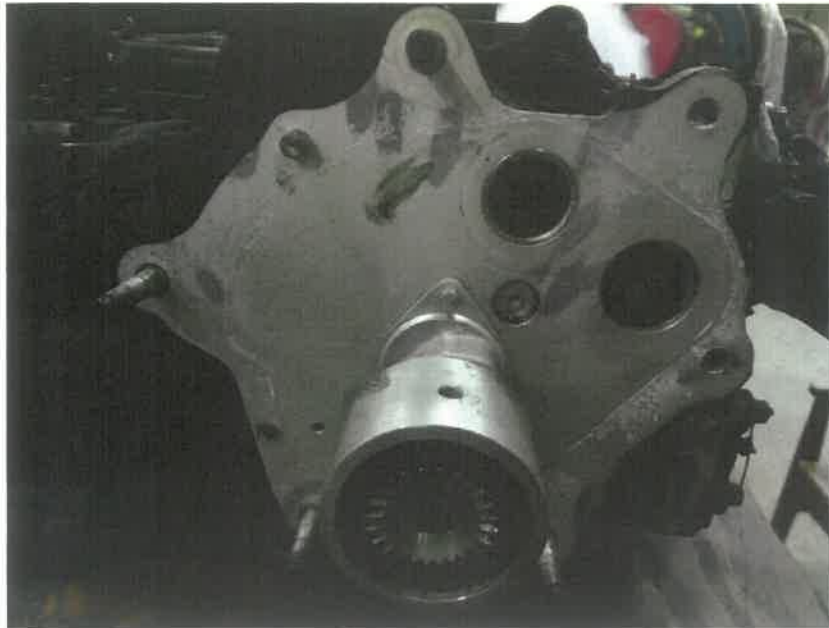
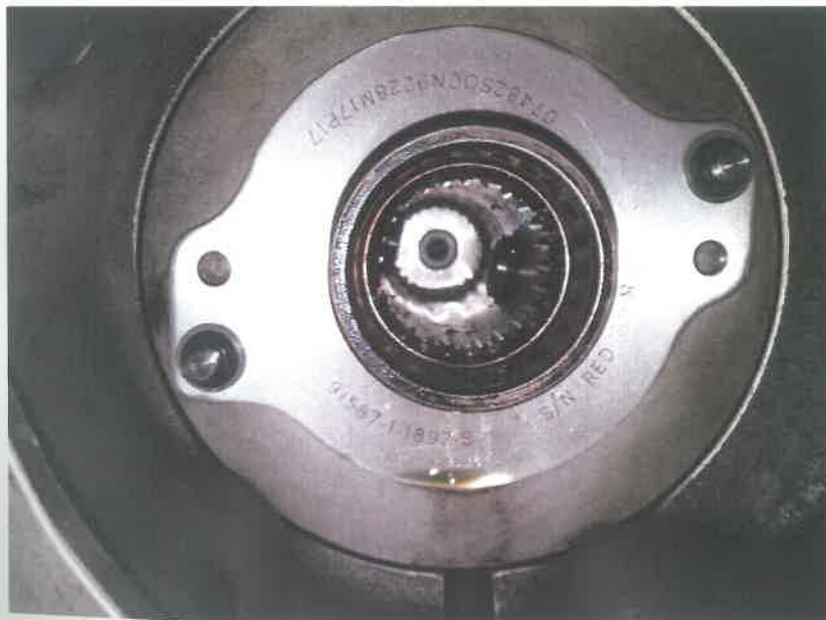
2.2.3.7 Both the AGB and MEC faces contacting the Gasket were normal and were not damaged.

**MEC Splines and Face**

**AGB Splines and Face**

3.2.22 There was no abnormality on the mating surfaces of MEC and AGB which could lead to gasket damage.

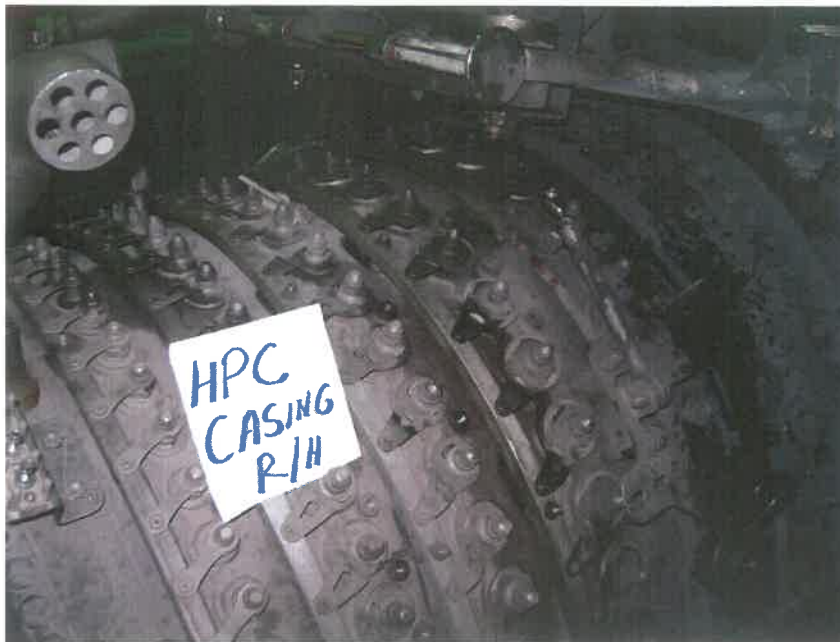
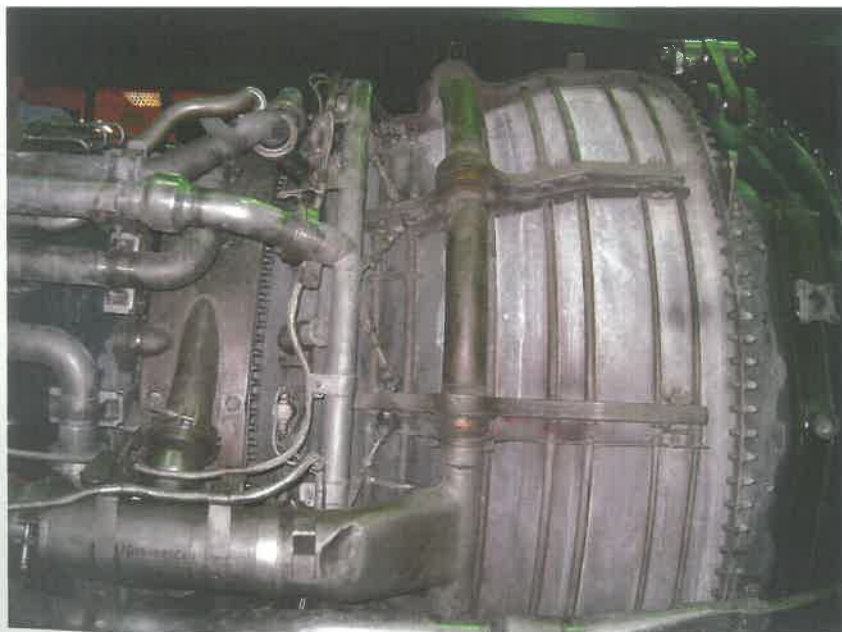
2.2.3.8 During strip examination of engine, no damage to the engine casing and its modules was observed. Only rubberized and soft material items / components were found damaged on the engine in nacelle area.

High Pressure Compressor Casing

High Pressure Turbine and Low Pressure Turbine Casing
