(SAFETY & INVESTIGATION BOARD)  
PAKISTAN CIVIL AVIATION AUTHORITY

## AIRCRAFT ACCIDENT INVESTIGATION REPORT

### CRASH OF CESSNA-172 AP-BFO NEAR SIALKOT ON 25 APRIL, 2004

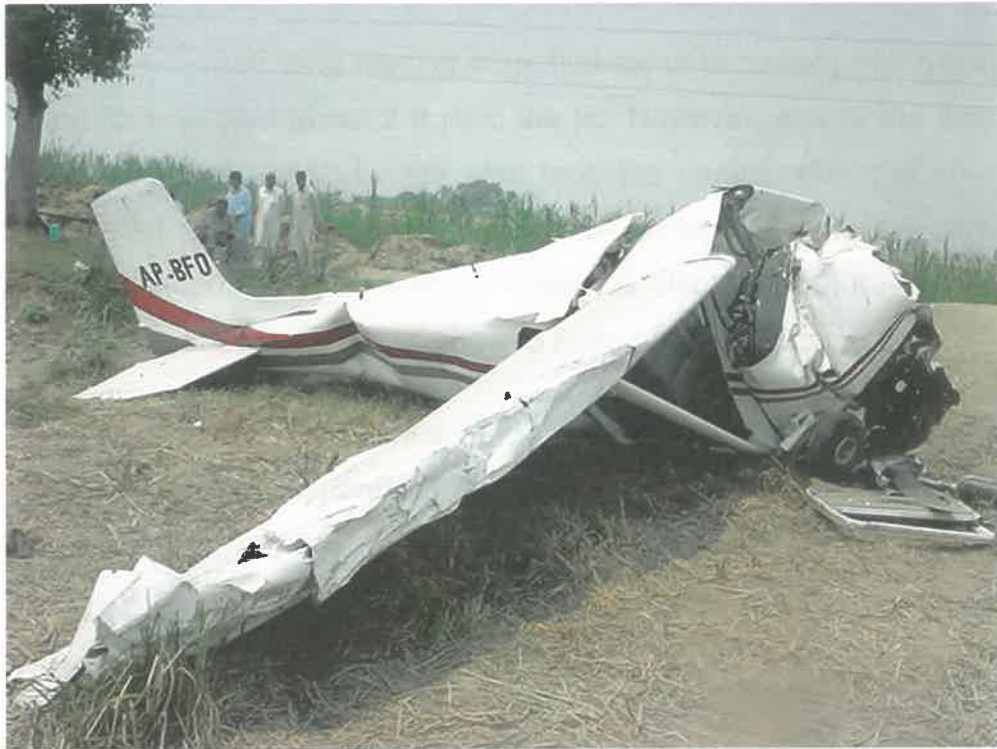
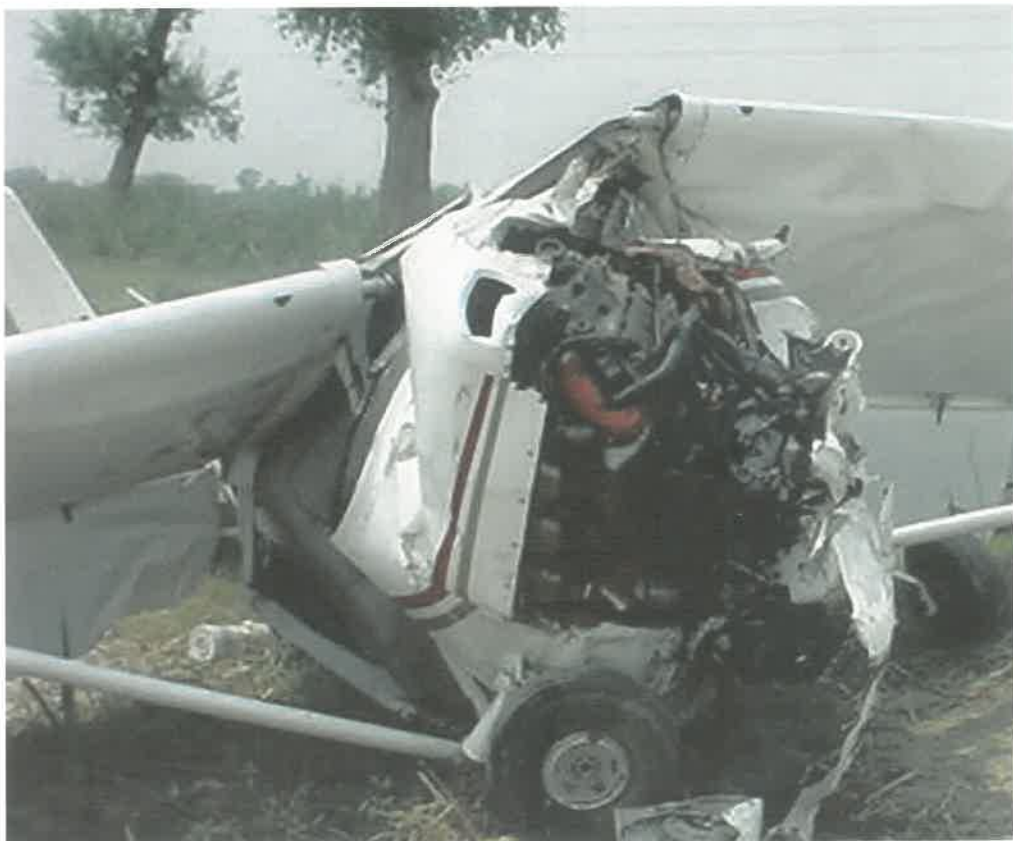
**Nose** The 04 ft nose, housing the engine, was completely smashed and engine was exposed. Major portion of the engine and instrument panel had moved inside the Cockpit and rested on left seat.

**Engine** The propeller was detached from the engine after coming in contact with ground 40 ft before main impact. The oil sump was broken,

the main block was cracked and; fuel lines and carburettor was damaged.  
The generator and electrical lines were damaged.

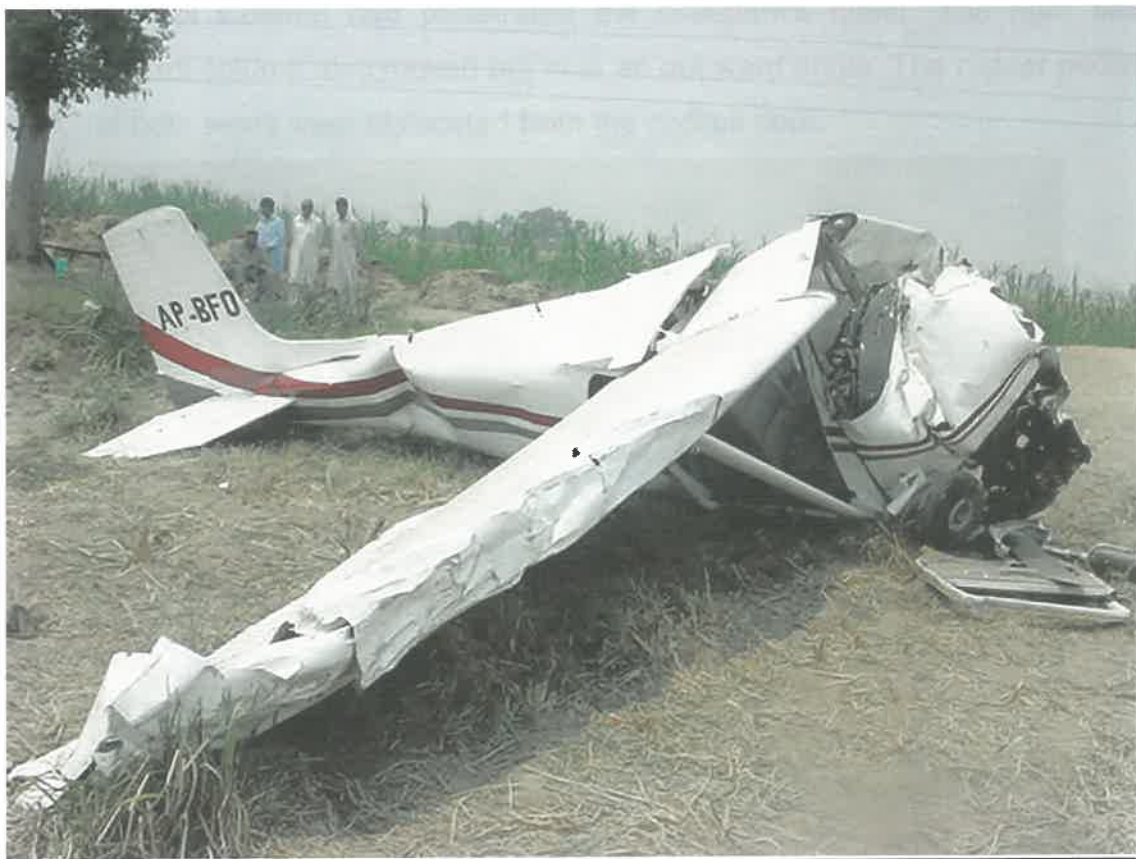
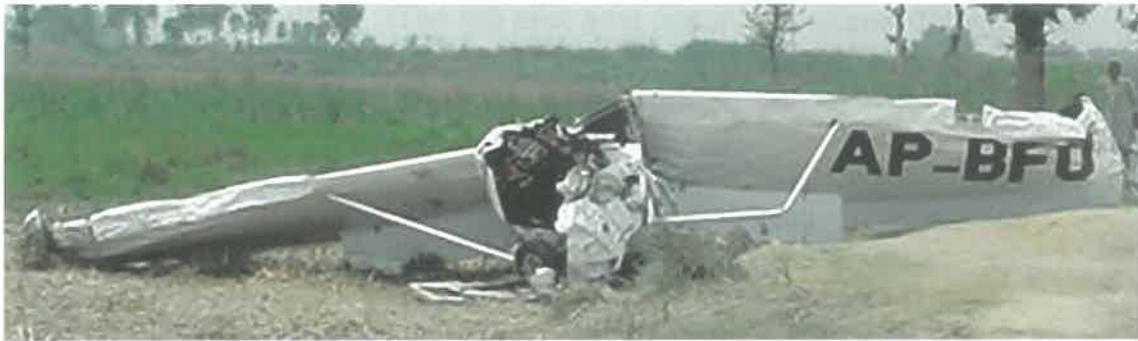
**Fuel tanks.** Both the fuel tanks had leaked due to the opening of welded-lining under impact force.

**Wings.** Left wing leading edge first came in contact with ground and wing tip was bent about 2 ft from the tip. However, due to the unlevelled ground the left leading edge also took the impact after the nose; and separated at half-chord length from the fuselage. During the cart-wheel impact motion right wing leading edge was also bent but it remained with the fuselage. Both the wings showed even-flaps deflation to  $40^{\circ}$ .

**Fuselage** All the frames and ribs of main fuselage had either bent/buckled or separated from the skin. The skin was wrinkled progressively towards tail, while front fuselage skin separated from different parts.

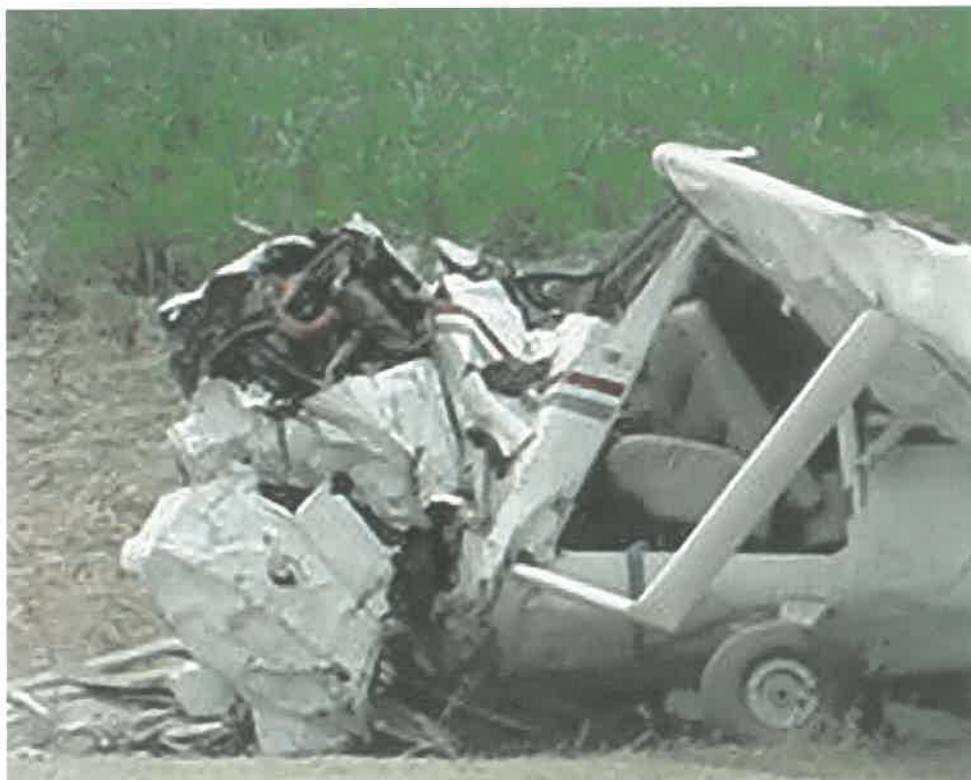
**Control Links/surfaces** All control cables were intact; however, levers' and pulleys' at transmission points from control columns were bent or separated. The ailerons, rudder and elevators had free movement until restricted by impact deformation of mounting frames.

**Cockpit** All the plexi-glass windows and wind screen were shattered. The nose of the aircraft i.e. engine and instrument panel had moved in at 45° angle into the Cockpit. The left pilot seat had shifted backward and Control Column had penetrated the occupant's chest. The right seat control column also moved but in at an out ward angle. The rudder pedals of both seats were dislocated from the cockpit floor.

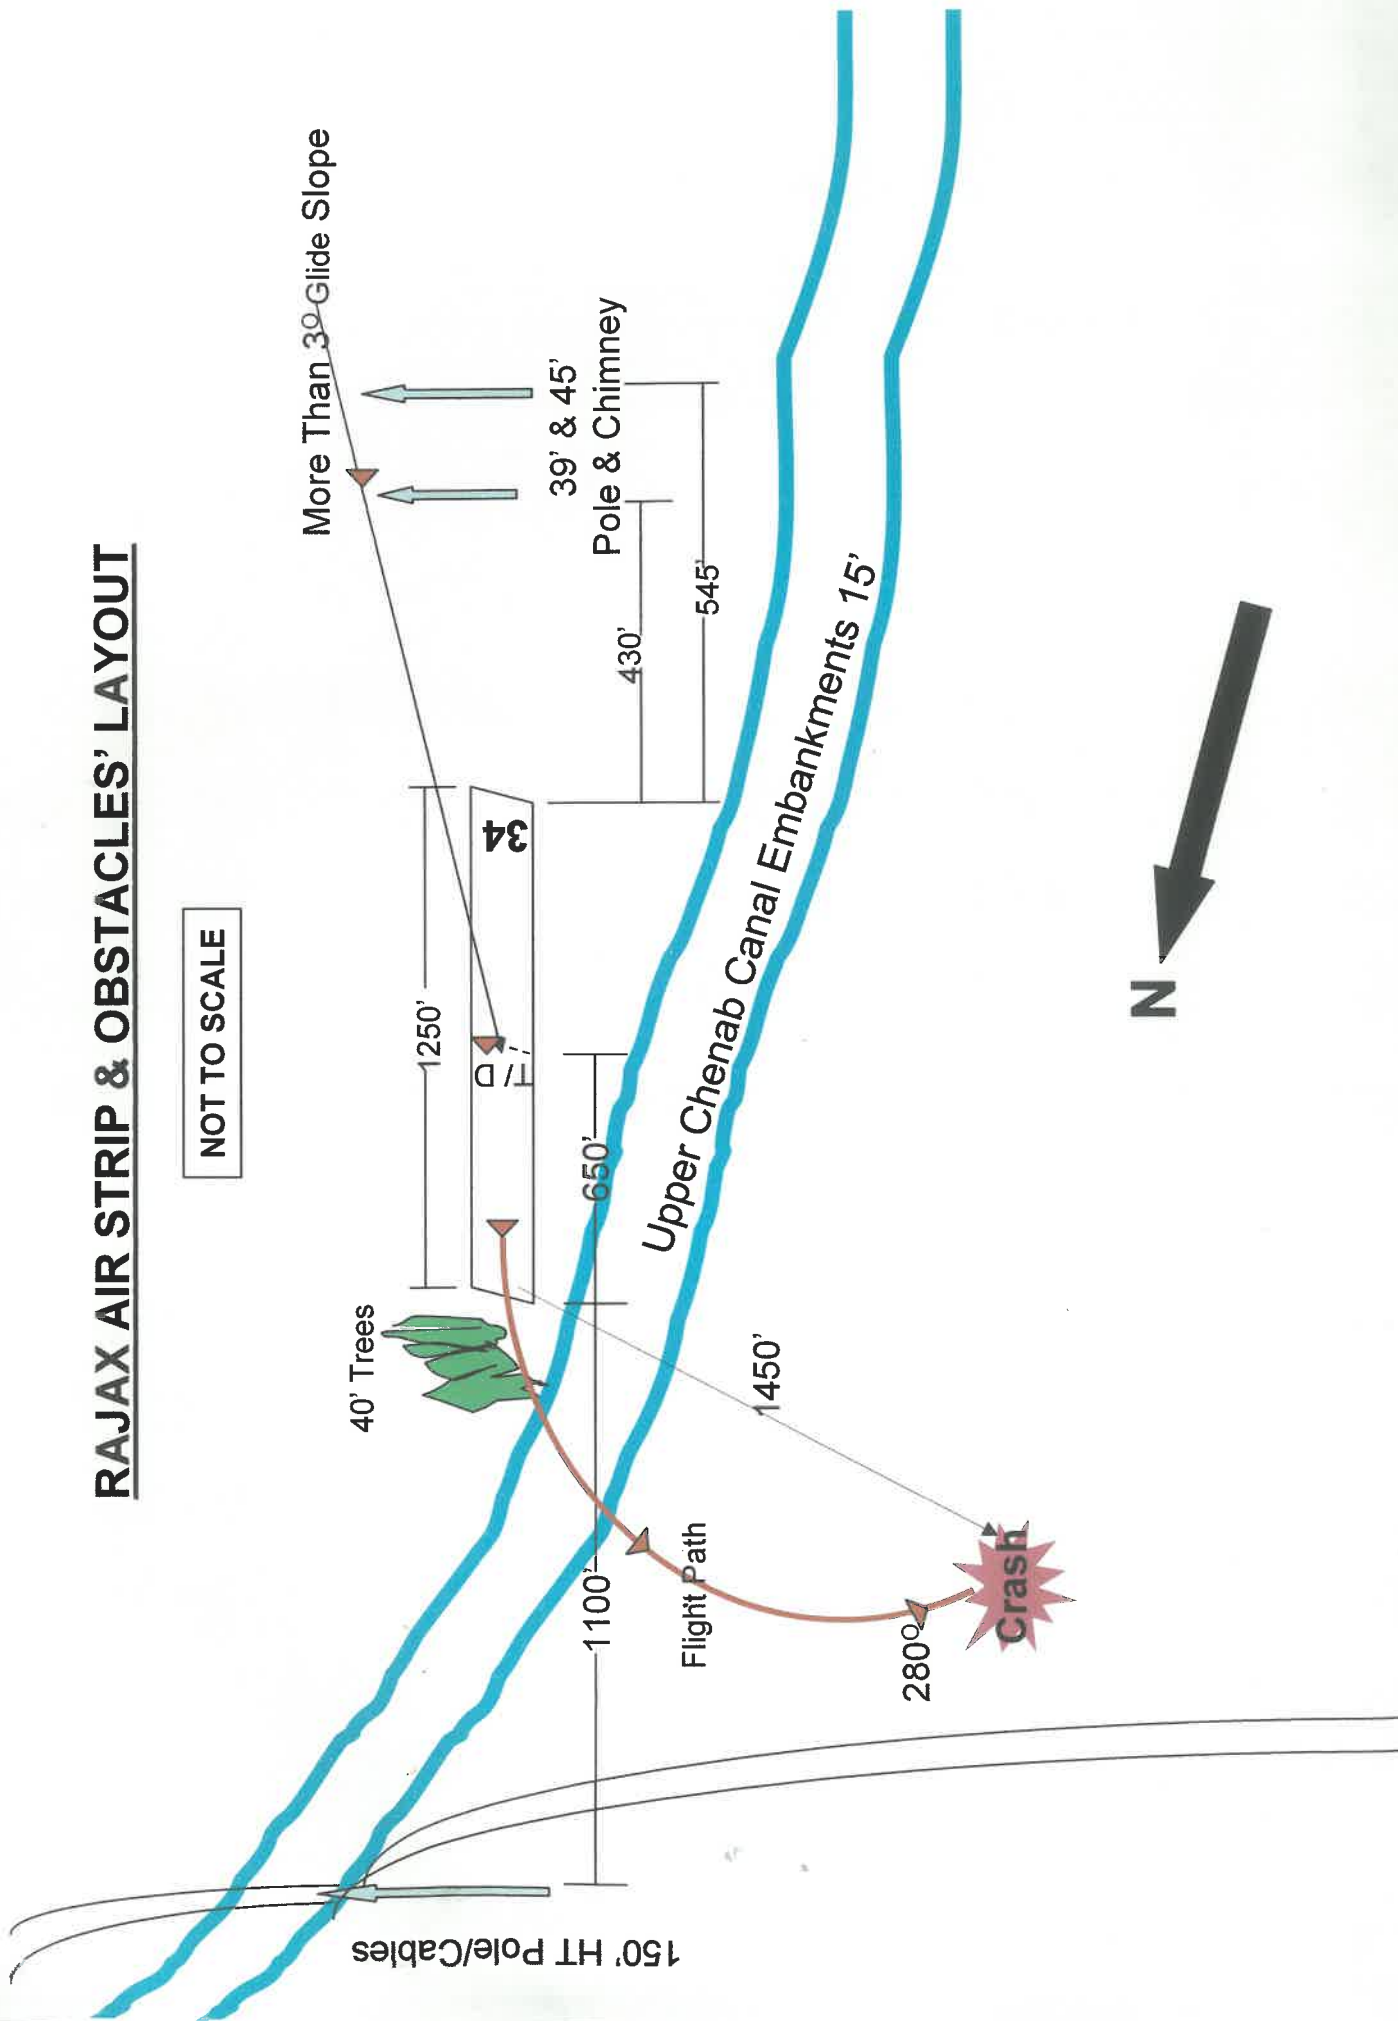
# RAJAX AIR STRIP & OBSTACLES' LAYOUT

21. **Airstrip Layout.** Since licensed on 09 June, 2003 no aircraft had operated from the airstrip until the mishap flight. The airstrip is located in the middle of cultivated land (Appendix 'K').. A 15 ft high embankment of Upper Chenab Canal is passing at an angle of  $45^0$  at a distance of 50 ft in the North. In between the embankment and the end of the RW 34 there is 40-50 ft high tree line. Further North in line with RW direction, a HT Cable Tower (150' high) stands at a distance of 1100 ft. The HT Cables are almost  $90^0$  to RW 34. The undershoot RW 34 has a pole and a chimney almost in line with RW direction. The distance of two 39 ft and 45 ft high obstacles from beginning of the RW is 430 ft and 540 ft respectively. Furthermore, 40 ft from edge of the RW 34 beginning there is a clump of 30-40 ft high trees in the West.

26. The Rajax Airstrip has obstacles on both ends of the Runway; however, landing direction was restricted to Runway 34 only and take off Runway 16 only, due to the obstacles. First 400 ft of 1250 ft Runway is not compacted properly. The obstacles of 39 ft and 45 ft height in undershoot of Runway 34 at a distance of 430 ft and 540 ft respectively prevent touch down in the beginning of 1250 ft long runway. These obstacles force a glide slope of more than  $5.2^{\circ}$  as against  $2.5^{\circ}$  normal glide slope for landing in the beginning. A glide slope of  $2.5^{\circ}$  i.e. just clearing the obstacle, would take the touch down point beyond 900 ft on 1250 ft long Runway or a maximum  $3^{\circ}$  glide slope would result in a touch down point beyond 750 ft. It means that only 350 ft Runway would be available to stop the aircraft on a landing roll with  $2.5^{\circ}$  glide slope and 500 ft with a maximum glide slope of  $3^{\circ}$ . Furthermore, a go-round after touch down would force a pre-mature take off to avoid 40-50 ft high trees in the overshoot. On Rajax Airstrip elevation on standard day, Cessna-172 required 700 ft to stop on landing roll as against

- e. Rajax Airstrip has 40-50 ft high trees on Runway 34 end and HT Tower at 1100 ft in line with Runway. In the undershoot there is a 45 ft Chimney and a 39 ft high a pole, which force a glide slope of more than 3° for touch down at or beyond centre of 1250 ft Runway.

- a. ANO on private airstrip be formulated and approval be given after physical inspection by a board which should have a member from Flight Standards, Operations and Licensing.
- b. Flying status of PIC may be reviewed by Flight Standard and Chief of Aviation Medicine in the light of memory lapse and cause of accident.
- c. Individually owned aircraft operations be supervised by an AOC holder i.e. Flying Club etc.
- d. Air Worthiness Directorate to ensure correct C of A documents.
