## FINAL INVESTIGATION REPORT

**INVESTIGATION INTO SERIOUS INCIDENT OF  
M/S SHAHEEN AIR INTERNATIONAL FLIGHT # NL-148,  
(SECTOR KHI-LHE) B-737-400 AIRCRAFT, REG # AP-BJN  
(BIRD HIT AT SHORT FINALS AND RUNWAY  
EXCURSION AFTER LANDING AT LAHORE  
ON 30<sup>TH</sup> DECEMBER 2014**

### SERIOUS INCIDENT OF M/S SHAHEEN AIR INT'L (SAI) FLIGHT NL-148 (SECTOR KHI-LHE), B737-400 AIRCRAFT, REG # AP-BJN AT AIIAP, LAHORE ON 30<sup>TH</sup> DECEMBER, 2014

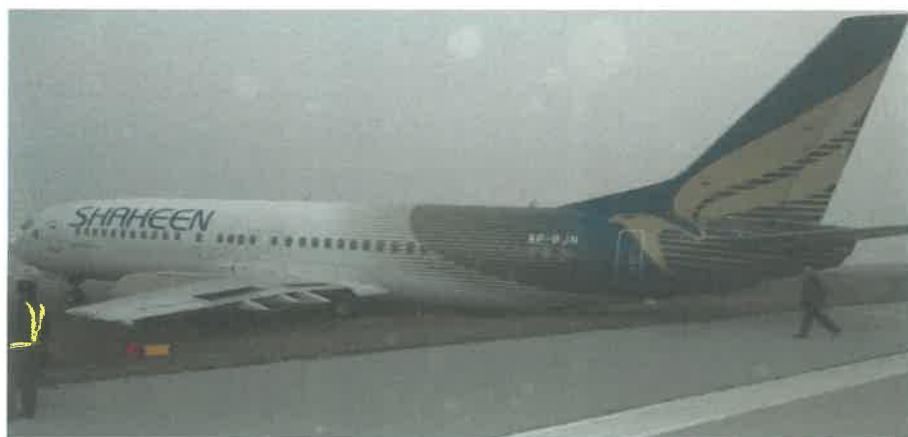
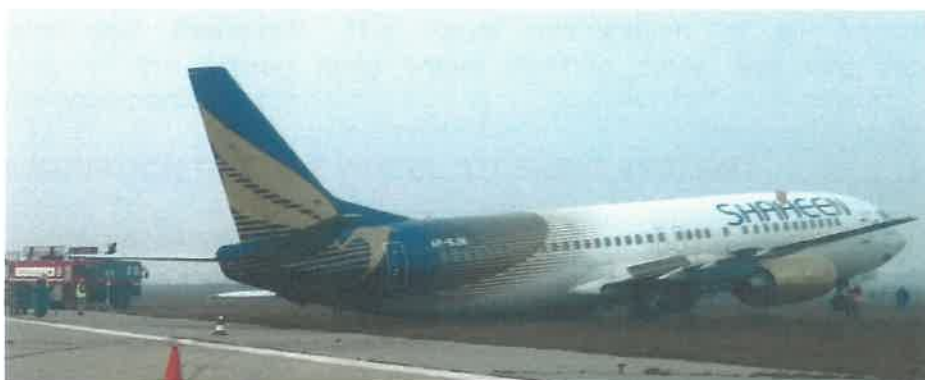
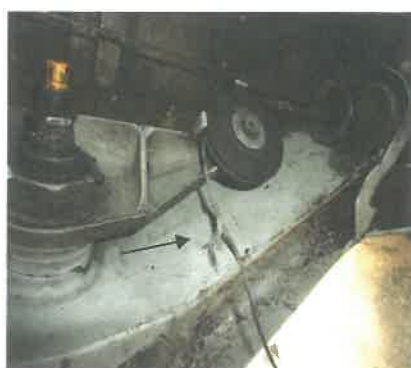
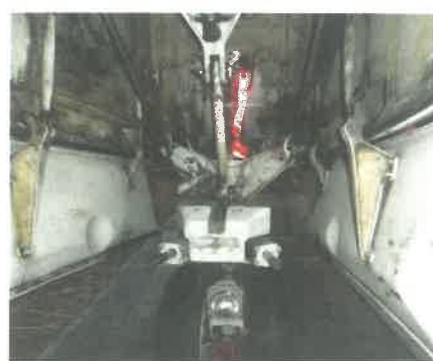
**1.12. Wreckage and Impact Information.** The aircraft remained intact after departing the runway. Left Main Landing Gear (LMLG) tires ploughed into the soft ground for about three meters and then the landing gear collapsed. The left engine touched the ground after the landing gear collapse and dragged for about two meters till aircraft came to a final stop. Fresh blood stains and bird feathers were present in the nose wheel well area, and nose wheel steering cable was found broken.

Bird hit area, blood stains and feathers on the broken cable

2.2.4. The nose landing gear had evidence of bird hit in the form of fresh blood stains. Few bird feathers were also found in the hardware around the bird strike area.

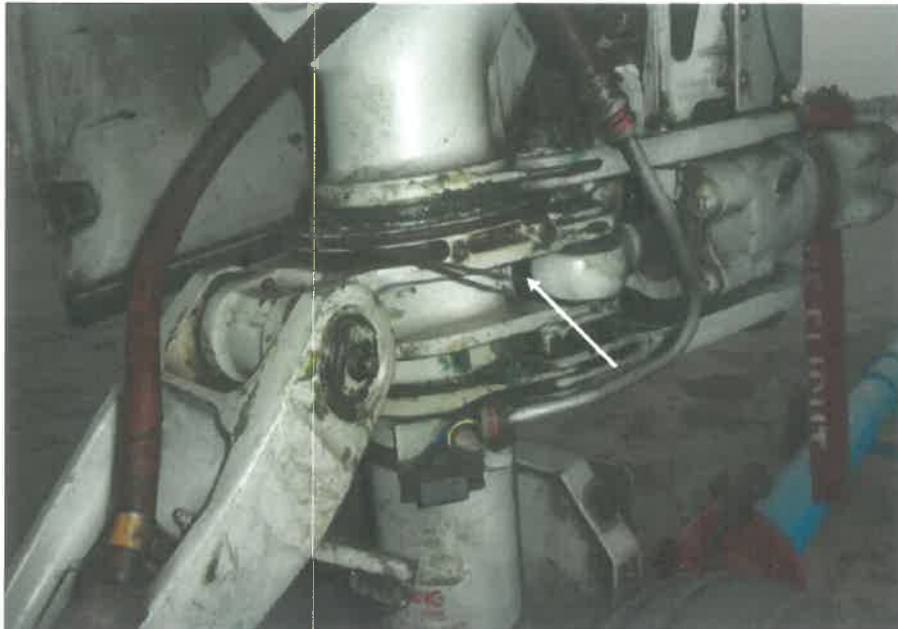
The lower end of broken steering cable on steering collar

2.2.6. The bird strike took place on left side of the nose leg top fork. The left side nose wheel system steering cable (NWSA) was found fractured approximately at a point where it starts its routing on the steering collar. A portion of the cable was found pulled out from the lower side pulleys mechanism (closer to steering metering valve). The upper side of the cable was dislodged from the pulley groove and was found stuck between the pulley guard and the pulley. The position of the cable indicated that the bird most probably struck directly on the cable.

4.2.4. The fracture surfaces of the failed cable (NWSA) revealed the failure mode as plain ductile overload.

5.1 The nose wheel steering cable (NWSA) fractured due to bird impact.

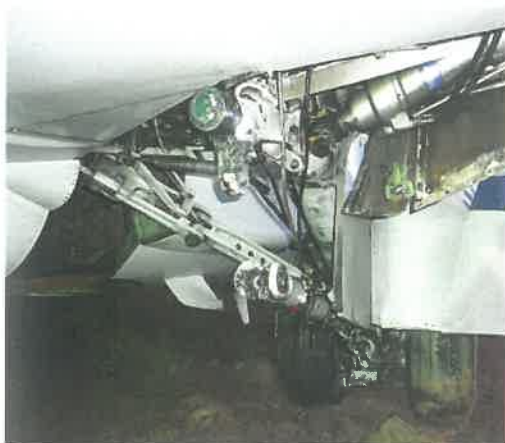
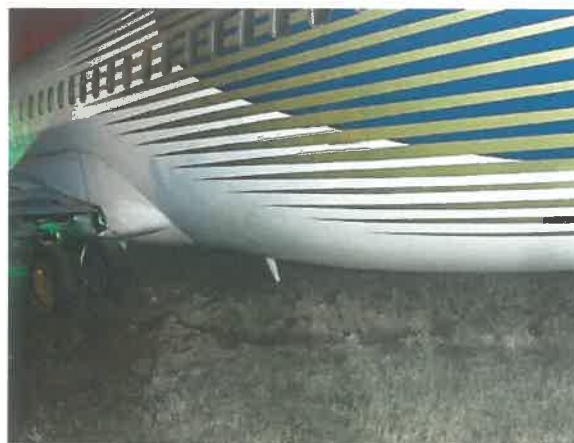
2.2.1. The detailed examination of the collapsed left main landing gear and ground marks indicated that LMLG collapsed when its tires ploughed through the soft ground off the runway, while the aircraft was moving forward.

2.2.2. The fractured surfaces of failed parts of the LMLG were closely examined, overload fracture was indicated by failure surfaces and associated deformation pattern.

The unspecified loads while tires of LMLG ploughed through the soft ground caused failure of attachment points and thus resulted in collapse of the landing gear.

4.2.8. The LMLG experienced overload after the aircraft went off the runway, LMLG tires ploughed through the soft ground and collapsed after failure of its attachment fittings.

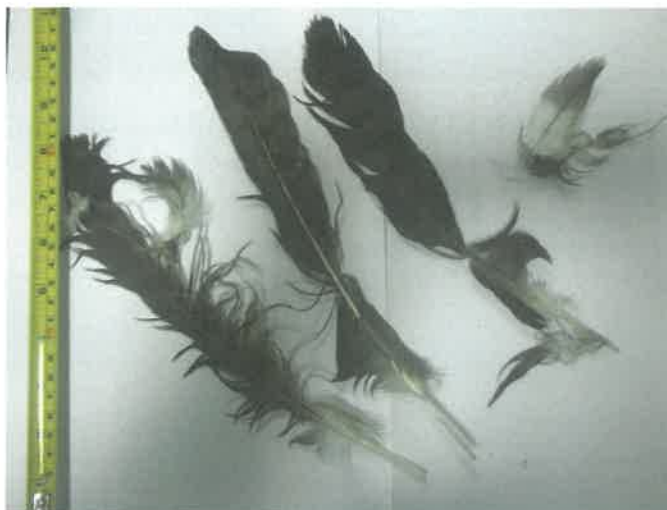
2.2.5. The bird feathers recovered from the wheel well area were similar in appearance to feathers of kite generally found in the local area.

Bird feather recovered from nose wheel area

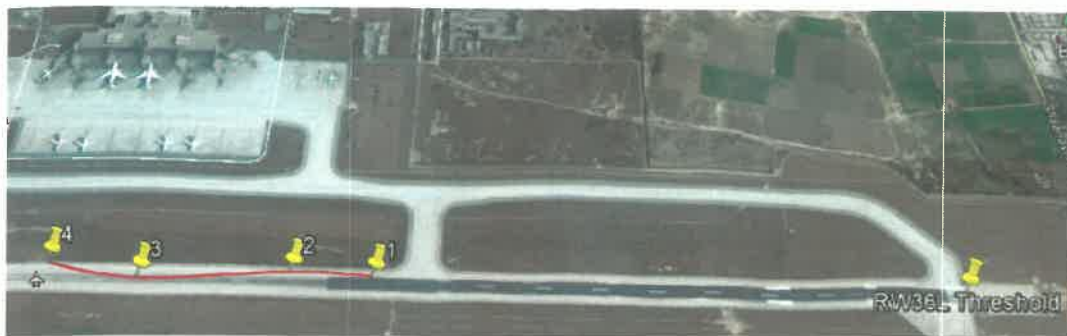
2.2.7. **Aircraft Track on Runway and Tire Marks.** The runway was critically examined to identify the tire marks of the mishap aircraft after landing. The aircraft track of the on the runway is depicted and described in following pictures and paragraphs:

Approximate track of the aircraft after landing based on tire marks

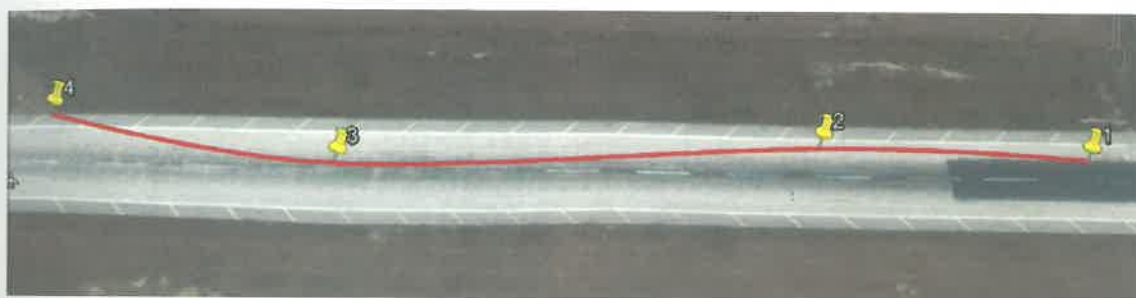
Enlarged view of the approximate track of the aircraft after landing

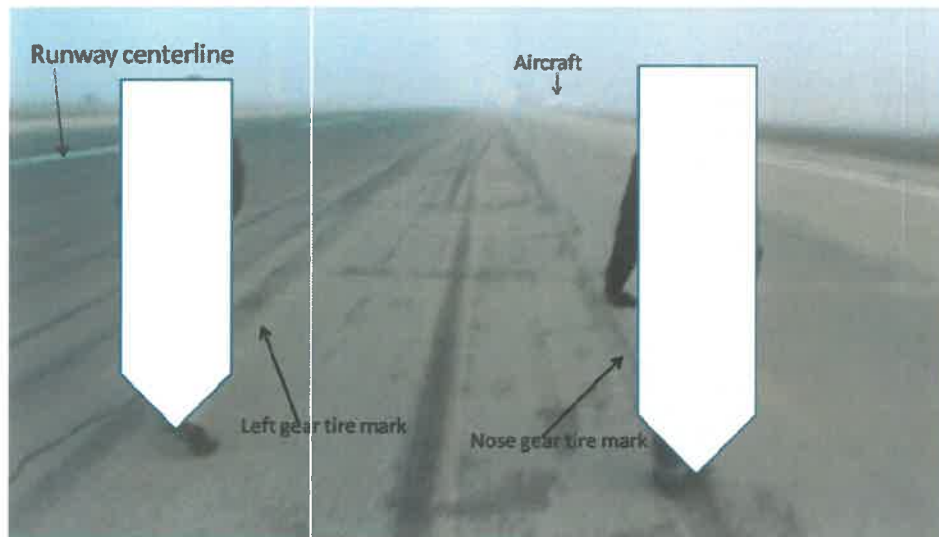
2.2.8. The measured distance from the runway threshold to the first identifiable mark of nose wheel on the surface of the runway (Point# 1) was 1049 m from runway threshold and 11.3m to right of runway centerline (CL).

First identifiable tire marks on the runway

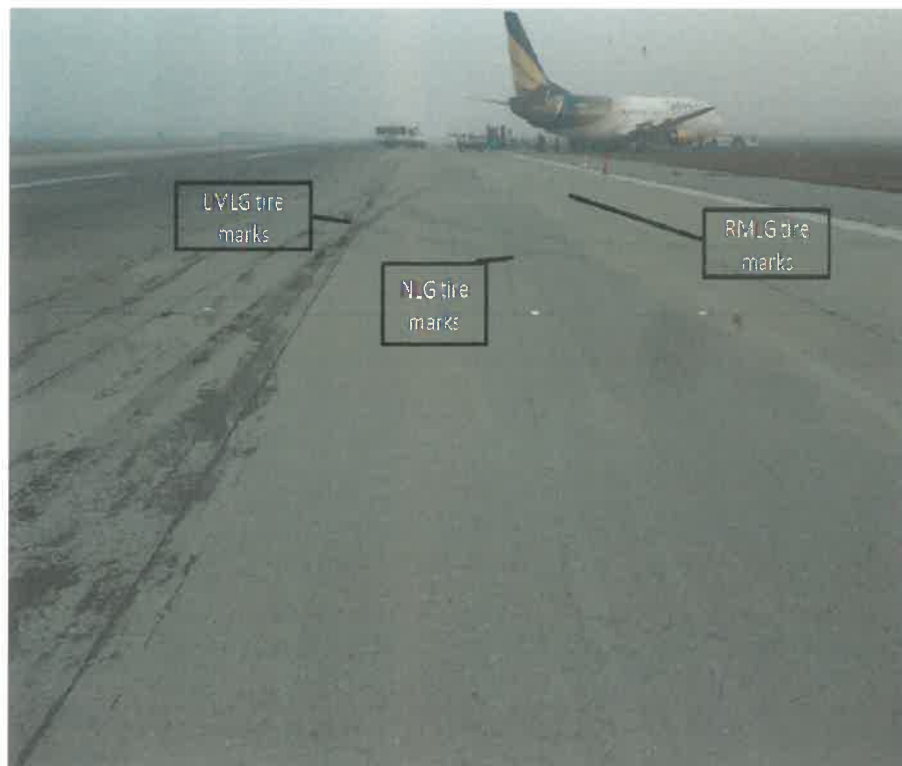
2.2.12. Tire marks indicated that significant left wheel brake pressure was applied in an attempt to turn the aircraft to left before it finally went off the runway on right side.

Tire marks before leaving the runway

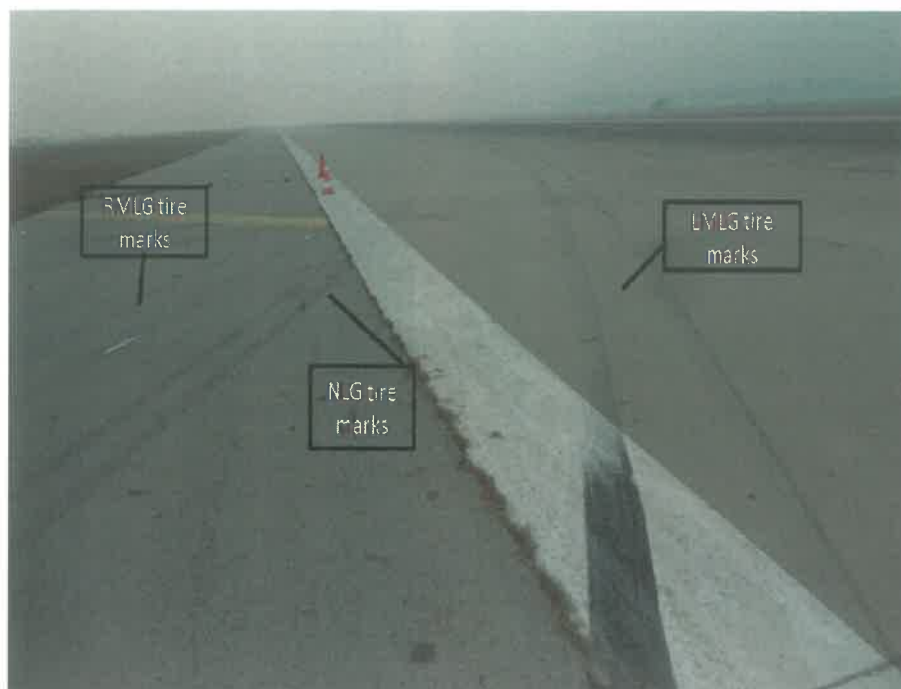
Tire marks before leaving the runway (viewing backward)

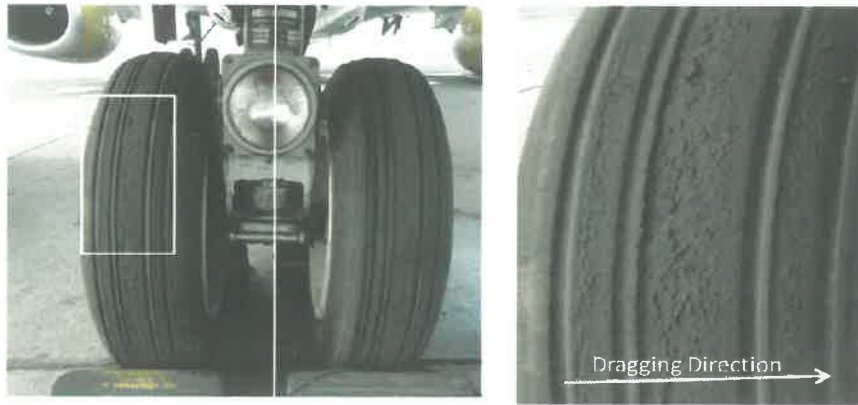
2.2.13. The dragging marks on the circumference of both nose tires had a consistent pattern as shown in the picture below. This pattern supports the finding that nose tire turned towards right while aircraft was forced to move towards left by application of rudder at high ground speed and probably some wheel braking at lower speeds. With the nose tire turned towards right the application of corrective controls dragged it left along with forward motion of the aircraft.

Nose wheel sideways dragging marks

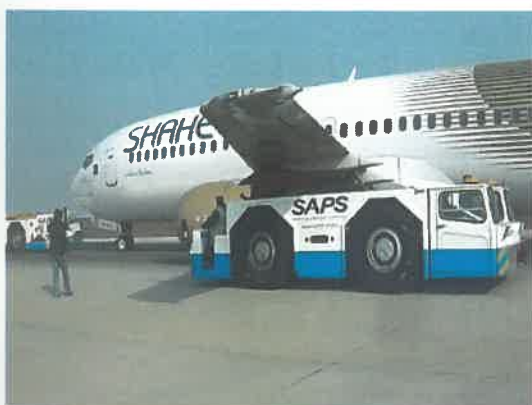
3.3. After repeated adjustments of the initial movable support the left wing was supported over tug master. Few wooden beams and old tires were placed on tug masters to adjust support height. This technique was comparatively more stable and aircraft was moved to designated place with few stops for adjusting the supports. Suitable capacity fork lifters, heavy duty trailers and pre planning could have made the task much easier.

Stable movable wing support arrangement

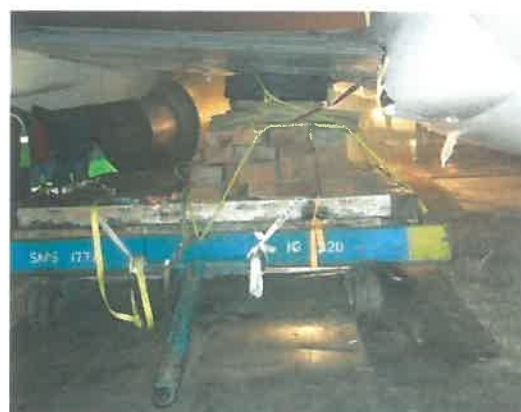
3.2. The recovery team initially tried to move the aircraft by supporting wings on wooden beams over a low bed tractor towed trolley. The technique was too risky as the support was very unstable and thus had to be abandoned.

Initial movable wing support arrangement (unstable)
