# FINAL INVESTIGATION REPORT

SERIOUS INCIDENT OF SHAHEEN AIR INTERNATIONAL FLIGHT  
NL-724 (SECTOR RIYADH – PESHAWAR), A-330-300 AIRCRAFT  
REG. NO. AP-BKN AT BACHA KHAN INTERNATIONAL AIRPORT  
(BKIAP) PESHAWAR ON 16<sup>TH</sup> OCTOBER, 2015

### SERIOUS INCIDENT OF SHAHEEN AIR INTERNATIONAL FLIGHT NL-724 (SECTOR RIYADH – PESHAWAR), A-330-300 AIRCRAFT REG # AP-BKN AT BACHA KHAN INTERNATIONAL AIRPORT (BKIAP) PESHAWAR ON 16<sup>TH</sup> OCTOBER, 2015

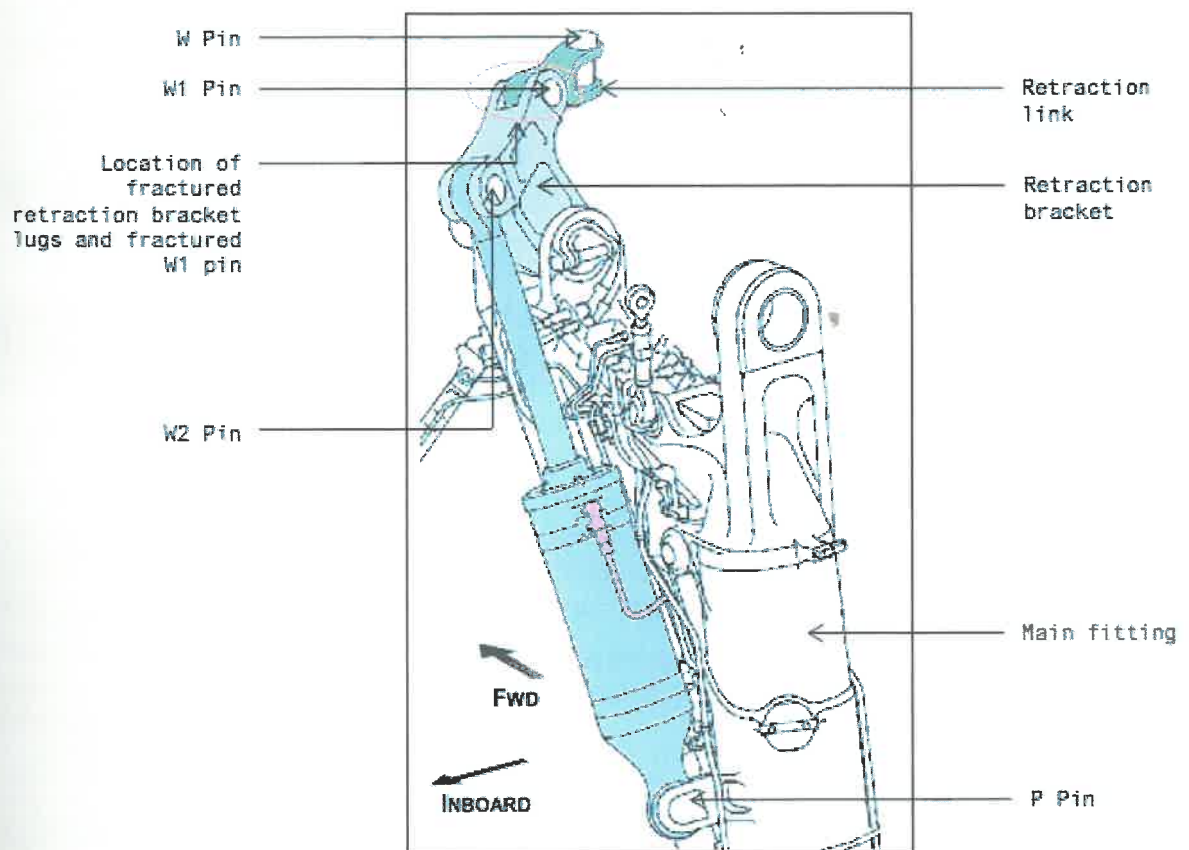
- 2.1. The following picture shows the location of failed part and other related components of LHMLG.

Location of Components on the RMLG (MBD Report)

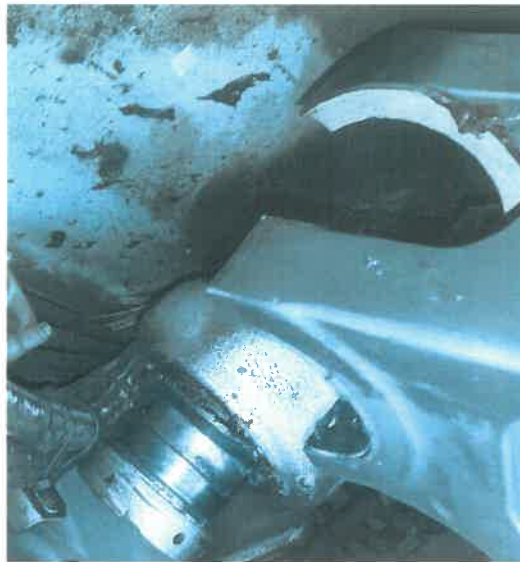
On aircraft close up view of the failed Retraction Bracket

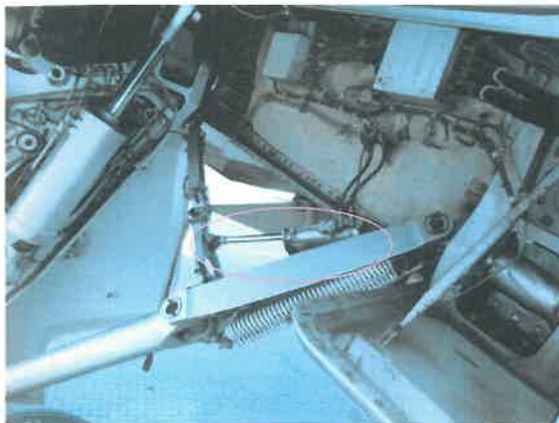
Position of Lockstay Actuator : LMLG

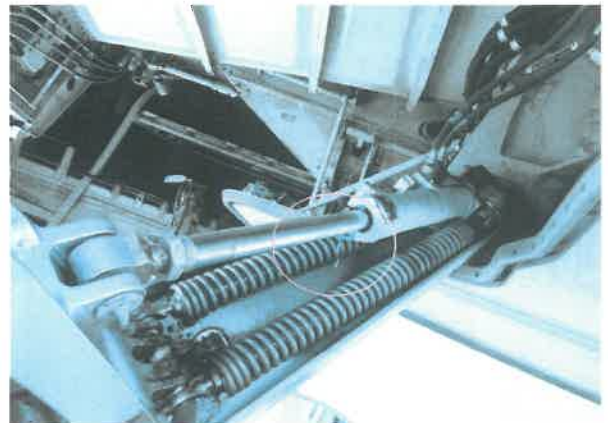
- 2.2. On post incident inspection the RMLG Lockstay Actuator internal seals were found protruding out and hydraulic fluid leak was observed from the damaged seals area.

RMLG Lockstay Actuator, Protruded seal

- 3.1.8 The fracture of the W1 Pin D-head end was due to overload and was a consequence of the fracture of the retraction bracket lugs.
- 3.1.9 The Lockstay Actuator seals protruded out as a consequence due to undamped extension of the RMLG after failure of the Retraction Bracket.

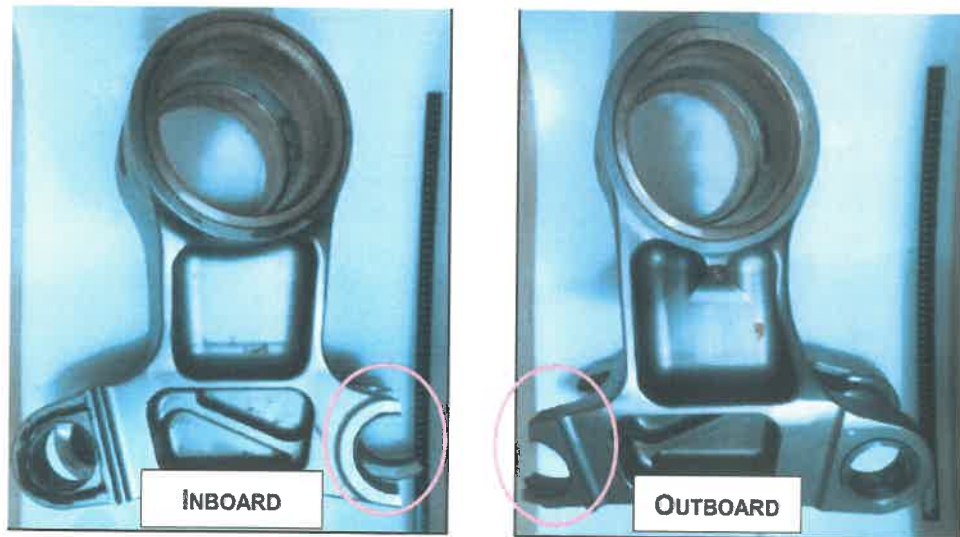
2.5.1. The retraction Bracket fractured at its two forward lugs. The W1 pin was found damaged, distorted and fractured at D-head end. The flange bush of W1 pin was found installed in wrong direction when received at MBD. However, on wing pictures indicated that it was installed correctly and wrong direction assembly was most probably performed after removal from aircraft while packing the parts for dispatch to MBD. The Lockstay Actuator had two rubber seals and one metallic seal protruding out.

Fractured Retraction Bracket

- 4.1. The Operator in consultation with OEM may adopt the procedure of introducing some precautionary inspection to avoid such reoccurrence in future.

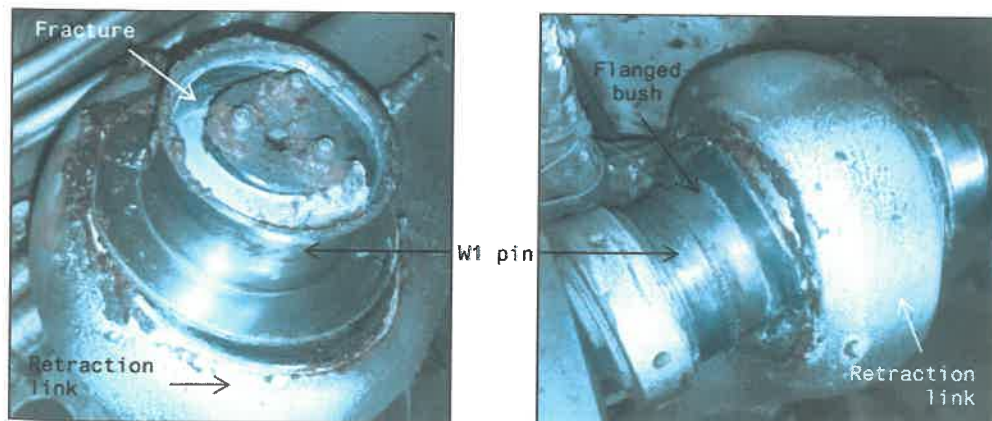
On wing picture showing correct mounting of W1 pin

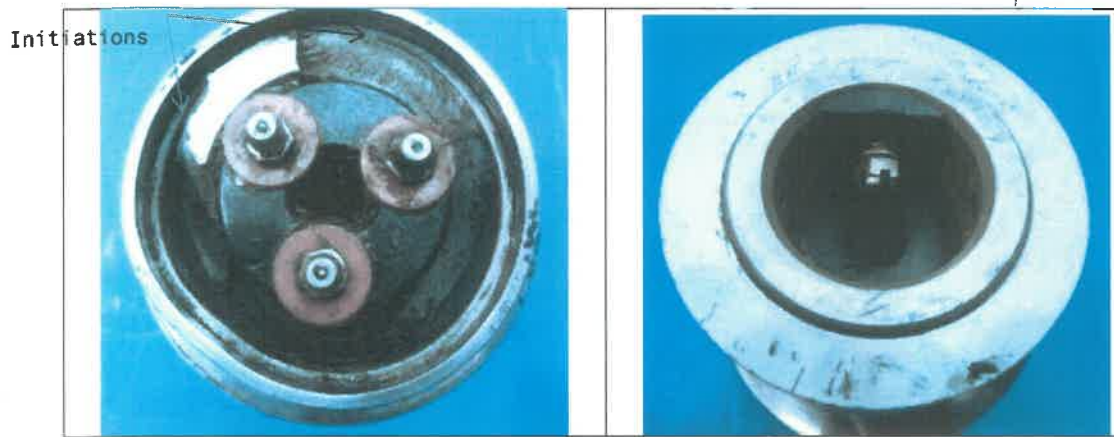
W1 pin (PN and D head missing)

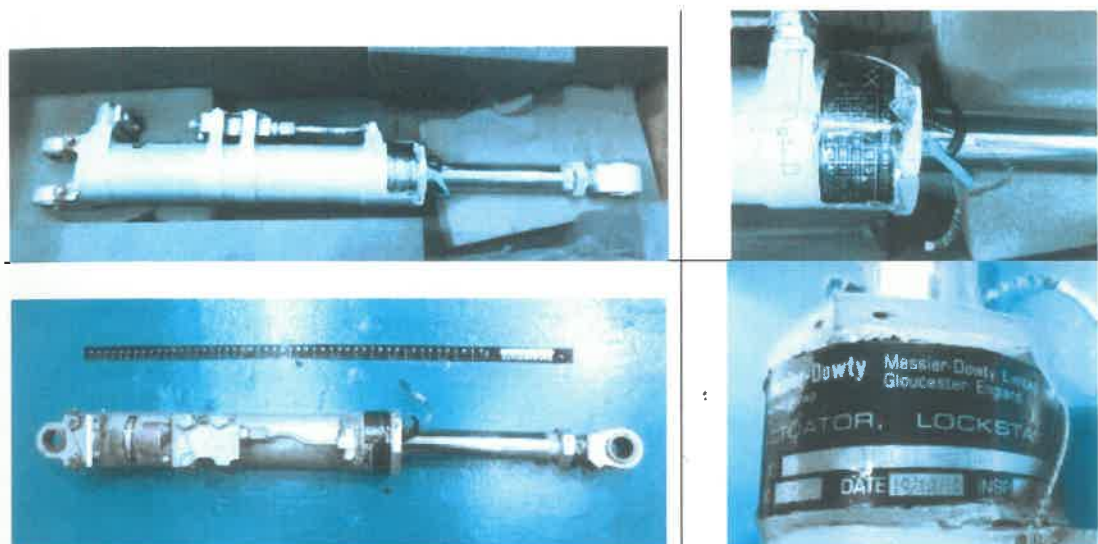
Lockstay Actuator (PN 114354001-010; SN 320), Two rubber seals and one metallic seal coming out

- 3.1.10 The Green system hydraulic fluid leaked from the damaged seals of the Lockstay Actuator and resulted in hydraulic fluid leak and subsequent low level and low pressure.

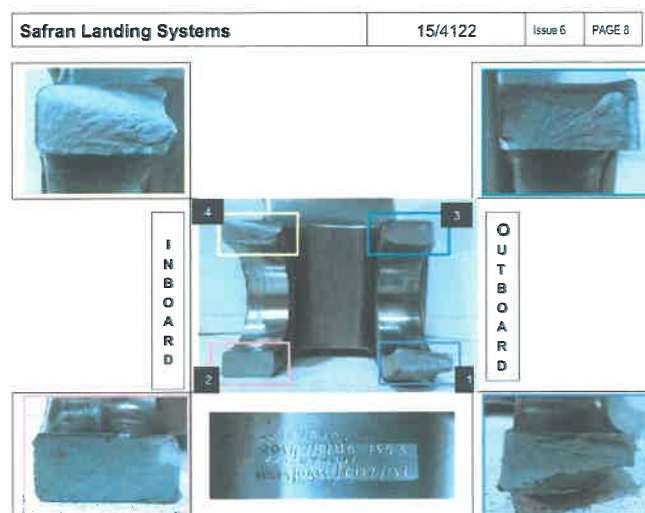
2.5.2. The fracture surfaces of the Retraction Bracket were arbitrarily numbered from 1 to 4 as shown in the following pictures.

Figure 5: Overview of the retraction bracket (PN 201478286; SN HSM/DAM/0127/93) confirming the fracture of two lugs. The fracture surfaces were arbitrarily numbered from 1 to 4.

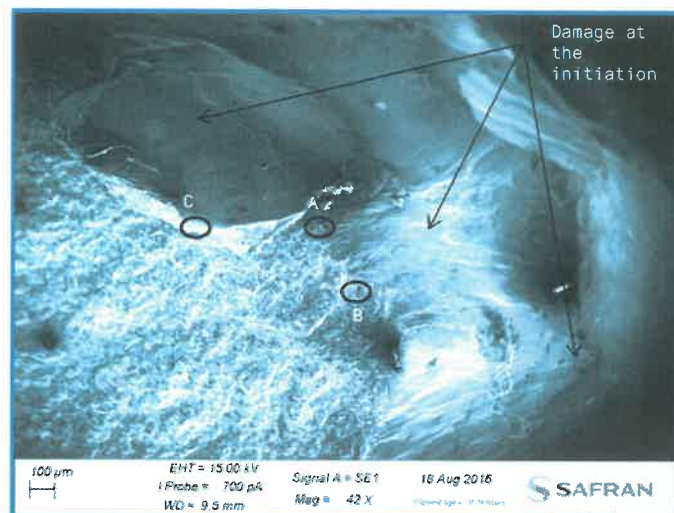
Figure 29: Close-up view near the initiation of fracture surface 2 showing fatigue locations.

- 2.5.3. Examination of the microscopic appearance of fracture surfaces suggested that fracture surface 2 was the first to occur. In addition, on fracture surface 2, there was evidence of fatigue cracking close to the fracture initiation site. The other three fracture surfaces only showed fracture due to ductile overload.

- 3.1.3 Examination of the microscopic appearance of fracture surfaces suggested that one out of four fractures (surface 2) was the first to occur.
- 3.1.4 On this fracture surface 2, there was evidence of fatigue cracking close to the fracture initiation site.
