**PAKISTAN CIVIL AVIATION AUTHORITY**  
**(SAFETY INVESTIGATION BOARD)**

**ACCIDENT TO M/S SCHON AIR**  
**CESSNA-172 AIRCRAFT, REG. NO AP-BJF AT**  
**NAWABSHAH AIRPORT ON 3 PRIL 2011**

## INVESTIGATION REPORT

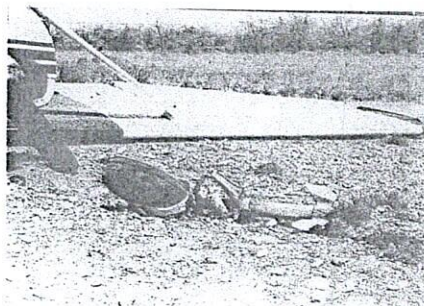
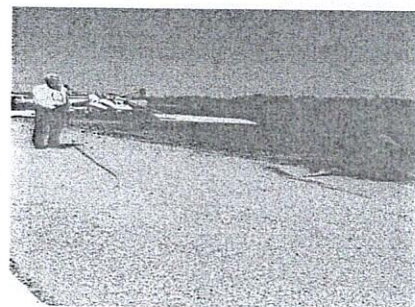
**1.3 Damage to Aircraft:** Propeller and nose gear assembly was badly damaged, with extensive distortions in the main forward fuselage and wing.

- 1.7 **Flight Recorder / CVR:** Aircraft was not equipped with FDR / CVR.
- 1.8 **Weather Information:** Fair, with visibility 6kms and wind calm.
- 1.9 **Wreckage and Impact Information:** After touchdown, the aircraft re bounced twice went into right side and got toppled leaving clear marks on unprepared surface.

- 1.14 Engine power was heard to be added, the airplane nose hit the runway edge and aircraft toppled over on its back. SP came out of inverted aircraft safe and unhurt. Later, on arrival the SP entered airplane and turned off the Master switch and Magnetos, and pulled the mixture out.
