**CIVIL AVIATION AUTHORITY**

**AIRCRAFT INCIDENT INVESTIGATION M/S PIAC**

**AIRBUS - 310 REG.NO.AP-BEC WHICH OCCURRED**

**ON 3RD JUNE, 1997**

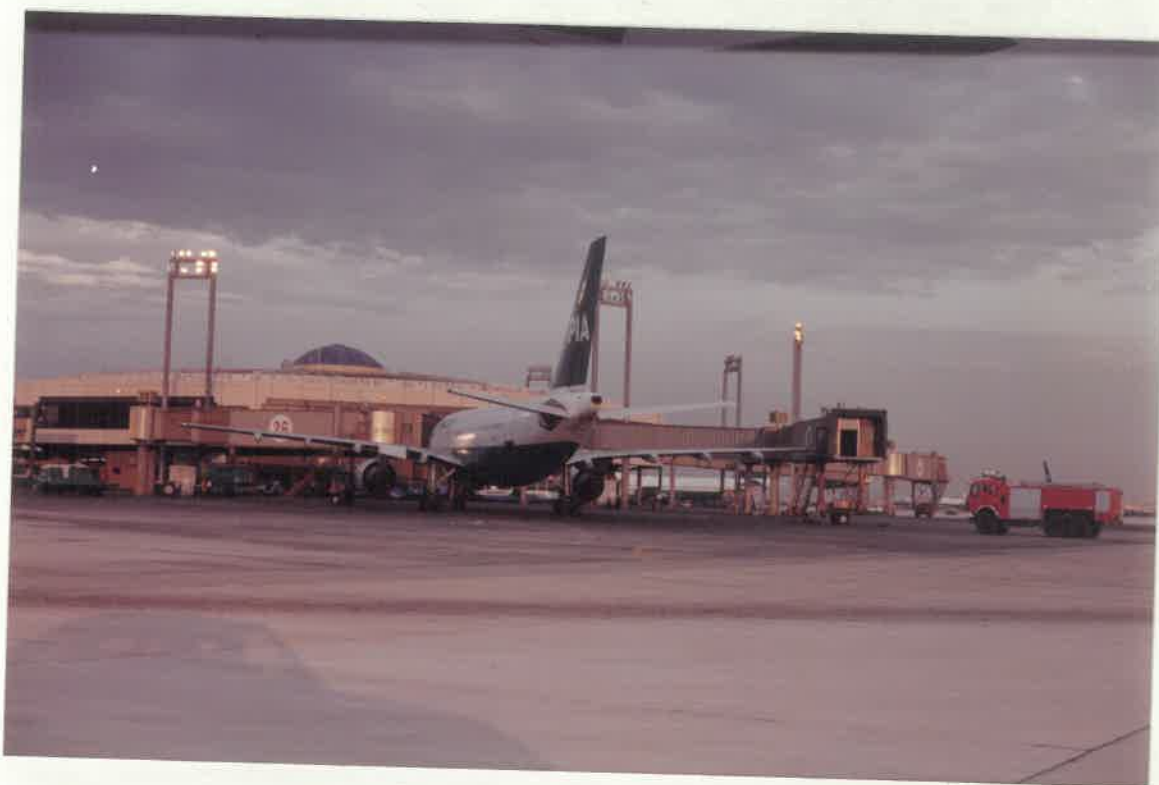
APP 'F<sub>1</sub>'

NOS.25 AVIOBRIDGE COLLIDED WITH M/S PIAC AIRBUS.  
PARKED AT GATE NO.26 SEE WHEEL POSITION

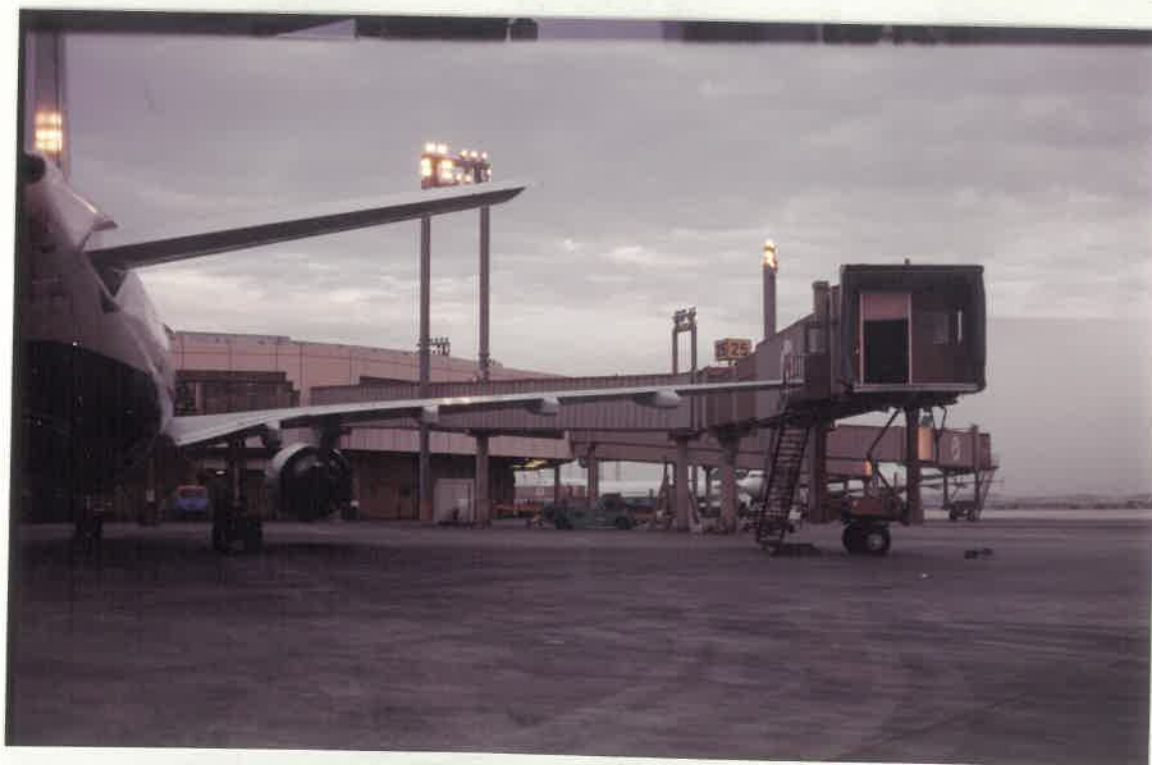
APP 'F<sub>2</sub>'

- 35.10. On 3rd June, 1997 at about 00 14 hours PST strong westerly wind condition of about 40 knots prevailed and 135 ft long Aviobridge No. 25 due to its unchocked wheel rolled and collided with the right wing of M/s PIAC Airbus-310 Reg. No. AP-BEC parked at gate No. 26.

- 36.1 Not chocking of the Aviobridge wheel which is normally aligned with the Aviobridge longitudinal plane after it was turned to about 85 degrees for maintenance.

AVIOBRIDGE NO.25 COLLIDED WITH RT WING OF AIRBUS REG.NO.AP-BEC  
PARKED AT GATE NO.26 AFTER IT ROLLED ON ITS WHEEL  
DUE TO STRONG WIND.  
NOTE: SEE PLB WHEEL POSITION.

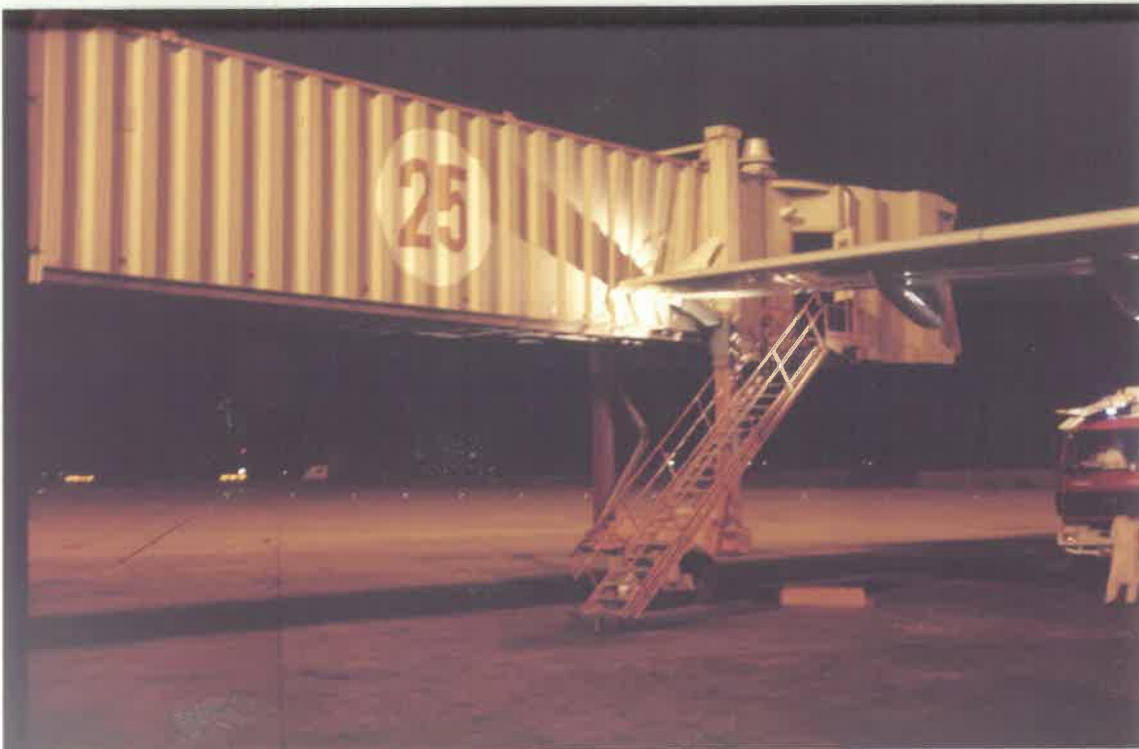
APP 'F<sub>3</sub>'

AVIOBRIDGE NO.25 AFTER IT COLLIDED WITH RT WING  
OF AIRBUS PARKED AT GATE NO.26.

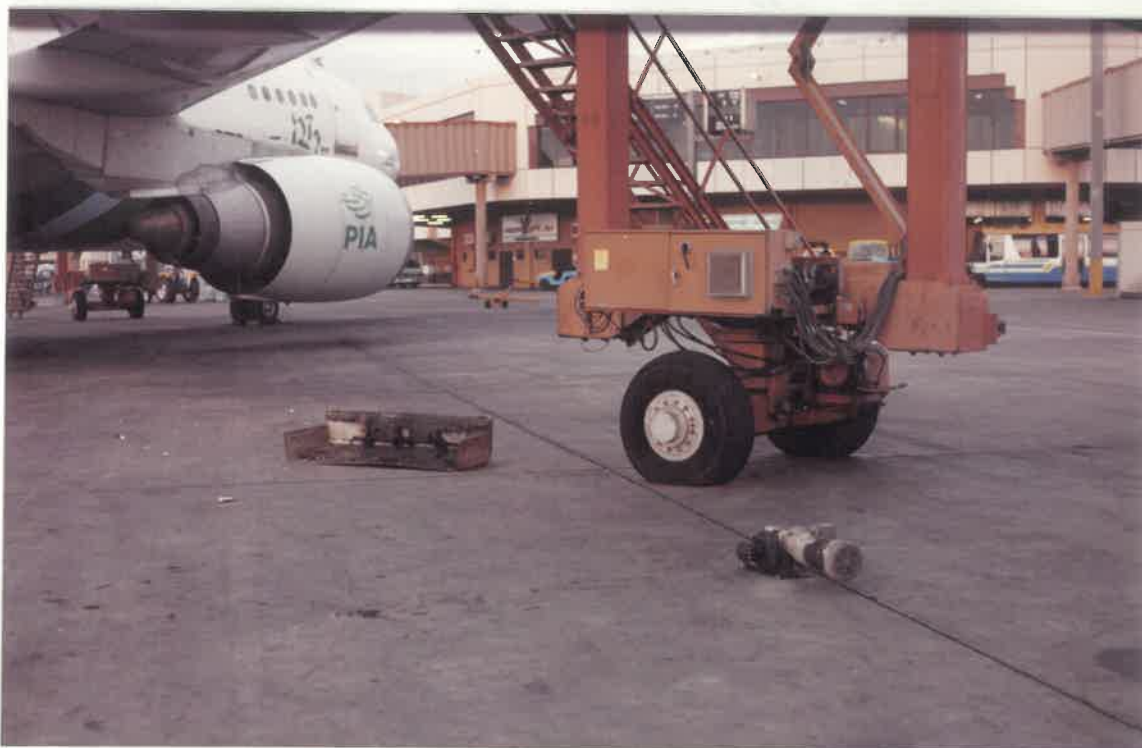
APP 'F<sub>4</sub>'

AVIOBRIDGE COLLISION.

NOTE: EVIDENCE OF PLB WHEEL AT ABOUT 850 TO THE AVIOBRIDGE  
PLANE ALSO ELECTRICAL MOTOR LYING ON THE GROUND.

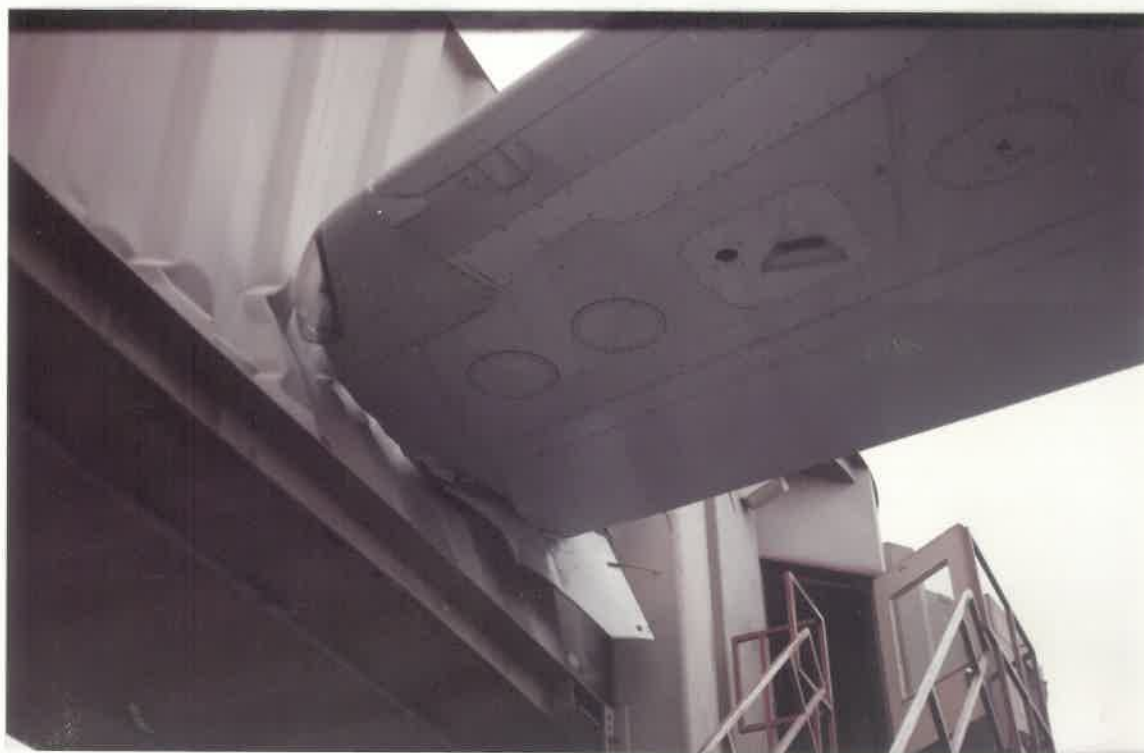
AVIOBRIDGE AND AIRBUS WING COLLISION

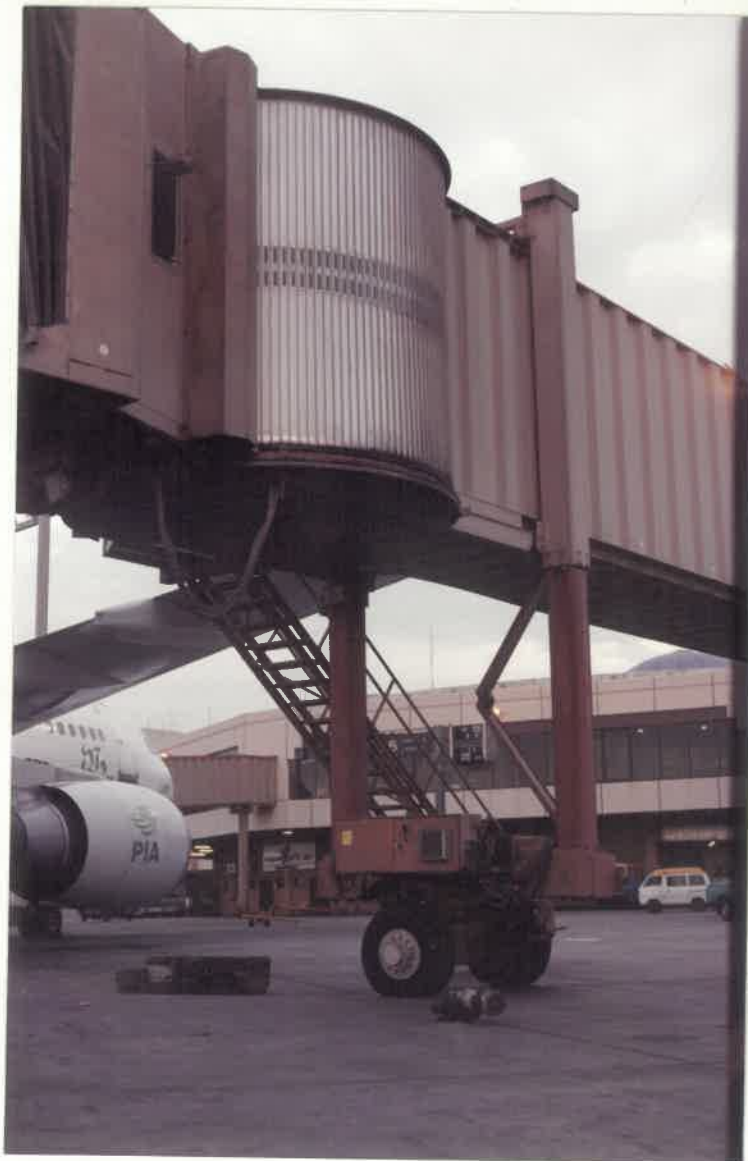
AVIOBRIDGE POSITION AFTER IT COLLIDED WITH RT WING OF AIRBUS  
NOTE: POSITION OF AVIOBRIDGE WHEEL.

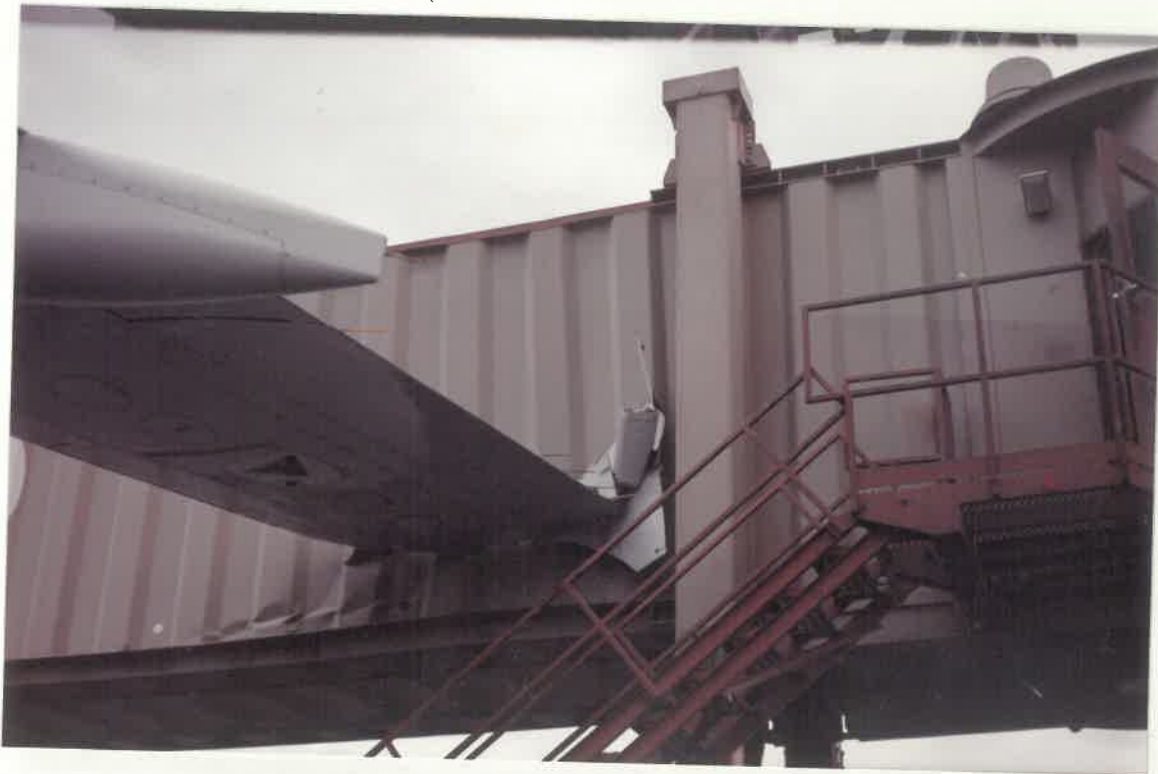
APP 'F7'

AVIOBRIDGE AND AIRBUS RIGHT WING CLOSE UP VIEW

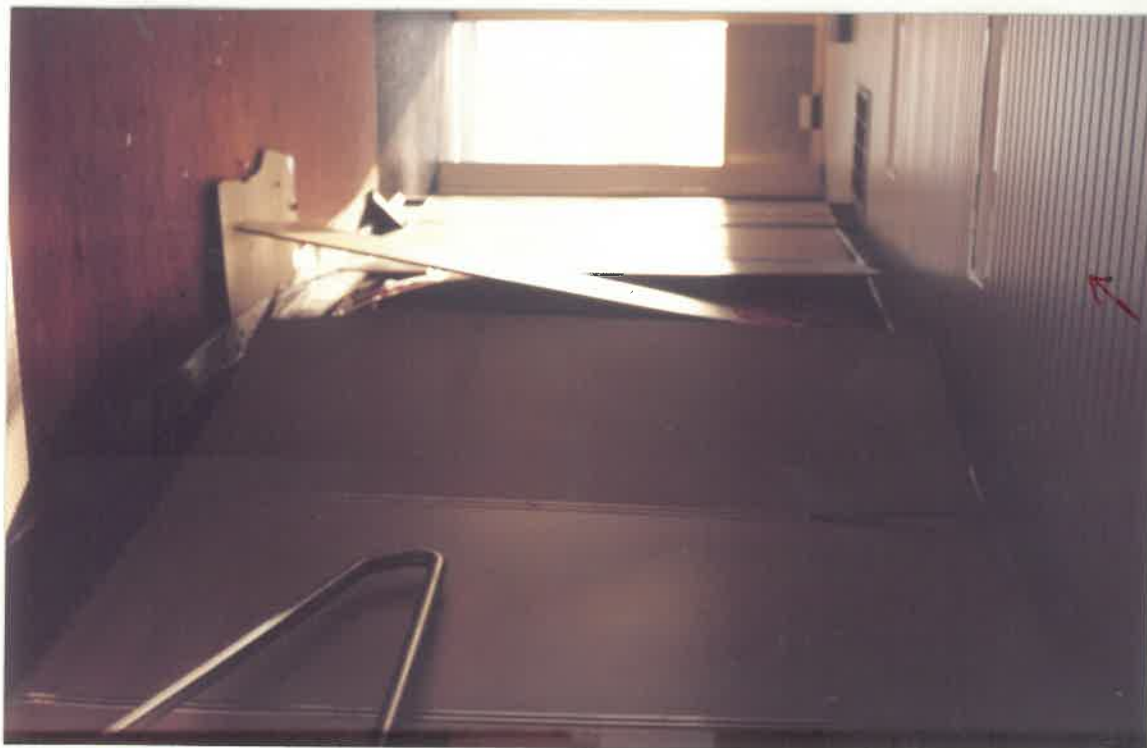
APP 'F8'

AVIOBRIDGE NO. 25 INTERNAL DAMAGE TO SIDE WALL  
AFTER THE INCIDENT

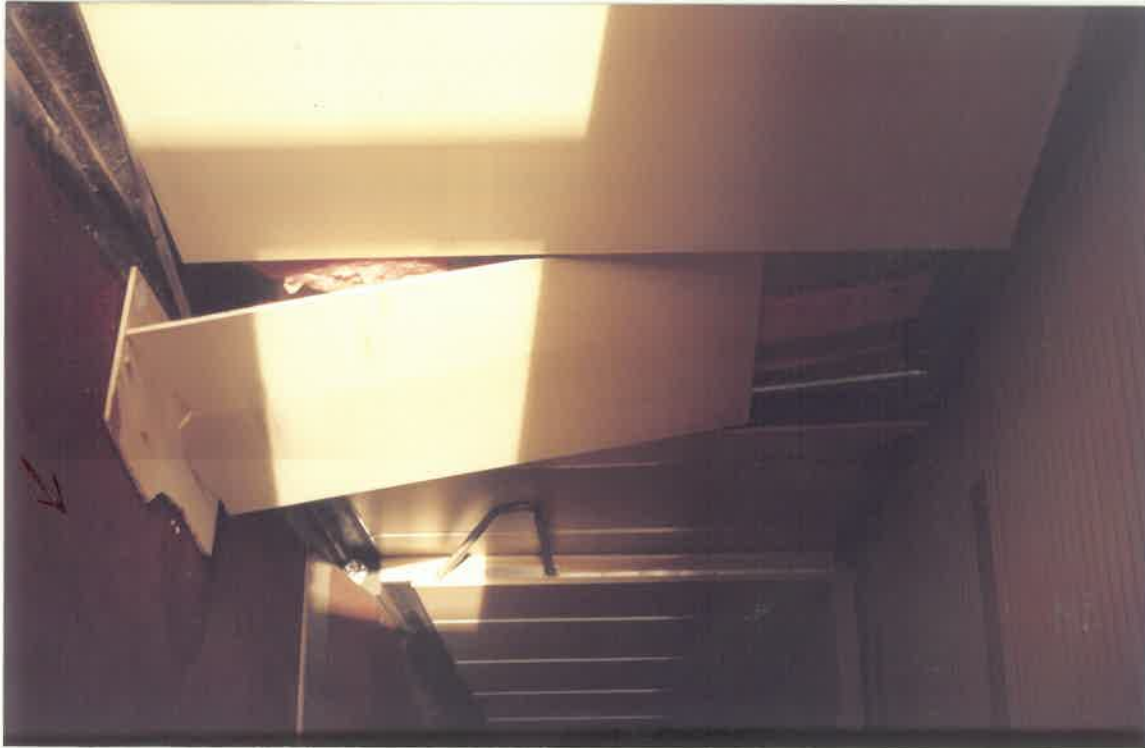
APP 'F9'

AVIOBRIDGE NO.25 INSIDE DAMAGE AFTER THE INCIDENT  
(ANOTHER VIEW)

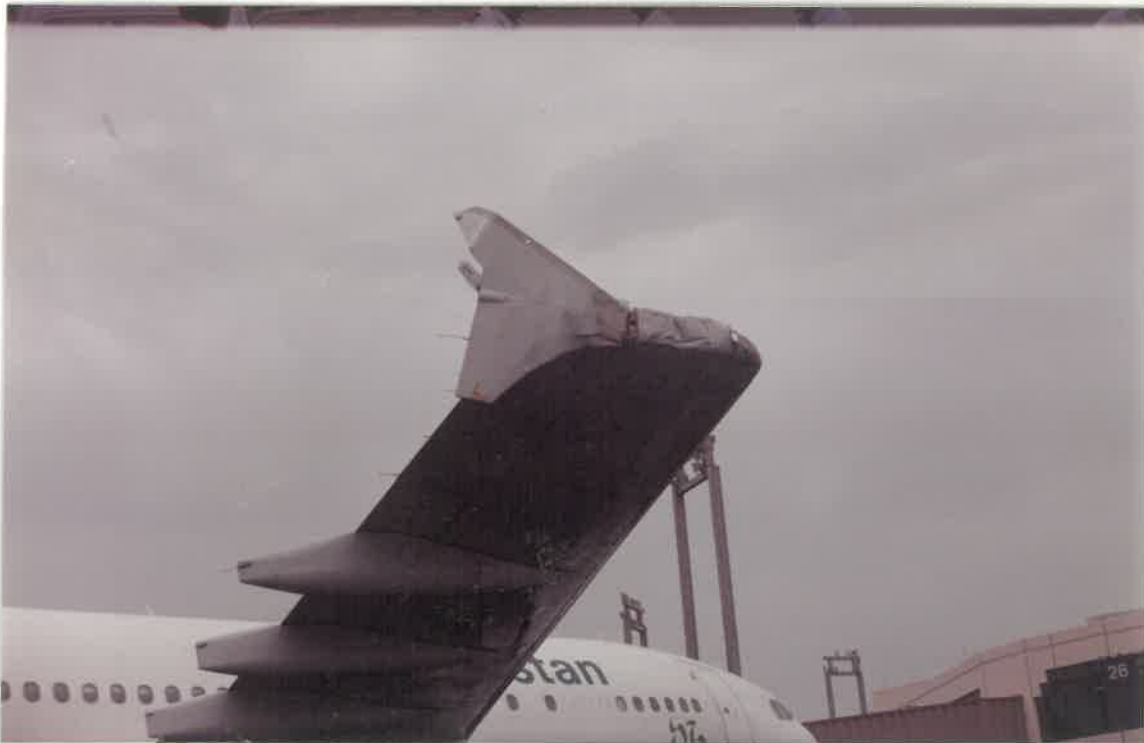
APP 'F10'

5.1. Right wing of the aircraft was substantially damaged.

RT WING DAMAGE CAUSED DUE TO AVIOBRIDGE NO.25  
STRIKING IN THE INCIDENT.

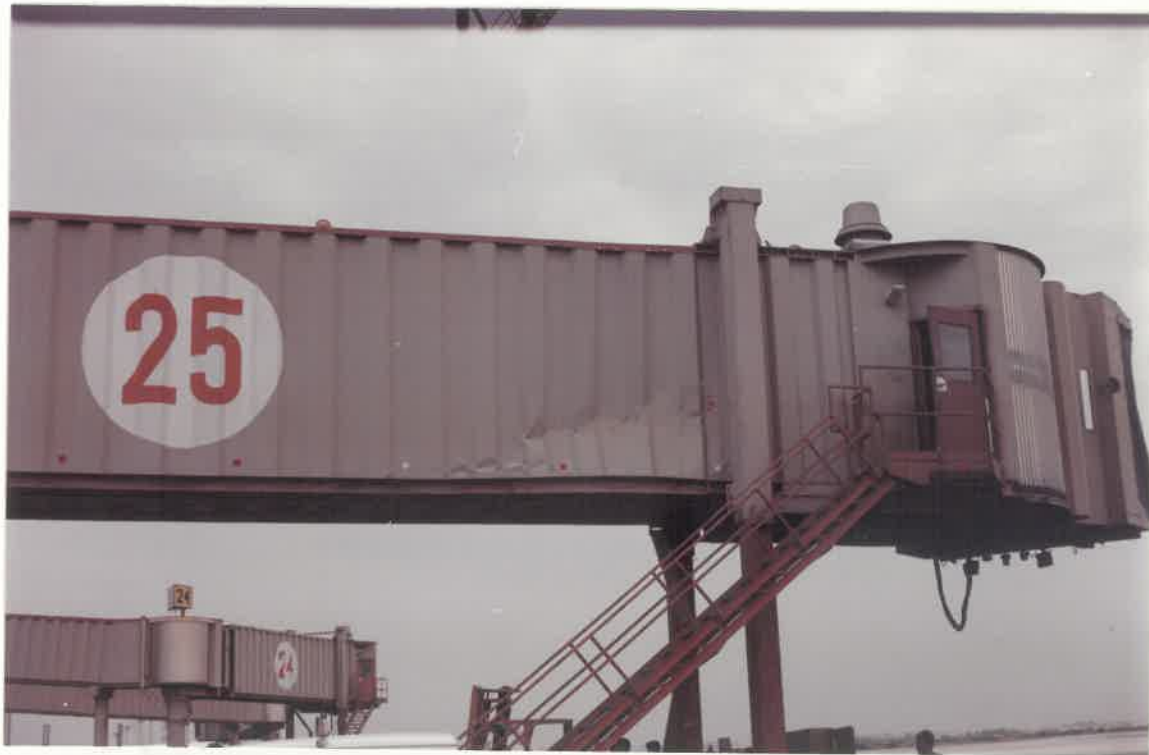
AVIOBRIDGE NO.25 EXTERNAL DAMAGE AFTER THE INCIDENT

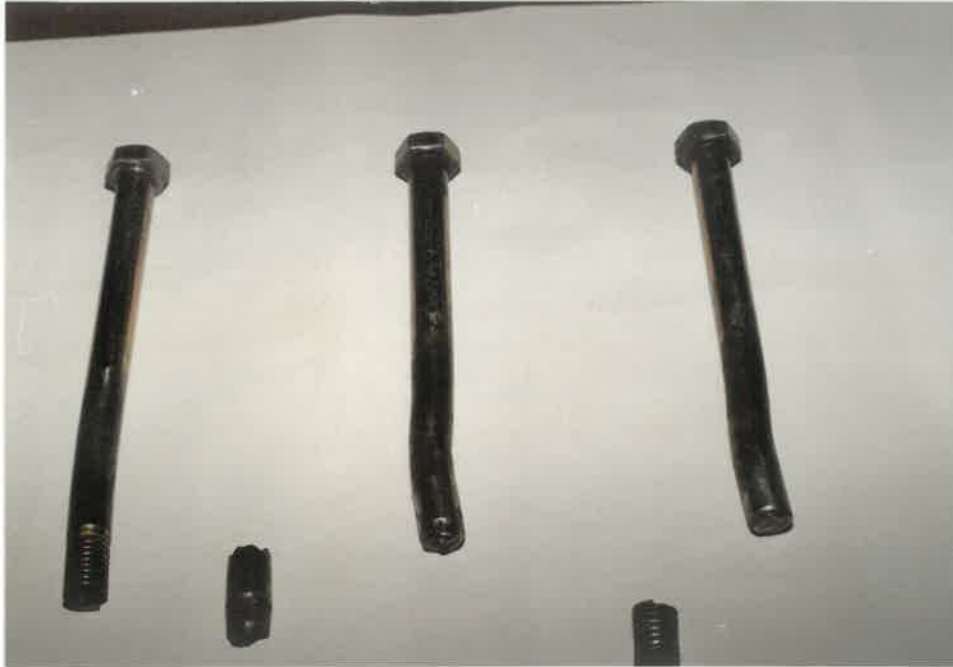
APP. 'F<sub>12</sub>'

32. Three sprocket bolts of PLB No. 25 were sheared-off in April, 1997 and subject PLB was running on 3 bolts till the date of incident. The bolts sheared-off due to improper torquing and resultant over-loading.

- 35.14. After the incident 3 sheared-off sprocket bolts had evidence of uneven bending and were sheared from its threaded end. Additionally, hub assembly holes were also elongated.

THREE SHEARED-OFF SPROCKET BOLTS

- 37.1. PLB Management must ensure that instructions are not only issued but they are also complied with.
- 37.2. PLB sprocket bolts installation procedure must be included in the M/s Stearns Ops& Maint Manual specifying the torque values for tightening of sprocket bolts.

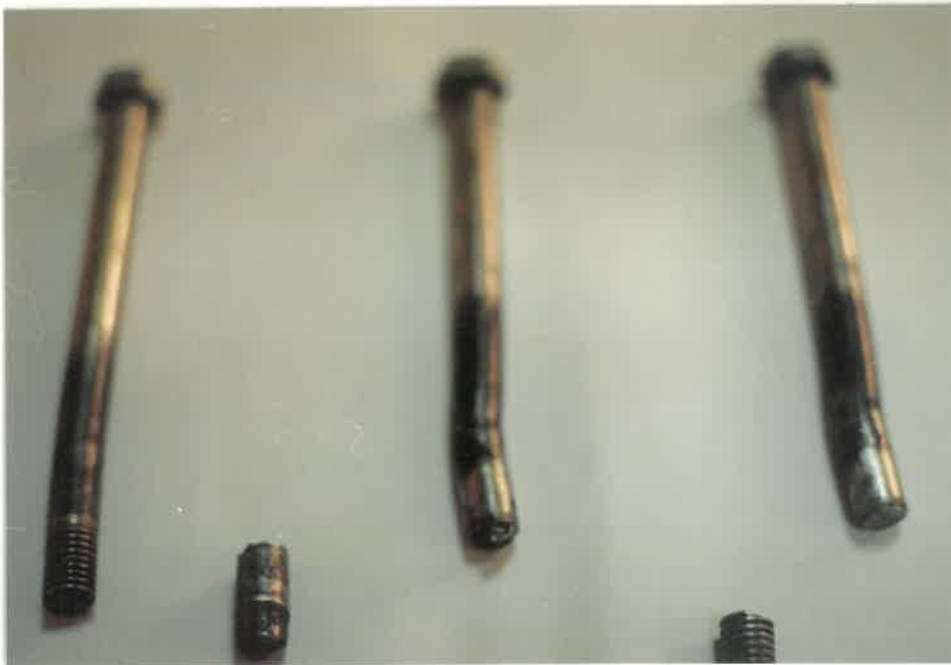
APP. 'F<sub>13</sub>'

THREE SHEARED-OFF SPROCKET BOLTS
