INVESTIGATION REPORT INTO FATAL ACCIDENT TO GOVERNOR  
OF BALUCHISTAN CESSNA-421 AIRCRAFT BEARING  
NATIONALITY AND REGISTRATION MARKS AP-AYQ  
WHICH OCCURRED ON 6-7-84 NEAR MANKERA  
AT 170608 P.S.T.

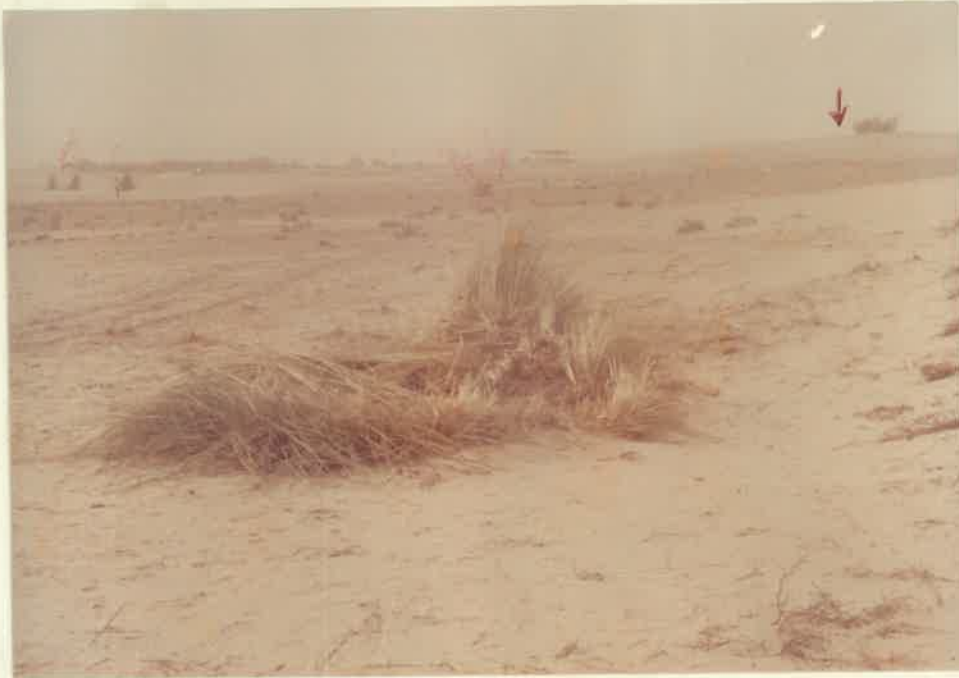
Point of initial impact. In the back ground field Camp is visible. Dune where the aircraft had second impact can also be seen in the background.

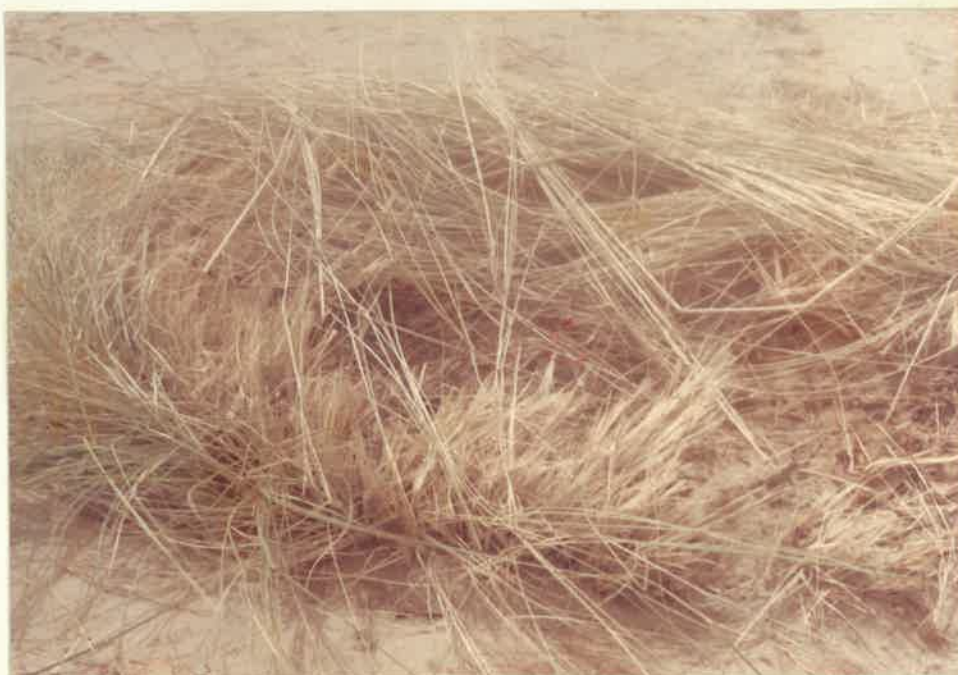
Close-up of point of initial impact.

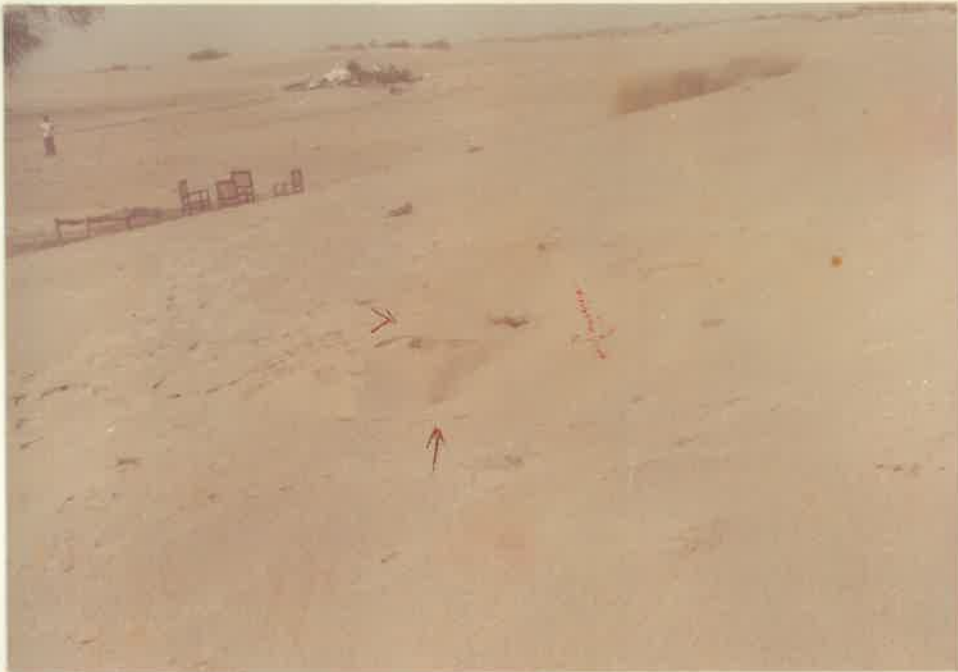
APP-'AN.3'

Point where the right engine bounced after detaching from wing.

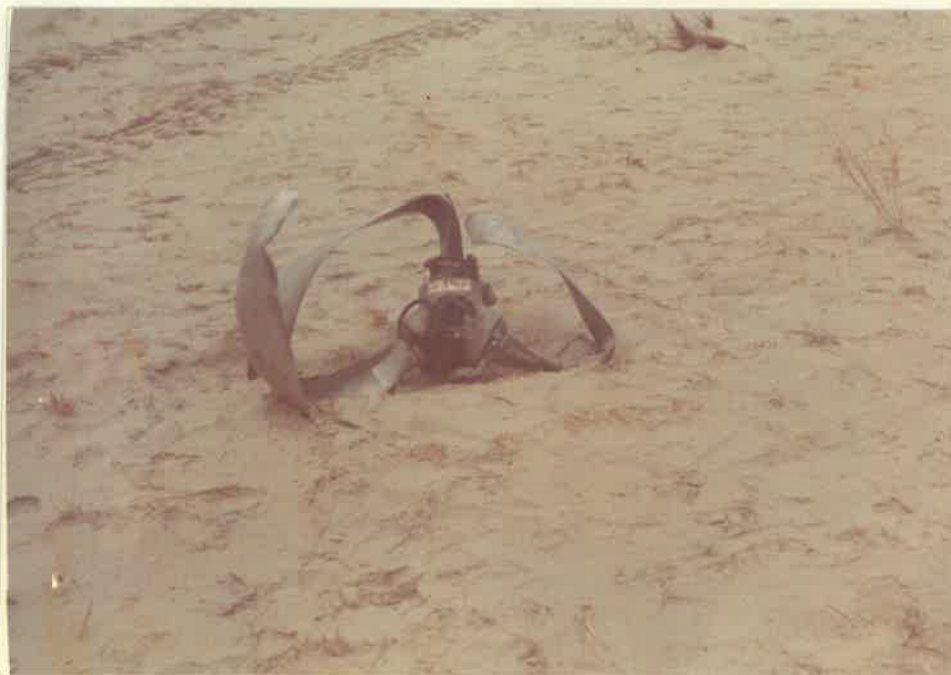
APP-'AN.4'

Propeller detached from the right wing.

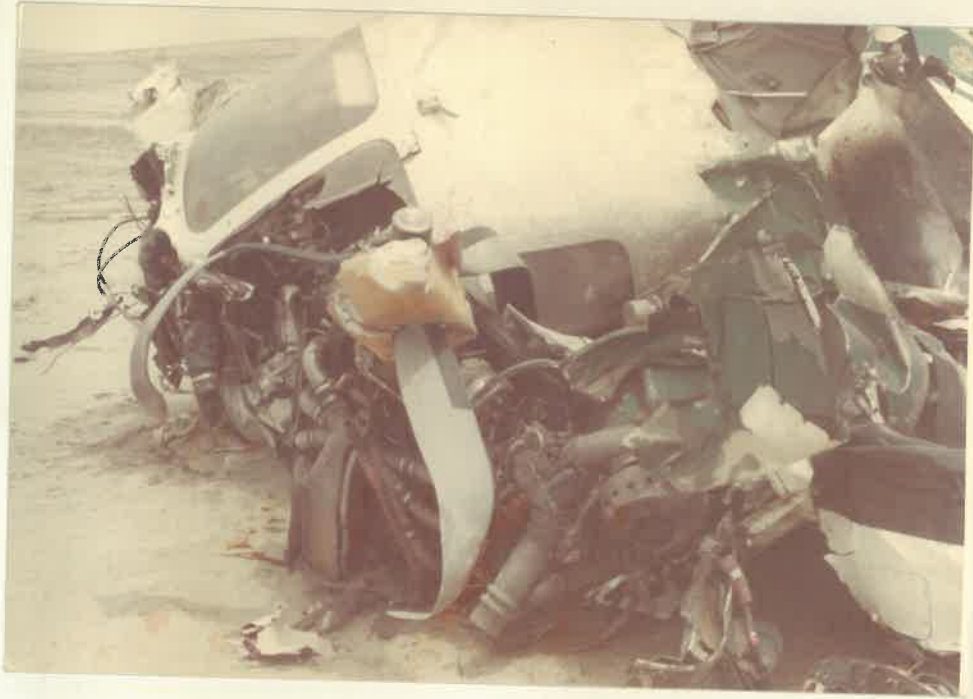
APP- 'AN.5'

Propeller of the left engine. It did not detach from the engine.

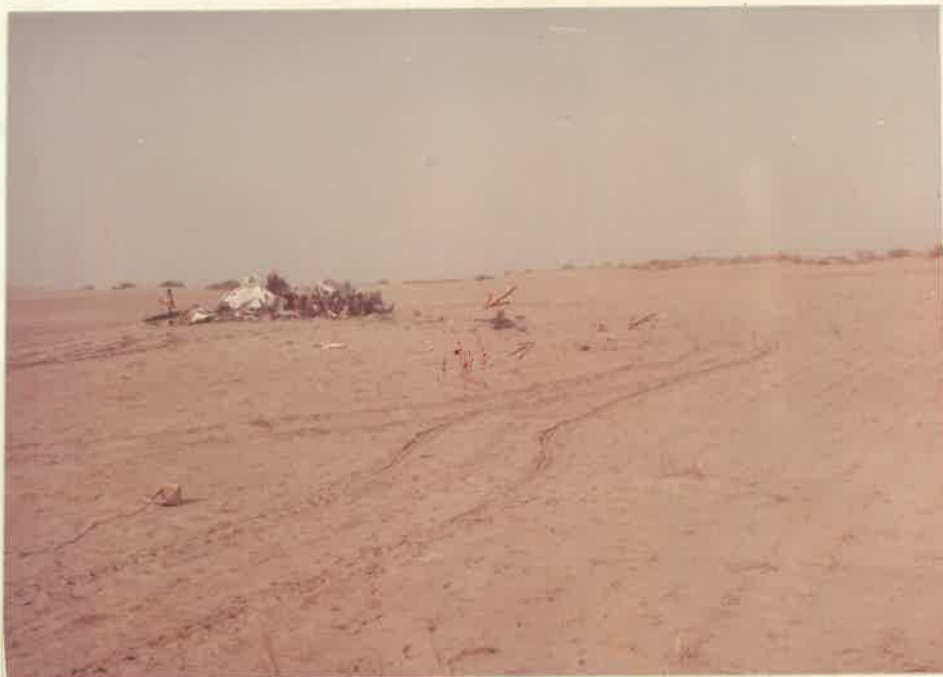
APP- 'AN.6'

Wreckage of Cessna-421. Broken parts from radome can be seen scattered before the main wreckage.

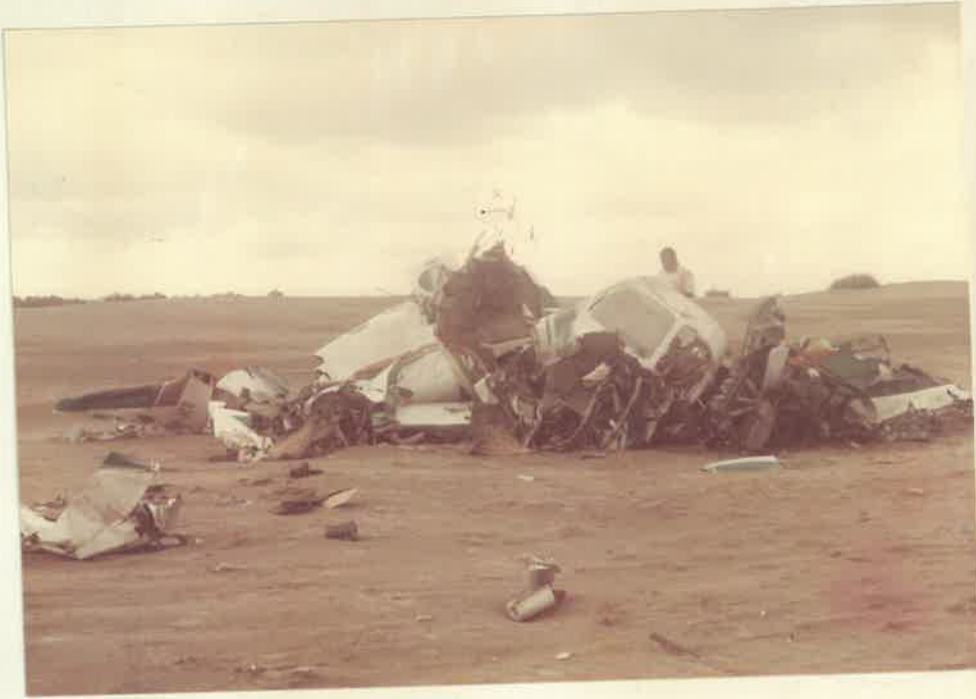
APP- 'AN.8'

Front view of the wreckage.

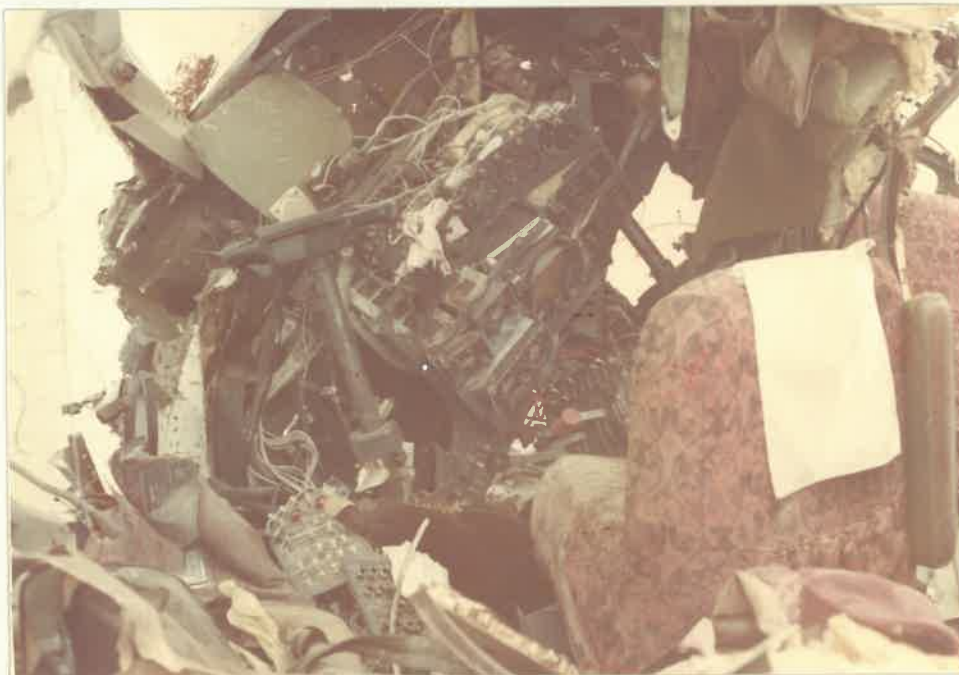
APP- 'AN.9'

Cockpit area.

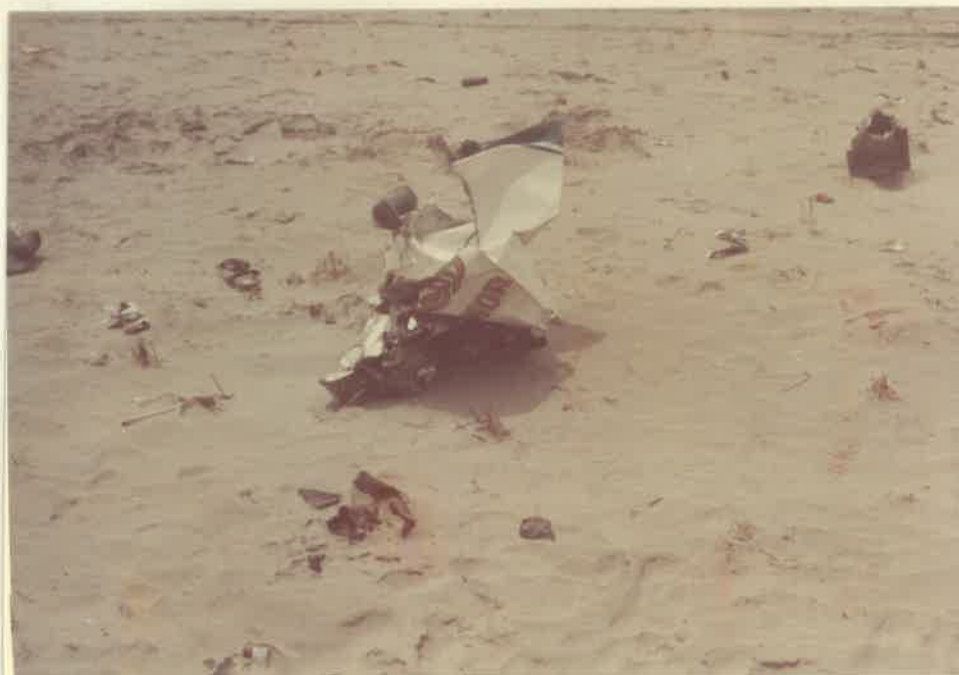
APP-'AN.10'

Logo of Governor of Baluchistan.

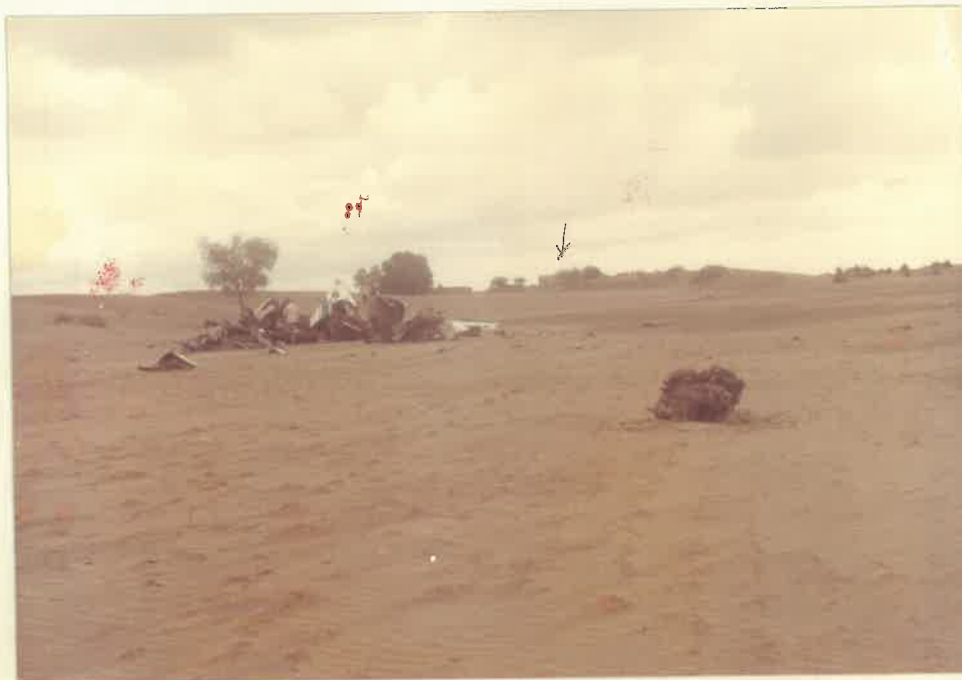
APP-'AN.11'

Right engine and main wreckage seen from the direction opposite the travel path of the wreckage. Village from where people came for rescue can also be seen in the back-ground.

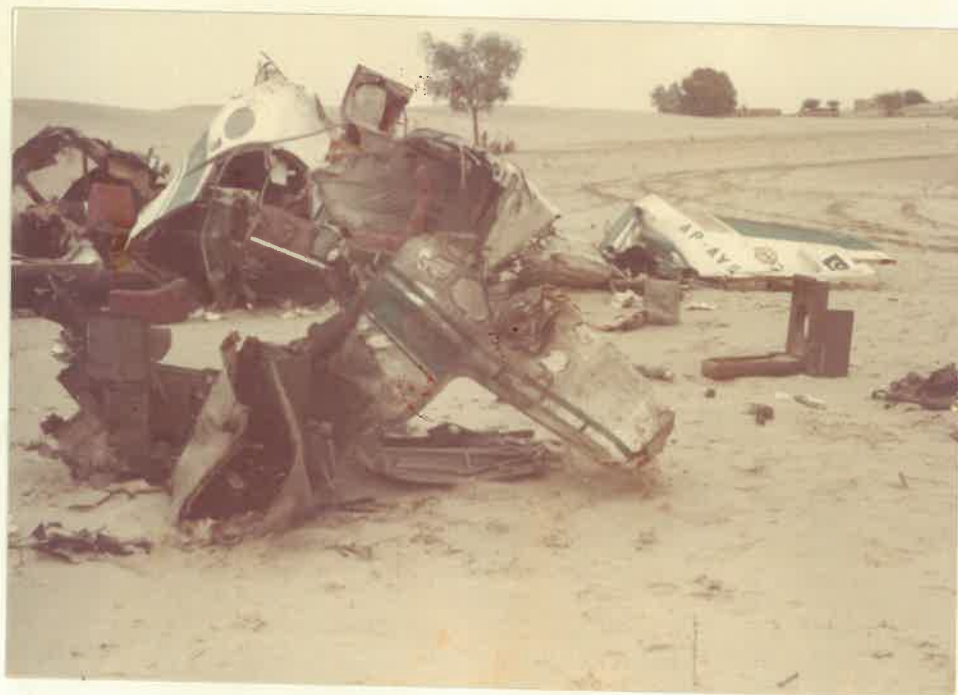
APP-'AN.7/C'

Wreckage of aircraft. Callsign of the aircraft AP-AYQ can be seen.

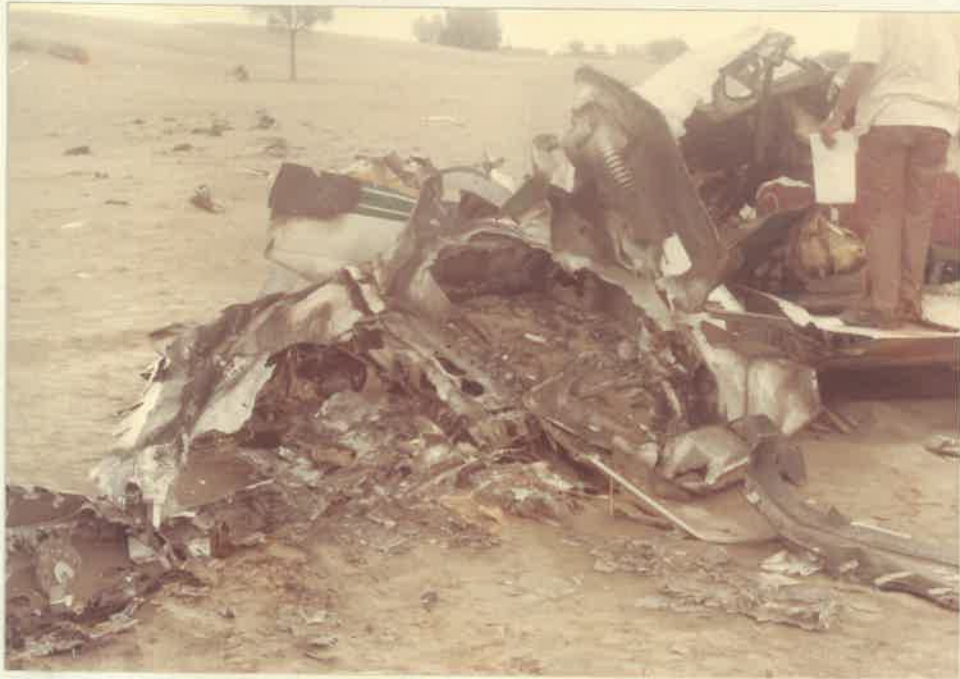
APP-'AN.12.'

Portion from the left wing consumed by fire

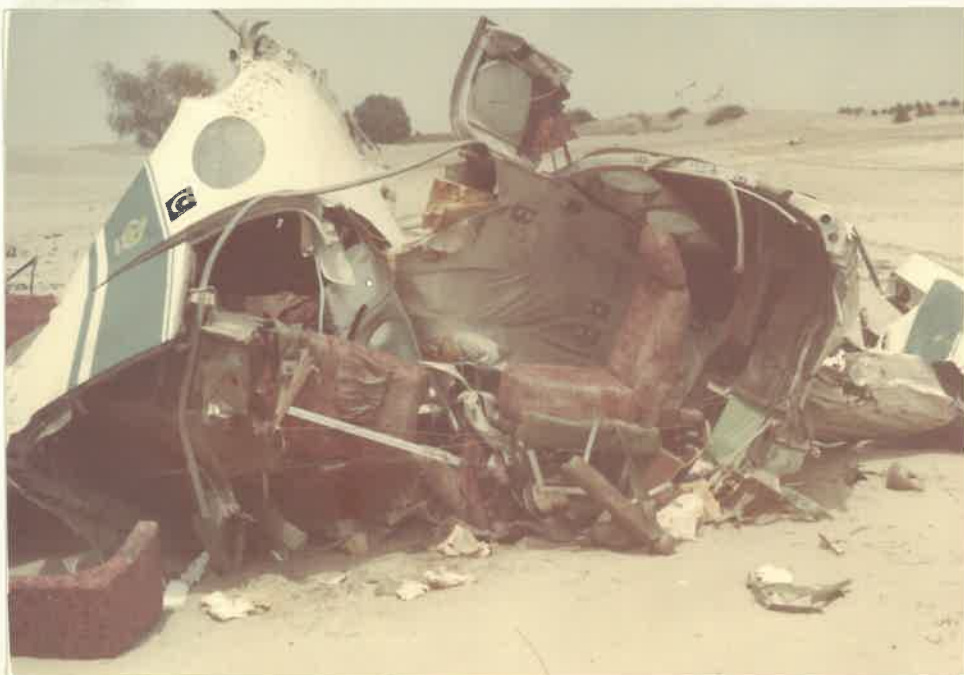
APP-'AN.13'

Wreckage seen from left side. Seat occupied by Gen.Lodi can also be seen.

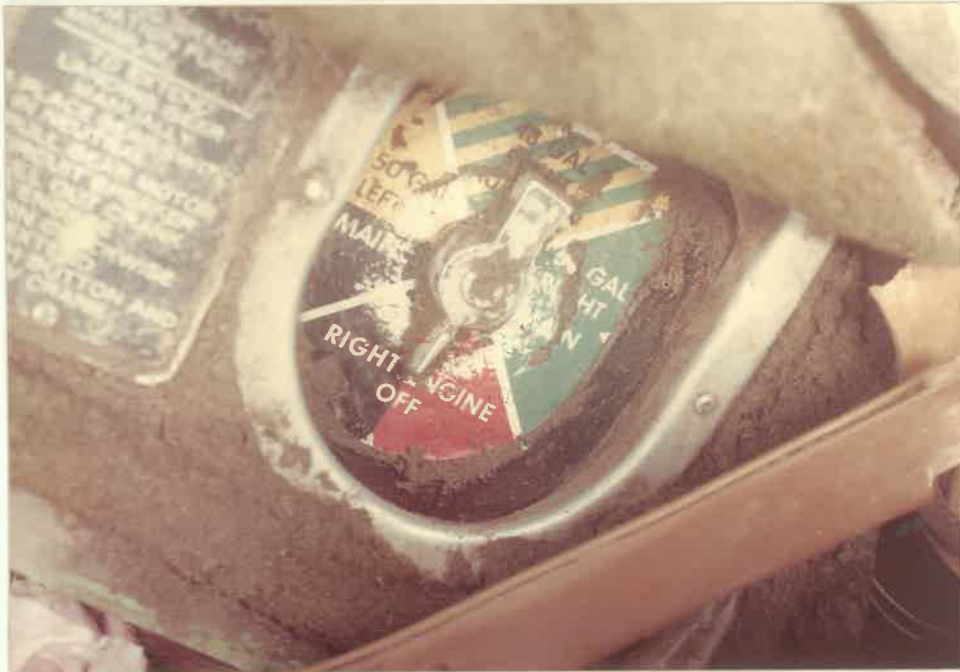
APP- 'AN.14'

Fuel cock in off position.

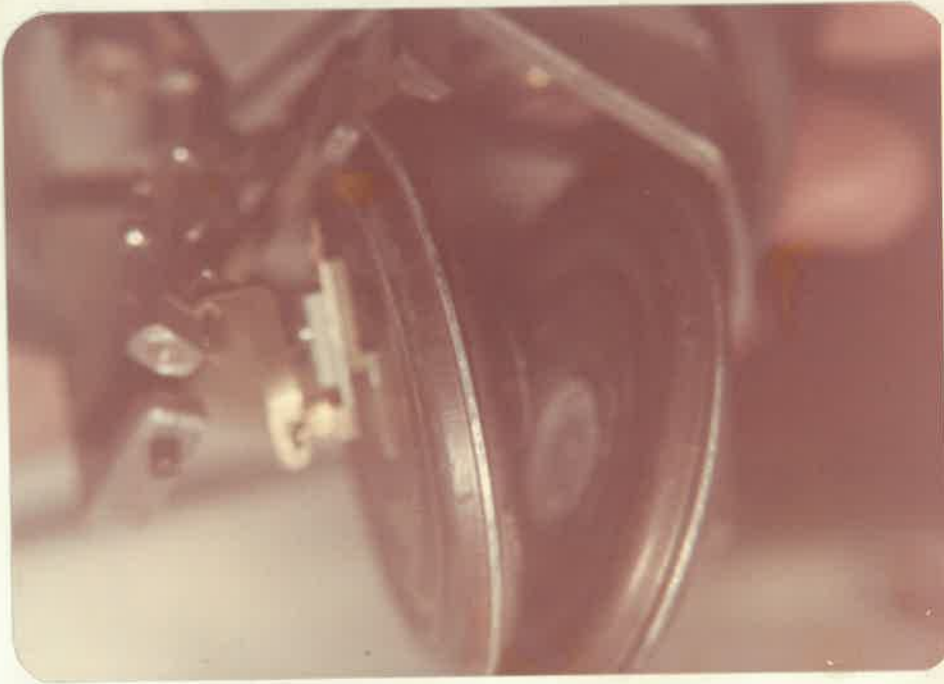
APP-'AN.15'

- 19.5. The altimeter was subjected to instrument shop examination at the PAF Base Mianwali to determine cause of altimeter being stuck at 4000 feet. After examining the altimeter the technician found that the instrument capules were separated from each other. (App: AN). The sector pivot was also broken. Sector was disengaged

Desoldered capsules of the altimeter.

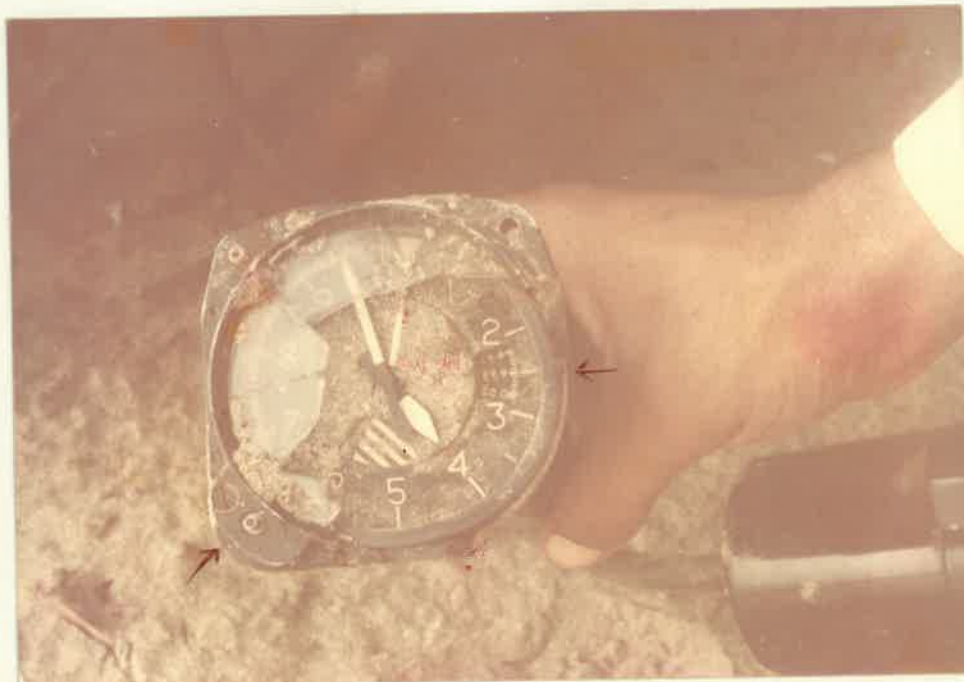
APP-'AN.16'

- 19.4. Altimeter of this Cessna-421 aircraft showed a reading of 4300ft on its sub-scale. Broken glass and the sand, which was stuck on the dial during the accident, had restricted movement of needles to the extent that the needle could move only between 4000' to 4500'.

- 20.15. In-correct pressure setting on the sub-scale caused the altimeter to over-read by a large figure. (Approx-840 feet or more).
- 20.16. The pilot probably relied on the in-correct reading of the altimeter and descended to an altitude when he had almost nil clearance from the terrain which resulted in ground impact.

Altimeter with broken glass sand stuck in the did can be seen. Setting of 29.92" on the sub-scale can be seen clearly. Knob for selecting setting is also missing.
