# AIRCRAFT ACCIDENT INVESTIGATION REPORT

PIPER SENECA-III REG. MKS. AP-BBU

AT TAJJAL AIRSTRIP

8TH SEPTEMBER, 1989

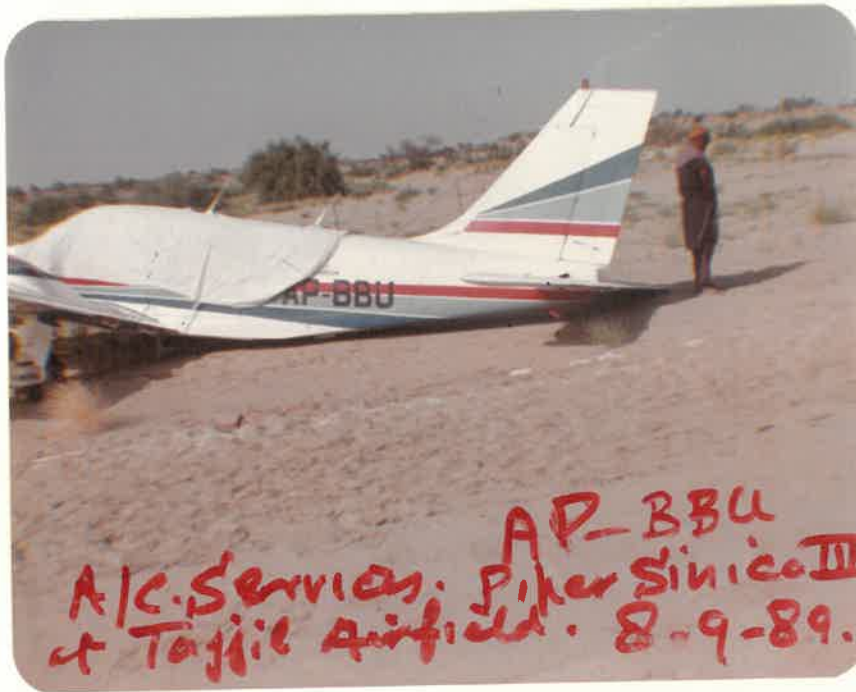
APP. G<sub>1</sub>"

- 1.13.6. Major Port of aircraft components parts damaged in this accident. :  
 i. R.H.Main Landing gear broken  
 ii. R.H.Flap damaged  
 iii. R.H.Aileron damaged  
 iv. R.H.Wing tip damaged

v. R.H.Stabilizertip damaged  
 vi. R.H.Wing skin only trailing edge damaged.  
 vii. R.H.Propeller damaged  
 viii. Nose gear and Main gears strained.
- (App. G<sub>1</sub> - G<sub>6</sub> Photos attached to this report).

5.1. As list in 1.13.6 and refer Photos App. 'G<sub>1</sub>-G<sub>6</sub>'.
