# **FINAL INVESTIGATION REPORT**

## **SERIOUS INCIDENT OF TCAS – RA**

On 15<sup>th</sup> February, 2018, Pakistan International Airline (PIA) flight PIA 585, ATR 42-500 aircraft, Reg. No. AP-BHP was a scheduled passenger flight from Dera Ghazi Khan Airport to Jinnah International Airport (JIAP), Karachi. PIA 585 reported Traffic Alert and Collision Avoidance System – Resolution Advisory (TCAS – RA) while maintaining Flight Level (FL) 100, Military Traffic, Pakistan Air Force (PAF) TIGER-1 03 x F16, operating from Bholari to Bholari and returning from Masroor Training Area via QILLA maintaining FL80, was the crossing traffic. At the time of TCAS – RA vertical separation of 2,000 feet (ft) existed. Traffic information was passed well before time by Approach. All available evidences were analyzed by AAIB Pakistan.

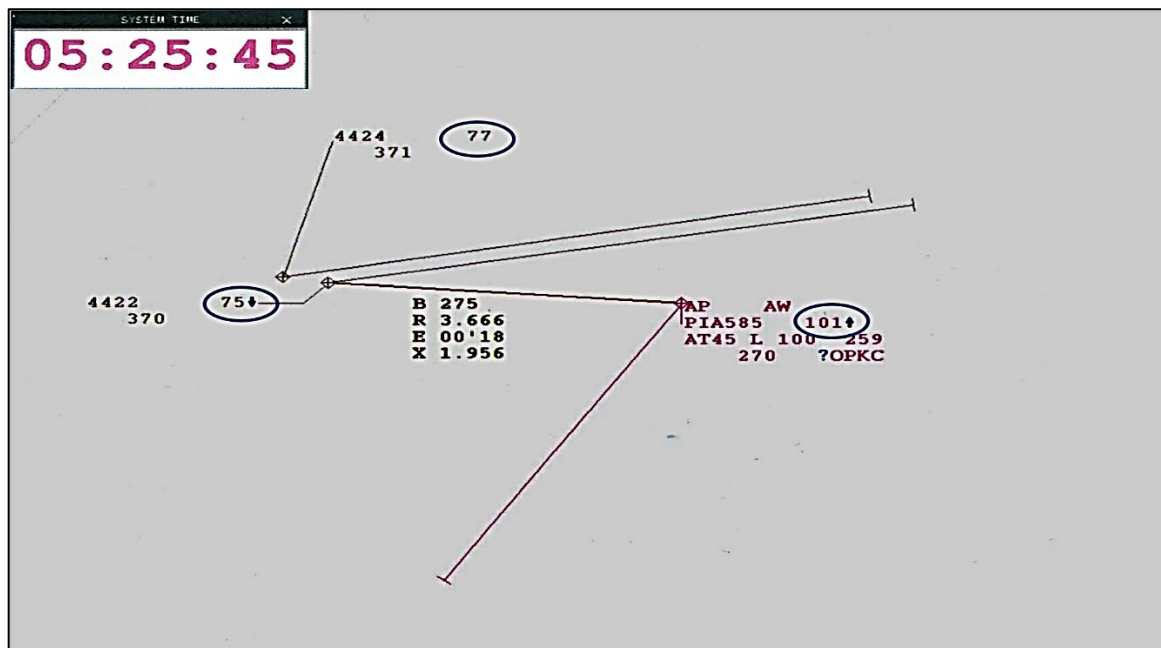
1.1.7. At 05:25:45, Karachi Approach Radar display showed PIA 585 on a bearing of 095° to TIGER-1 and range was 3.6 NM. PIA 585 was showing climbed to FL101↑ and two out of three military aircraft showing their transponder FL77 and FL75↓.

Figure 2 Radar Display Picture PIA 585 on FL101↑

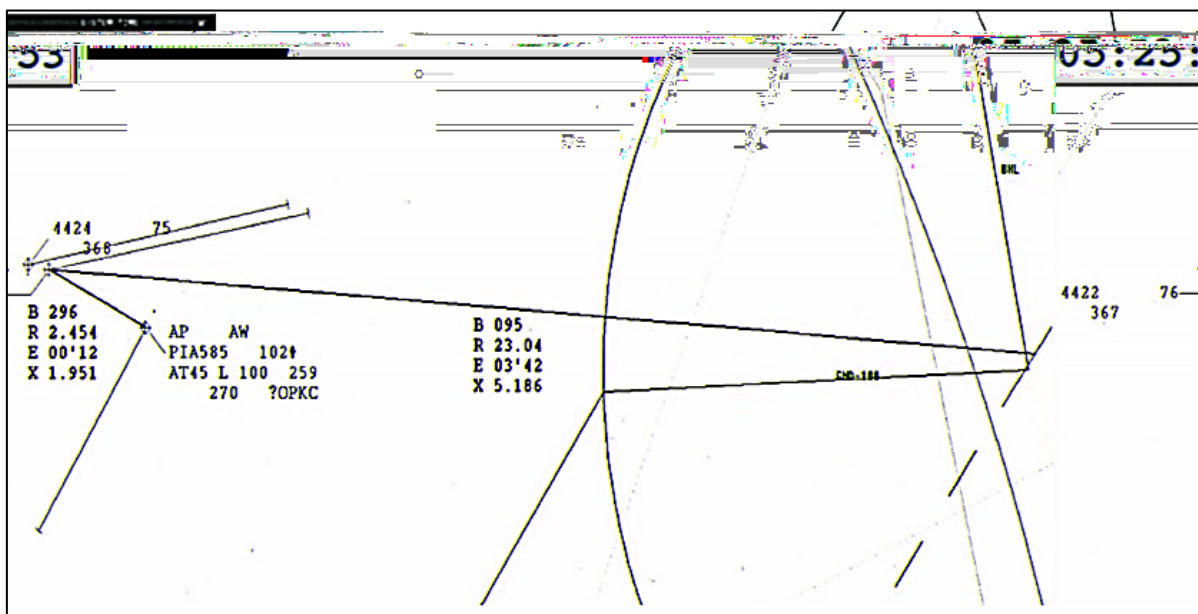
1.1.9. At 05:25:53, Karachi Approach Radar display showed PIA 585 on a bearing of  $116^\circ$  to TIGER-1 and range was 2.45 NM. PIA 585 was showing climb to FL102↑ and two out of three military aircraft showing their transponder FL75 and FL76.

Figure 3 Radar Display Picture PIA 585 on FL102↑

2.1.6. Military aircraft remain all the time below FL80. PIA 585 never crossed below FL100, and initiated climb to FL102 on TCAS – RA.
