**PAKISTAN CIVIL AVIATION AUTHORITY**  
**(SAFETY INVESTIGATION BOARD)**

**FINAL REPORT**

**M/S SCHON AIR CESSNA-172D REG # AP-BHT**  
**FORCED LANDING AT MALIR CANTT NEAR JIAP KARACHI**  
**ON 10<sup>th</sup> DECEMBER, 2012**

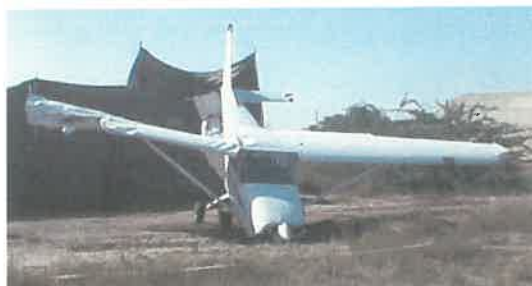
Fig 1: Aircraft Final Full Stop Point

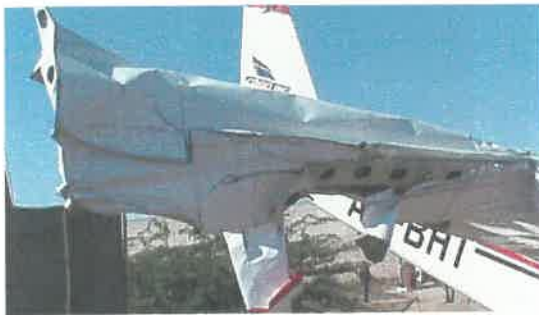
**Fig 2: Right Wing Structure severely damaged**

- 2.1.22. The aircraft right wing impacted with the concrete wall and resulted in severe damage to the right wing.
- 2.1.23. As a result of this impact, the right wing fuel tank got ruptured and fuel started to leak from the fuel tank.

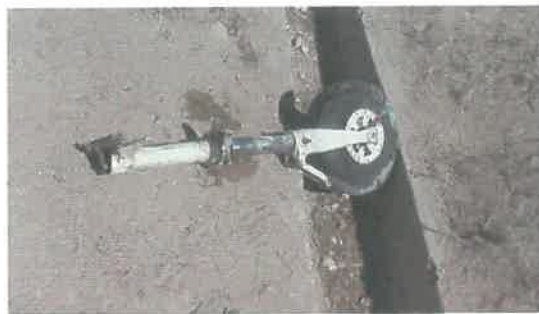
**Fig 3: Nose Landing Gear broke in air after hitting the concrete wall**

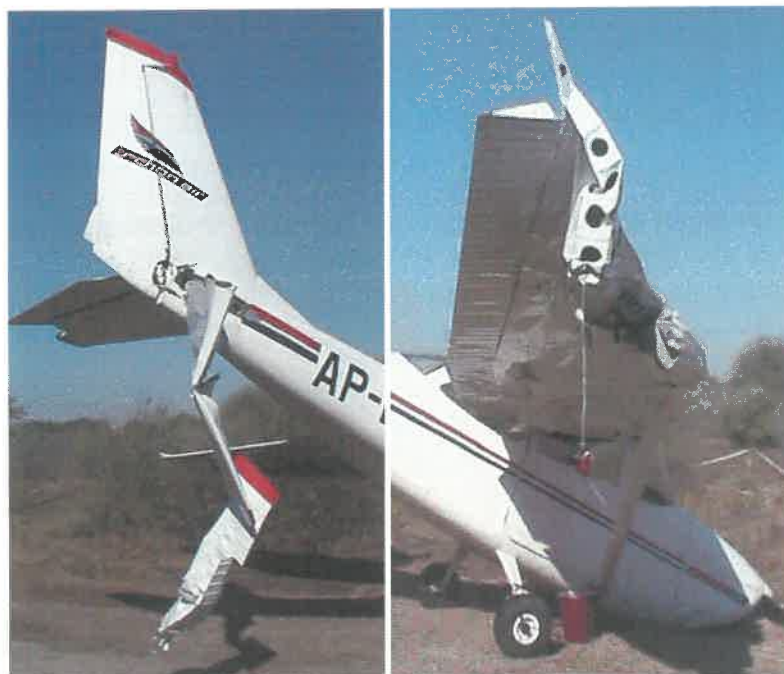
**Fig 5: Damaged Right Wing and Horizontal Stabilizer**

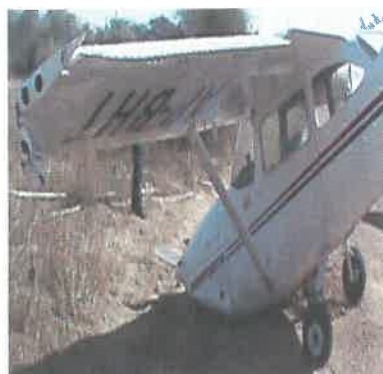
**Fig 6: Minor Damage on Left Wing**

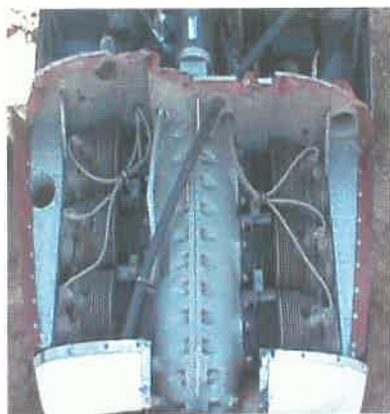
Fig 7: Un-damaged Engine Top Side

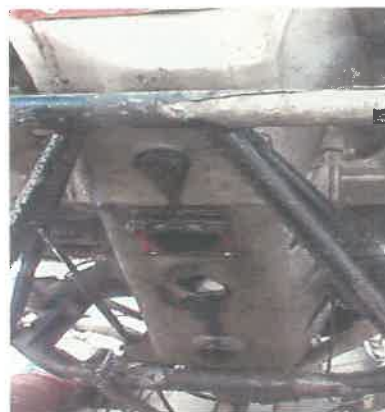
Fig 8: Damaged Engine Lower Side,  
(Oil sump damaged due to breakage of  
Carburettor)

- 1.12.1.4. Carburettor of the engine broke off from its housing after the engine rubbed against the ground due to nose landing gear breakage. It was found lying near left wing about 4 ft from the engine.

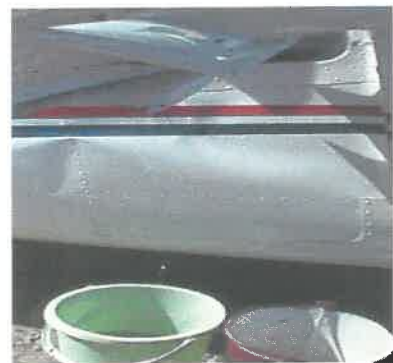
- 2.2.1. **Fuel.** Fuel was found splashed on ground and continuously leaking out from the right wing tank due to rupturing of the wing structure. As there was no damage to the left wing, therefore, no fuel leakage was observed from the left wing tank. Later on, when its drain was opened, sufficient fuel was found available in the tank. About 25 ltrs of fuel was collected from both the tanks.

Fuel being collected from  
Right Wing Tank

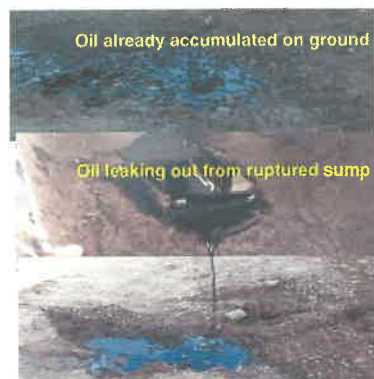
2.2.2. **Engine Oil.** When the aircraft nose was lifted up, oil was found splashed on ground and also leaking from the ruptured oil sump. It indicated that sufficient quantity of oil was available in the engine oil system prior to the mishap. Oil sample was collected for subsequent lab test.

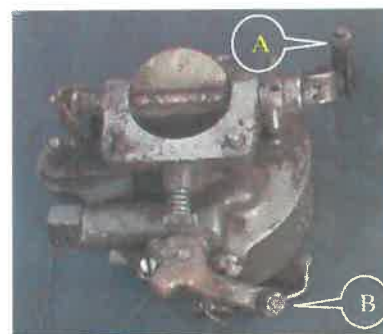
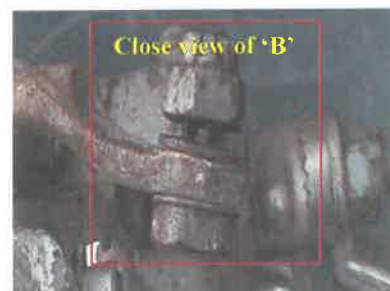
2.2.4. **Carburettor.** Carburettor of the engine was found dislodged from its housing and lying on left side of the cockpit underneath the left wing. It was badly damaged due to rubbing against the ground. Throttle control cable linkage indicated on the figure as 'A' was found broken; whereas, no trace of mixture control cable was found on the installation bolt and nut, indicated on the figure as 'B'. There was barely any damage to the installation nut and bolt which can be clearly seen in the close up view of 'B'. Even the bolt-hole through which the mixture control cable passes did not show any signs of damage. The carburettor was preserved for subsequent examination.

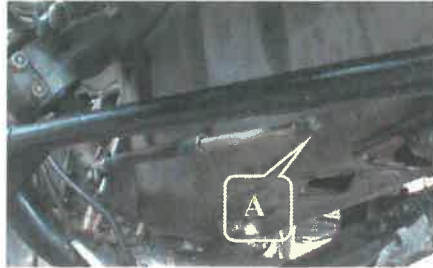
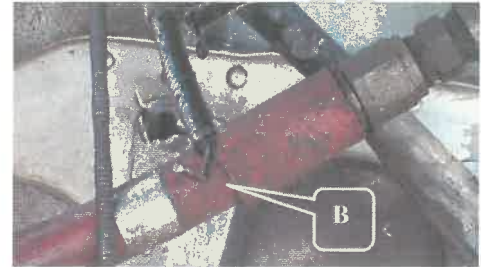
- 2.2.5. **Throttle and Mixture Control Cables.** Both these cables were found hanging alongside the engine. Throttle control cable linkage 'A' was found broken; whereas, mixture control cable 'B' was apparently not broken. However, the mixture control cable indicated two minor bends at its extreme end.

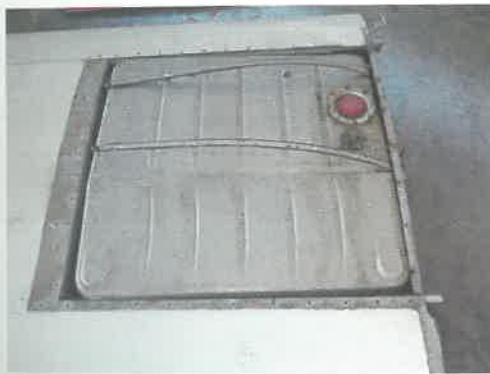
Properly Secured and un-damaged  
Left Wing Fuel Tank

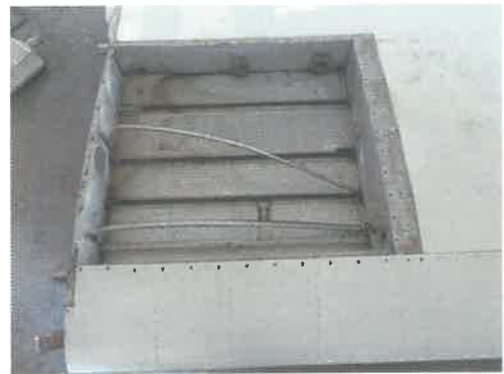
No Anomaly observed in the Cavity of  
Left Wing Fuel Tank

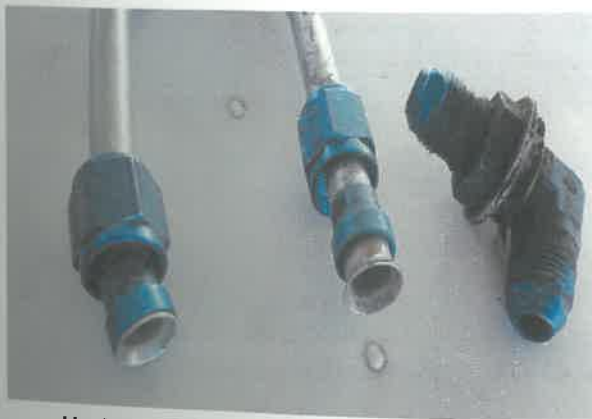
Undamaged fuel pipes and elbow union  
fairings

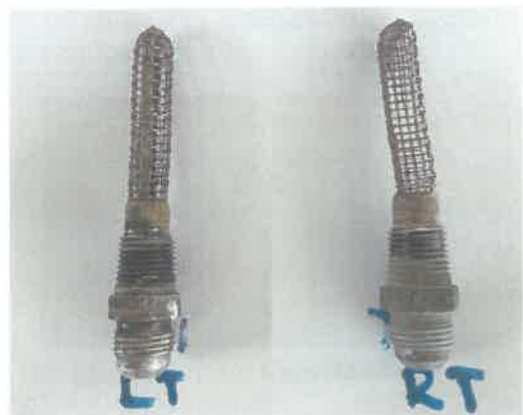
Screen Filters of Left and Right Wing Fuel  
Tanks clear of clogging or contamination

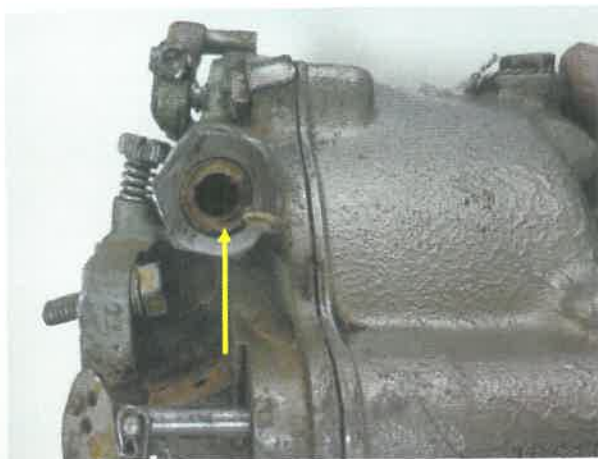
**Carburettor Inlet Filter intact inside**

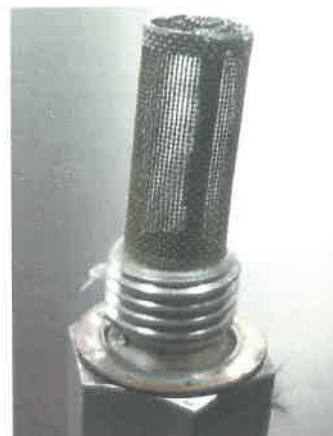
**Carburettor Inlet Filter  
Undamaged and Unclogged**

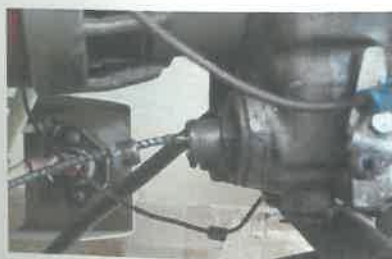
**Undamaged Oil Filter Housing**

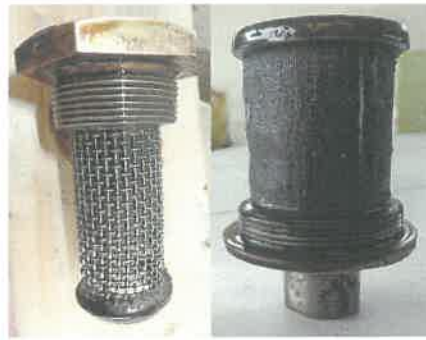
Undamaged and Unclogged Oil Filter

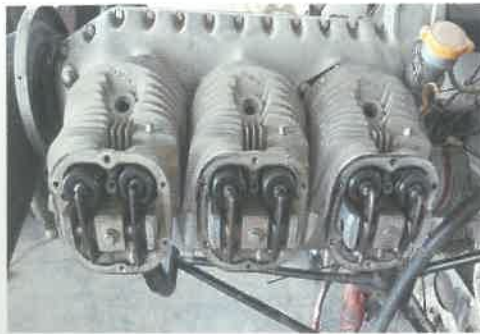
2.2.9.5. **Failure of Engine's Internal Parts.** Strip examination of the engine was done till the connecting rods level. The examination of all six cylinders and their associated hardware did not point to any abnormality. All these parts were found intact, well lubricated and without any distortion or damage signs.

Left Hand Side 03 Cylinders

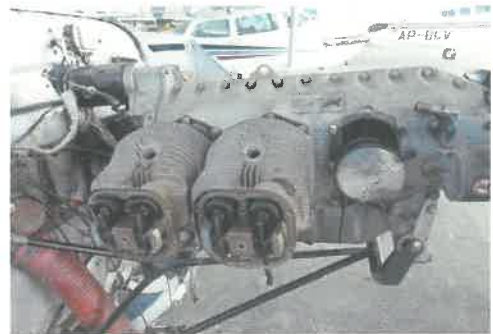
Right Hand Side 03 Cylinders

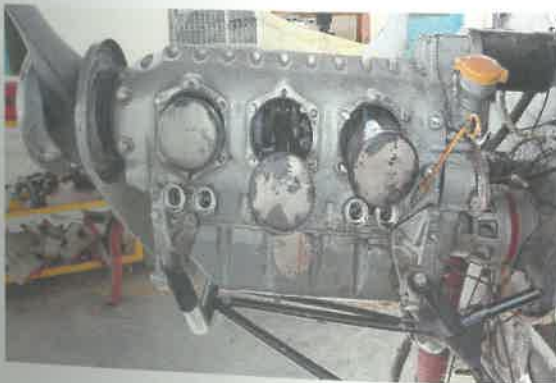
Left Hand Side 03 Pistons

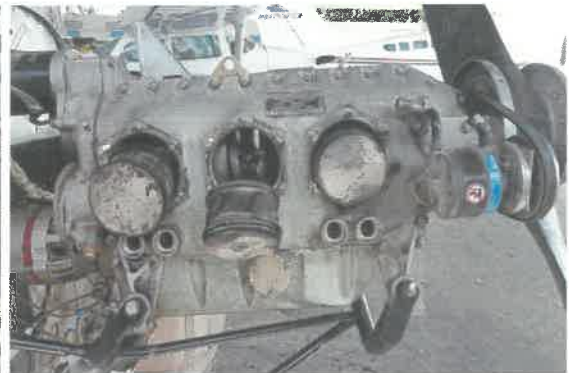
Right Hand Side 03 Pistons

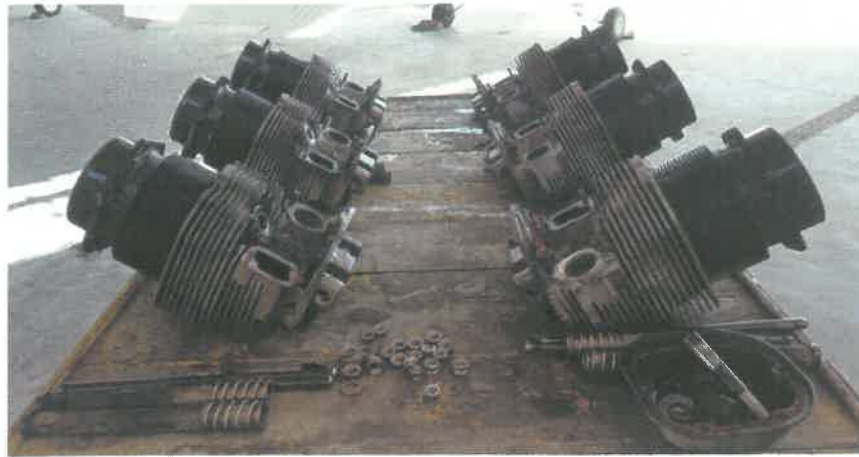
**Undamaged 06 Cylinders along with their associated Parts**

2.2.9.6. Examination of pistons, cylinders, connecting rods and associated parts indicated that there was no mechanical damage to the engine's internal parts and engine operation was unhindered.

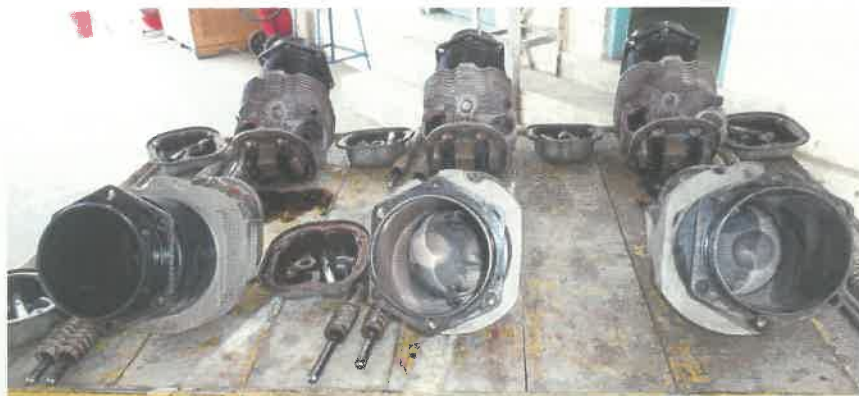
**No scoring, scratches or overheating signs observed on inner side of 06 Cylinders along with their associated Parts**

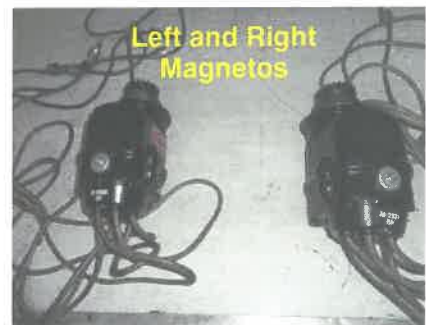
2.2.9.7. **Failure of Electrical Supply to Spark Plugs.** Critical examination of all electrical leads and connections did not indicate any discontinuity. Both magnetos were removed and inspected for any damage signs. Physical condition of both the magnetos and their leads was satisfactory. Operation of magnetos could not be checked due to non-availability of testers. However, with perfectly normal condition of both magnetos and their electrical leads, the possibility of both the magnetos breakdown at the same time was extremely rare.

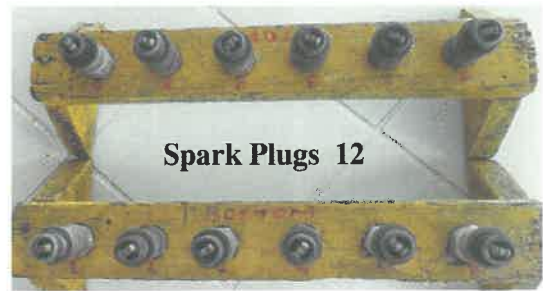
2.2.9.8. Similarly, all 12 spark plugs were removed, inspected and tested on the tester. Their physical condition was excellent and their operation was also satisfactory.

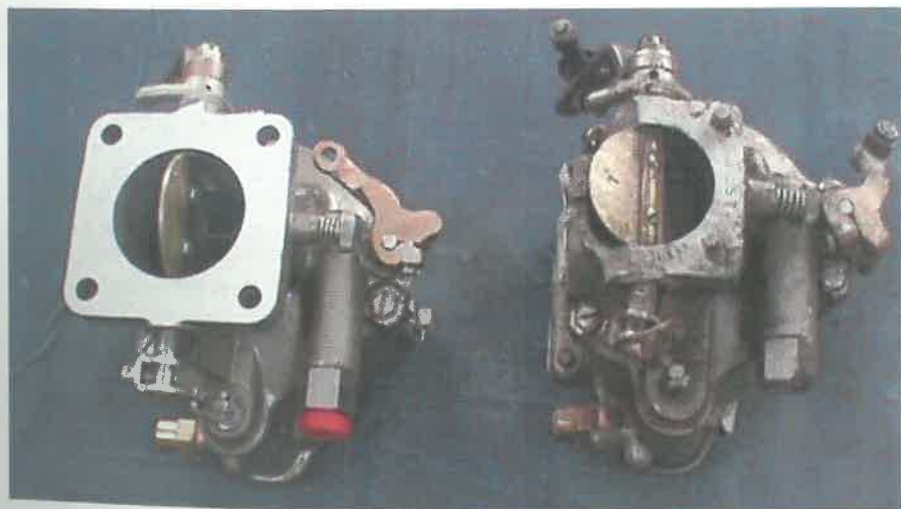
2.2.9.10.1. Upper half of Butterfly Valve of the Carburettor was slightly bent and had severe scratch marks in the direction of Butterfly Valve closed position.

Severe scratch marks on Butterfly valve and its bending toward closed position

Piston slightly lifted up

2.2.9.11. From the comparison it became evident that Butterfly valve was in "Fully Open" position (throttle full open) at the time of impact. Due to rubbing against ground its upper half suffered severe scratches and was bent in the direction of closed position, but the lower half remained in open position.

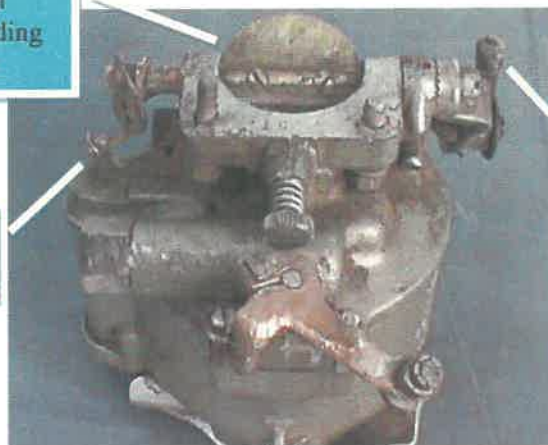
Throttle control linkage moved slightly towards Butterfly closed position

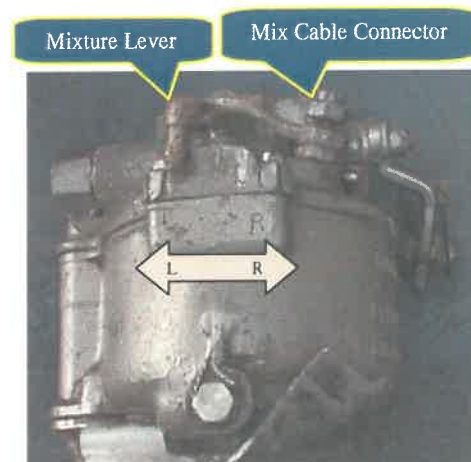
2.2.9.12. Air Fuel Mixture Control Lever on the carburettor has two positions, marked as "L" and "R" which stand for 'Lean' and 'Rich' respectively. It was found moving freely between L & R and, hence, was non-conclusive of its position at the time of impact.

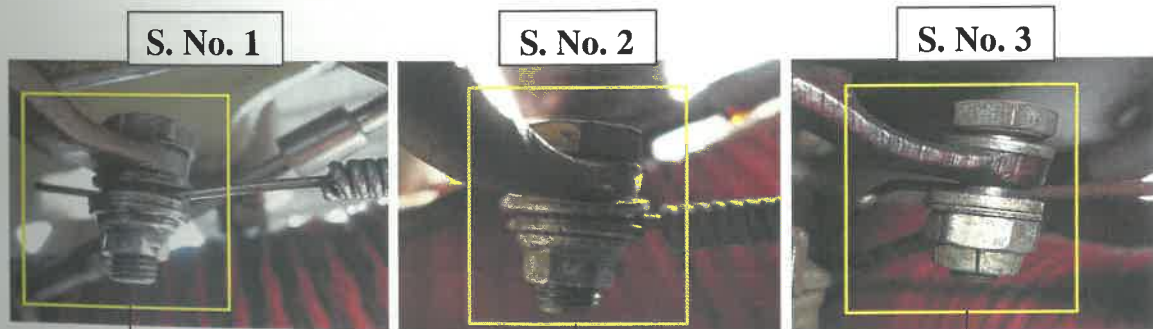
As per Cessna Model 100 series Service Manual (1963 through 1968),  
Page 12-23, Para 12-62, cable after passing through the bolt-hole and secured by tightening  
the nut should be bend 90 degrees to provide additional security against disengagement during  
routine service.

- Additional Cable length after passing through the bolt-hole is not maintained up to a standard scale.
- Bending of cable 90° after passing through the bolt-hole for additional security against dislodgment is not ensured.
- Use of washers on either side of the cable is not ensured and is not even standard on all aircraft.
- Nuts used on the bolt for tightening the cable are not of same type and design.
