**PAKISTAN CIVIL AVIATION AUTHORITY**  
**Safety Investigation Board**

**REVISED INVESTIGATION REPORT**  
**(25 JULY 2012)**

**FATAL ACCIDENT OF CESSNA 150 AIRCRAFT, REG AP-BCS**  
**OF HYBRID AVIATION (PVT) AT MODEL TOWN**  
**LAHORE, ON 23 FEBRUARY 2012**

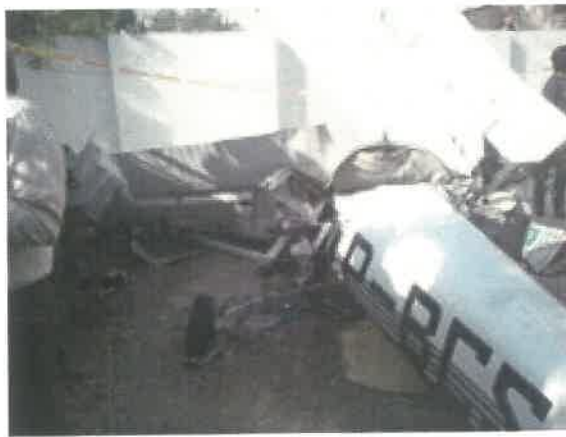
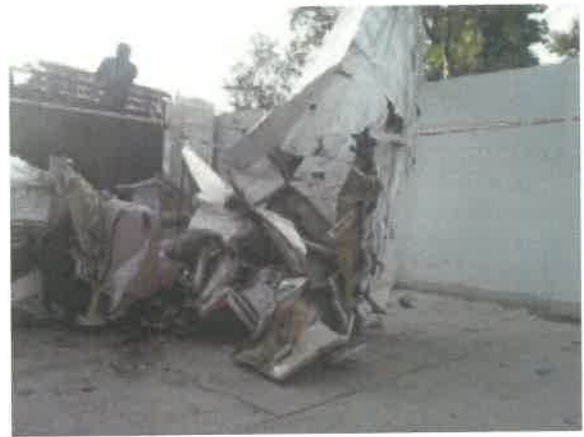
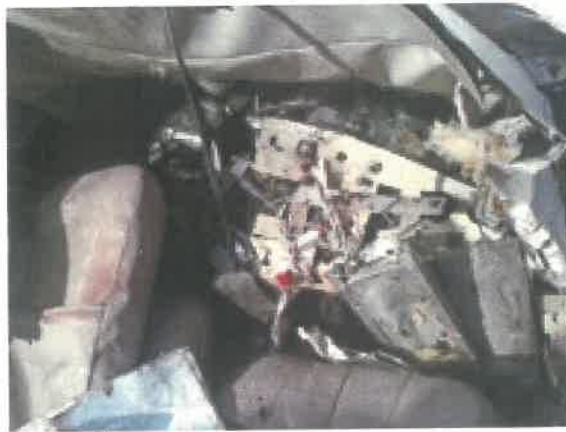
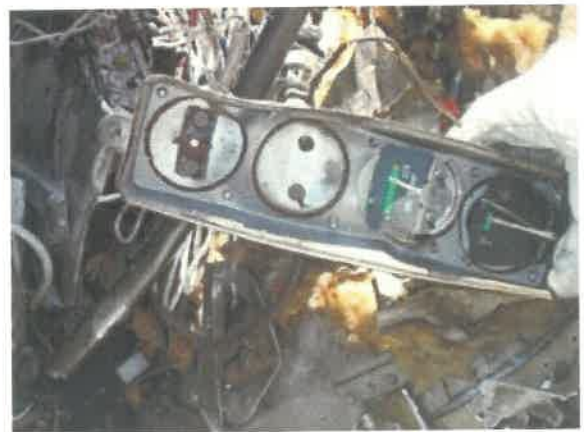
1.9 **Wreckage Description:** The wreckage description is covered in details in Technical report of the investigation. However, important pictorial views are appended as below:

- c. **Technical:** The physical Impact/ Wreckage damage pattern indicates that the Aircraft hit the ground straight "Nose-Down" with a Steeper Impact Angle; brakeage to the aircraft and its engine parts was consequential. All the significant structural parts of the aircraft were accounted for at the accident site. The aircraft, its engine and all related systems were functioning normal; the aircraft was airworthy till sudden contact disappearance at 1405 hrs with ATC and it fatally crashed. Probably, the low instructional experience of aircrew and incorrect handling techniques in training circuit flying at low altitude might have caused the crash.

- 4.3 The impact of aircraft with ground indicates, aircraft being at high dive angles, at low air speeds with right bank angles / right side-slip, wreckage spread in a small and confined area within the space of a drive way to a car porch. The aircraft was though, completely destroyed, but in one piece and did not leave any oil & fuel splashes / marks on the white clean wall in the very near vicinity of hardly 3-5 feet of impact point. Therefore, it can be safely established that aircraft was under stalled conditions at the time of impact.
