# FINAL INVESTIGATION REPORT

**SERIOUS INCIDENT OF REJECTED TAKEOFF M/S  
SHAHEEN AIR INTERNATIONAL FLIGHT NO. NL-766,  
A-320 AIRCRAFT, REG NO. AP-BLH AT AIIAP LAHORE  
ON 2<sup>ND</sup> JUNE, 2016**

**FINAL REPORT**  
**SERIOUS INCIDENT OF REJECTED TAKEOFF M/S SHAHEEN AIR INTERNATIONAL**  
**FLIGHT NL-766, A320-232 AIRCRAFT, REG NO. AP-BLH AT AIIAP LAHORE**  
**ON 2<sup>ND</sup> JUNE, 2016**

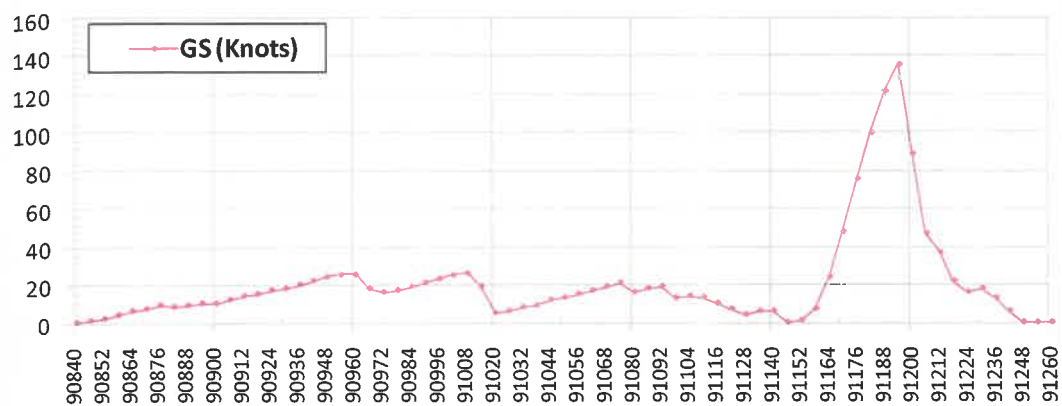
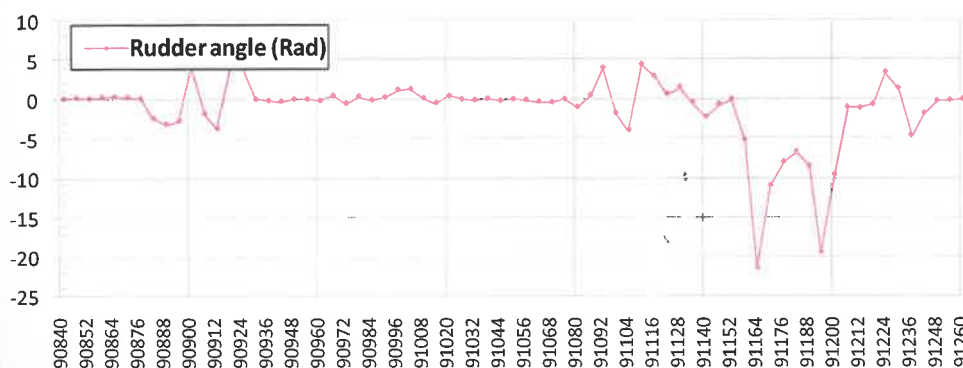
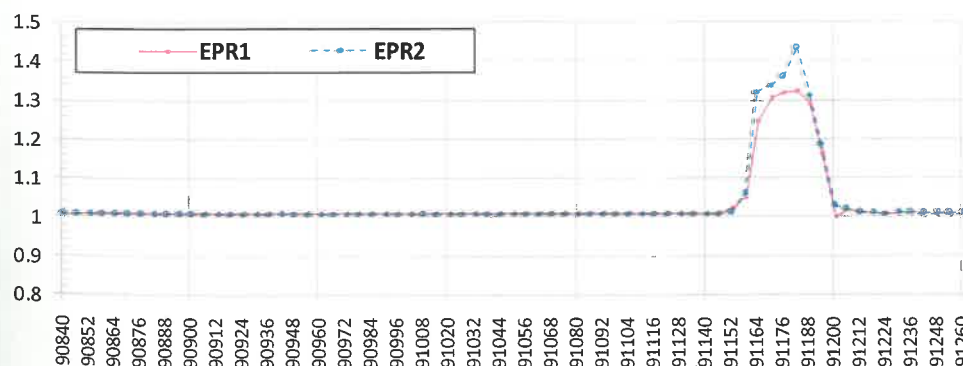
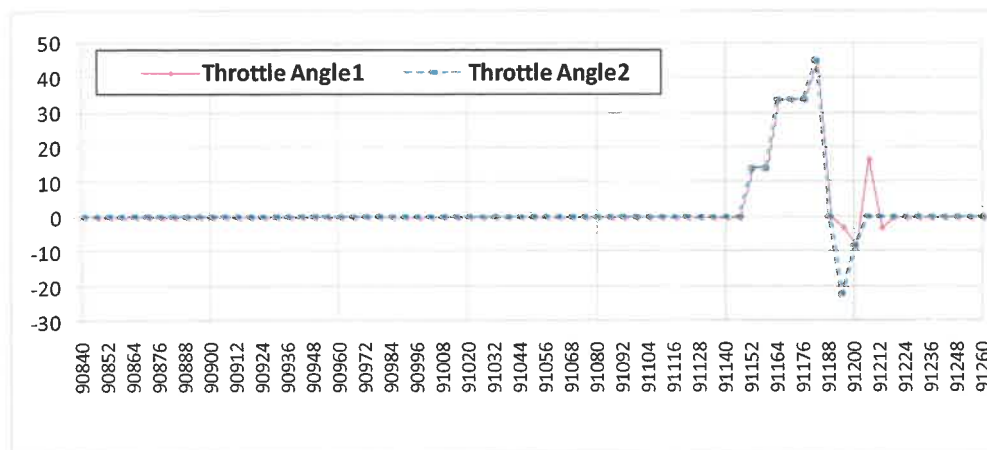
2.2.4 The plots of relevant FDR parameters vs. FDR subframe count (one second interval between subframes) is shown below. FDR data showed that aircraft ground speed peaked to 138 kts and application of rudder to counter the asymmetric thrust before Thrust Levers were retarded for rejecting the takeoff.

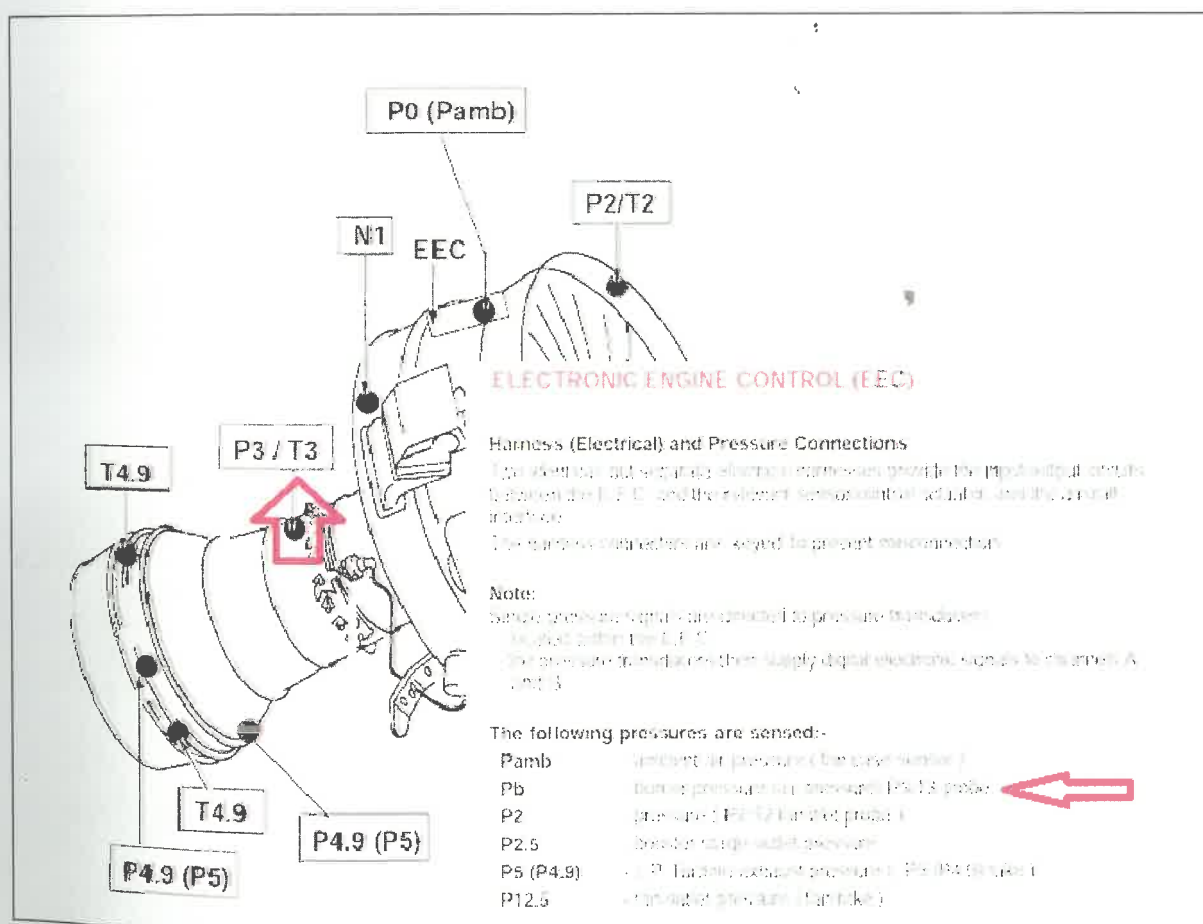
- 2.2.5 The post incident troubleshooting checks by the operator revealed that Engine No. 1 thrust did not develop due leak in the Burner Pressure (PB) line.
- 2.2.6 In order to control different parameters of the engine, one of the inputs is taken in from P3 (Pressure from HP Compressor) and fed to Engine Electronic Control (EEC). This pressure is called Pressure Burner (Pb) as shown in the figure below :-

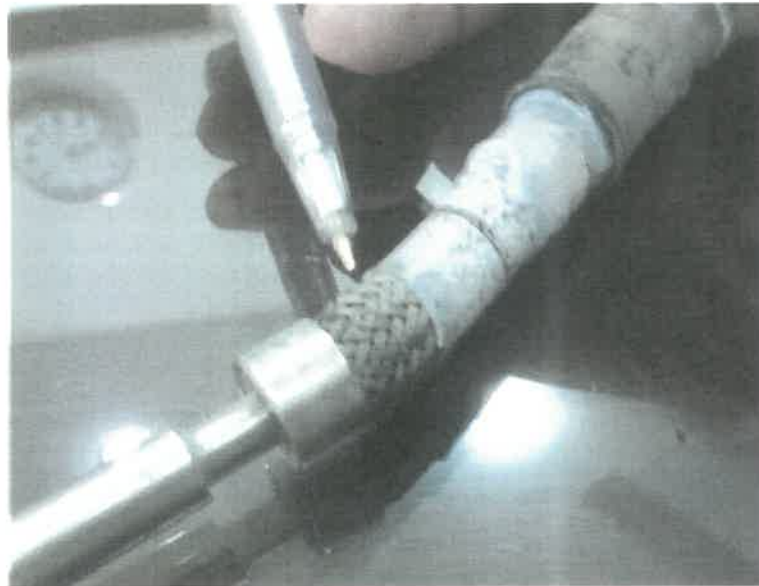
**Location of the leakage on PB Line**

- 2.2.7 The P3 or Pb is transferred to the EEC thru Pressure Burner line. The defective PB line Part No. 6A9039 is removed & re-installed at every A-check for water wash of the engine. The last water wash was carried out on 26<sup>th</sup> May, 2016 at A-check at Karachi. The aircraft flew 20 cycles after water wash before the incident. During leak check of the faulty PB line by the operator, the leakage was found at the swaged end as pointed out with PEN in picture below. The defective line was dispatched to the engine manufacturer, International Aero Engines (IAE) for further investigation. The OEM has informed that process of redesigning the PB line is under consideration at their end in collaboration with the Vendor who provides material for this line. This indicate that :-

- 2.2.7.1 The leakage of air pressure from PB line lead to a reduced pressure signal to EEC of No. 1 engine. Accordingly, the EEC reduced the fuel flow rate to the combustion chamber leading to a lesser thrust during takeoff role.

- 2.2.7.2 There being no pressure leakage from the ends of PB line indicates that there was no maintenance error on part of the operator.
- 2.2.7.3 The OEM's update after analysis that the design of PB line is being reviewed including review of the vendor provided material indicate that the leakage was due to some material flaw in the line.

- 3.1.4 The Engine No. 1 did not develop desired power due to leak in its PB line.
- 3.1.5 There was no maintenance error on part of the operator which led to the leakage of Air Pressure from the PB line.

- 3.1.6 The investigation of defective PB line is still under investigation by the Engine OEM, IAE (International Aero Engines) and has updated that the design of PB line is under review indicating some flaw in the material of the PB line.

- 4.7 IAE (international Aero Engines) is requested to redesign and improve the material of PB line and intimate all users.
- 4.8 Airbus / SLS (Safran Landing Gear System) is requested to analyze the industry experience for similar cases where the tyres got burst due malfunction of the fuses. In case there are more number of similar cases, a design review of the tyre deflate system may be under taken.

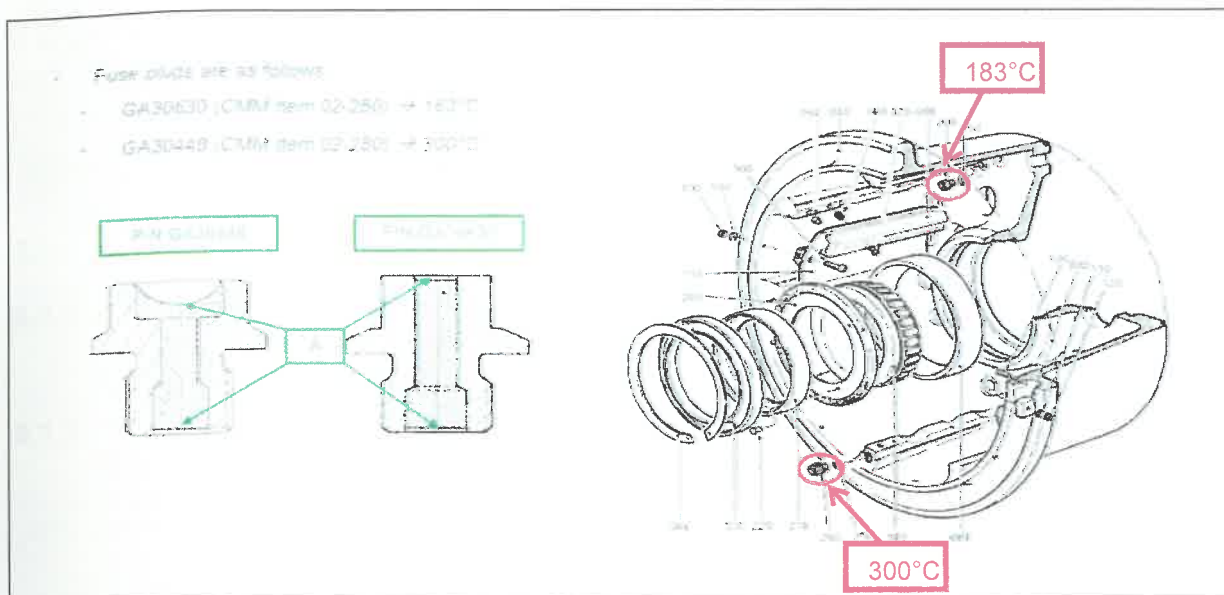
- 2.2.8 In order to prevent the tyre burst, the main wheel hubs are fitted with 02 sets (each set containing Qty-03 fuses). The first set (Pt No. GA30630) operates if the temperature of wheel reaches between 180-186°C and deflate the tyre. The second set (Pt No. GA30448) operates if the temperature of wheel reaches 300°C and deflates the tyre.

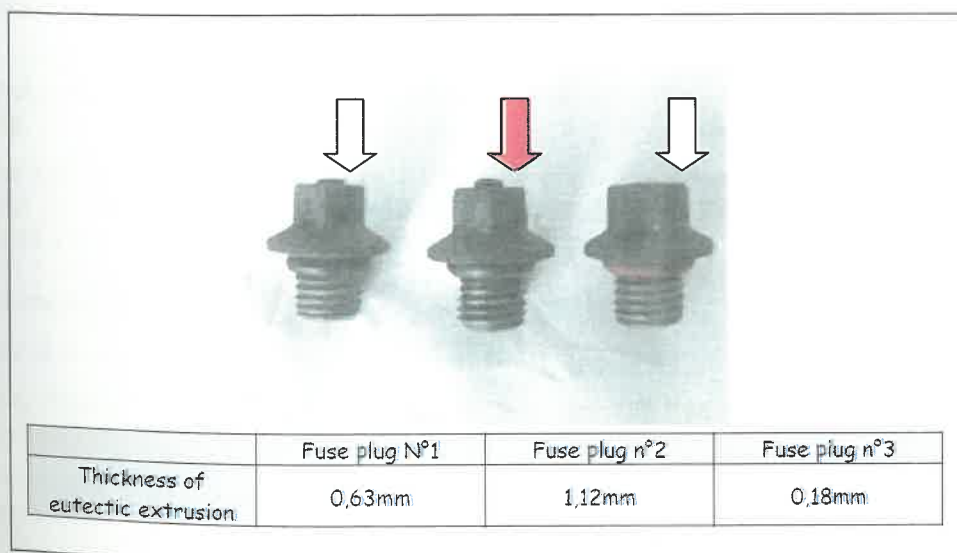
2.2.12 On the other hand, during visual inspection of No. 2 Wheel (C20225510, SER 07304), none out of the six fuse plugs (**GA30630 Qty-03 and GA30448 Qty-03**) are melted.

2.2.13 The three GA30630 fuse plugs installed on wheel No. 2 present a partial eutectic extrusion at the screw head.

- 2.2.14 Measurement of eutectic alloy melting temperature for fuse plug GA 30630 No. 2 demonstrated an average melting temperature started at 182.98°C. Exposition at this temperature would partially melt the eutectic as observed in this case.

- 3.1.10 The Lab analysis of the fuses indicated that the average temperature of the No. 2 wheel rose to 182.98°C (Range 180-186°C). Accordingly, at this transient temperature, the fuses extruded partially, hence not deflating the tyre.

- 3.2.1 Non adherence of FCOM/QRH rejected takeoff procedure by the captain.
- 3.2.2 The Engine No. 1 did not develop desired power due to leak in its PB line as a consequence of its material failure.
- 3.2.3 The fuses of No. 2 tyre were exposed to a closed but below the melting temperature, which was not enough to deflate the concerned tyre.
