CIVIL AVIATION AUTHORITY PAKISTAN

INVESTIGATION REPORT

AIRCRAFT INCIDENT TO M/S AERO ASIA YAK-42D

REGISTRATION NO RA-42425

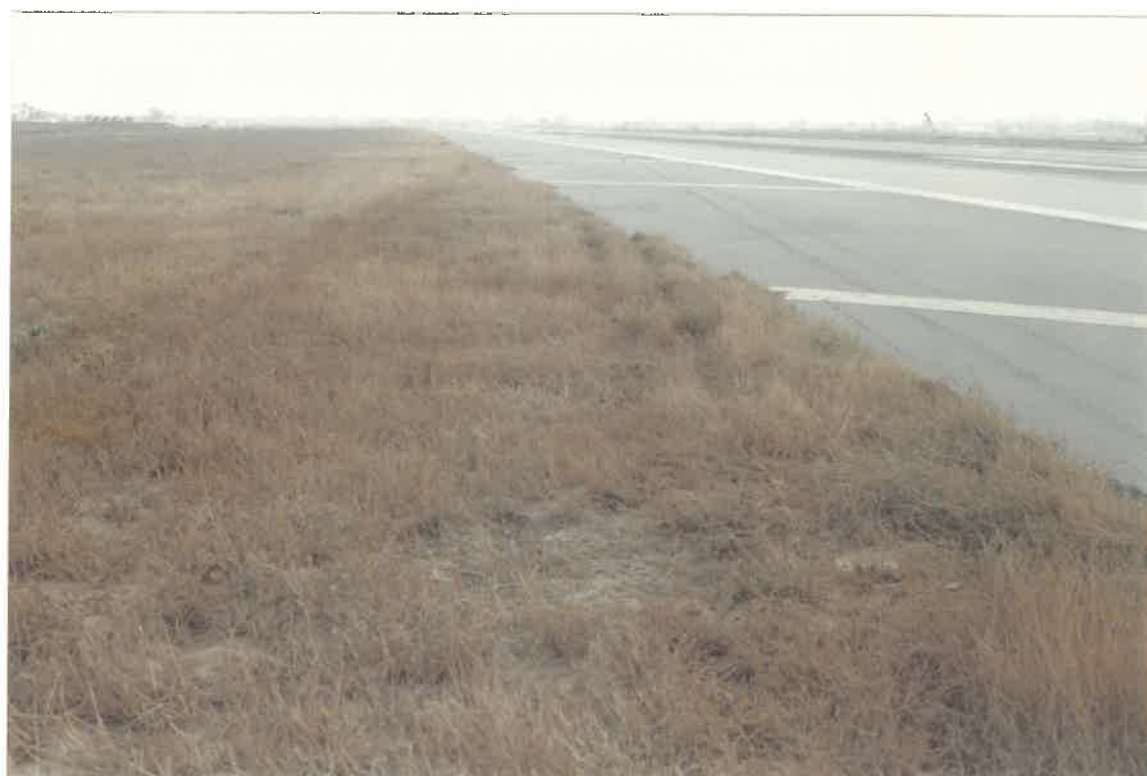
- 1.12.1 Sketch of the initial touch down and subsequent ground roll is placed as Appendix " E-1 ". The aircraft initially touched down at 1520 feet down the runway with its nose inclined slightly to the right. The right landing gear went off the runway and the hard shoulder at about 2500 feet from threshold. This was followed by the left landing gear which went off the runway and the hard shoulder at 2750 feet from the threshold. The aircraft remained on the unprepared surface up to a distance of 4880 feet from the threshold, came on to the hard shoulder between 4880-5400 feet (approx) and returned to the unprepared surface for the second time. From 5400 feet to about 6000 feet from the threshold the aircraft again remained on the unprepared surface. The total landing roll of the aircraft on the unprepared surface was approximately 2980 feet. The aircraft was about 55 feet away from the edge line of the runway while rolling to a stop. During the landing roll the aircraft knocked down a taxiway designator board belonging to new terminal complex (NTCL).

**AIRCRAFT ENTERING THE UNPREPARED SURFACE**

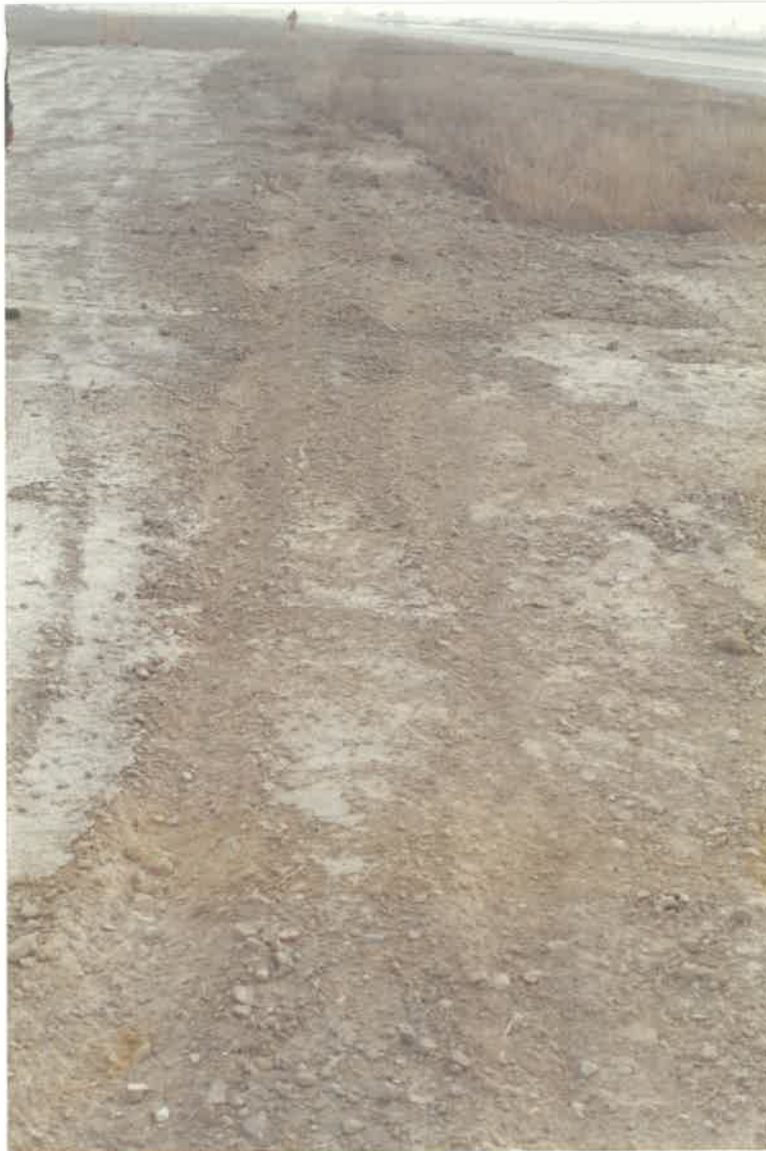
**TYRE MARKS ON UNPREPARED SURFACE**

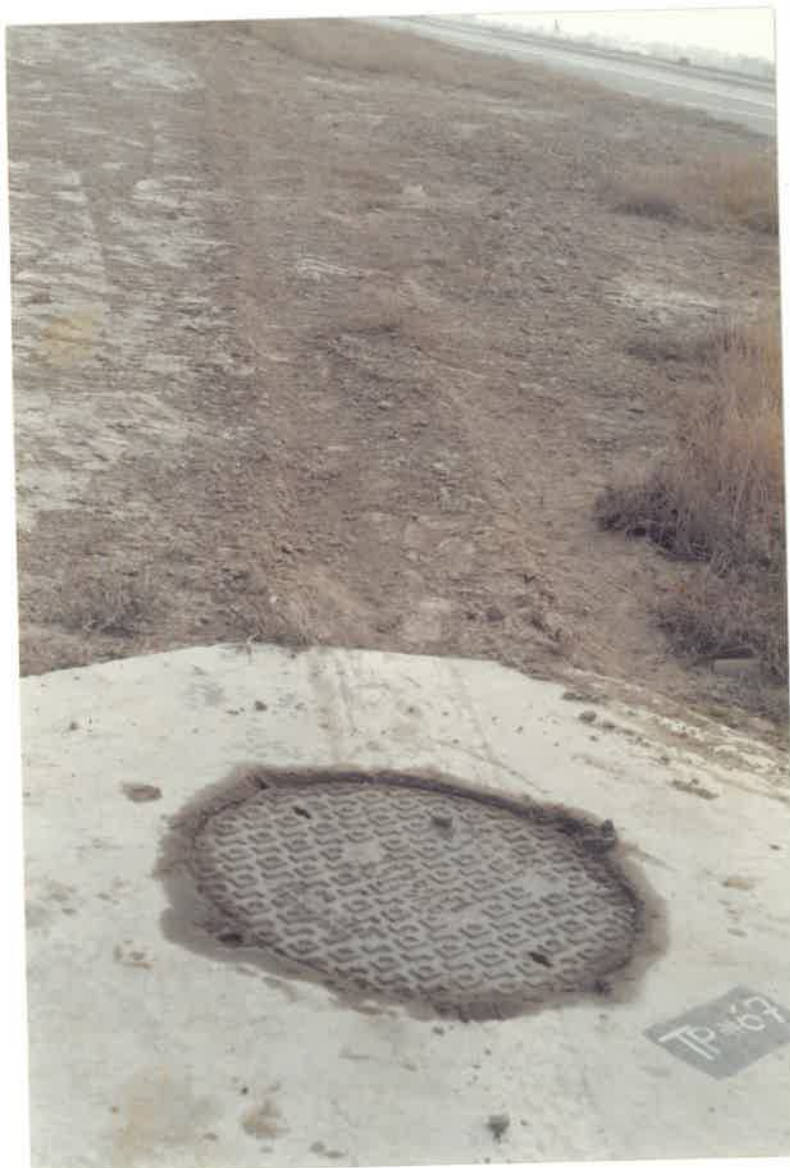
**TYRE MARKS ON UNPREPARED SURFACE**

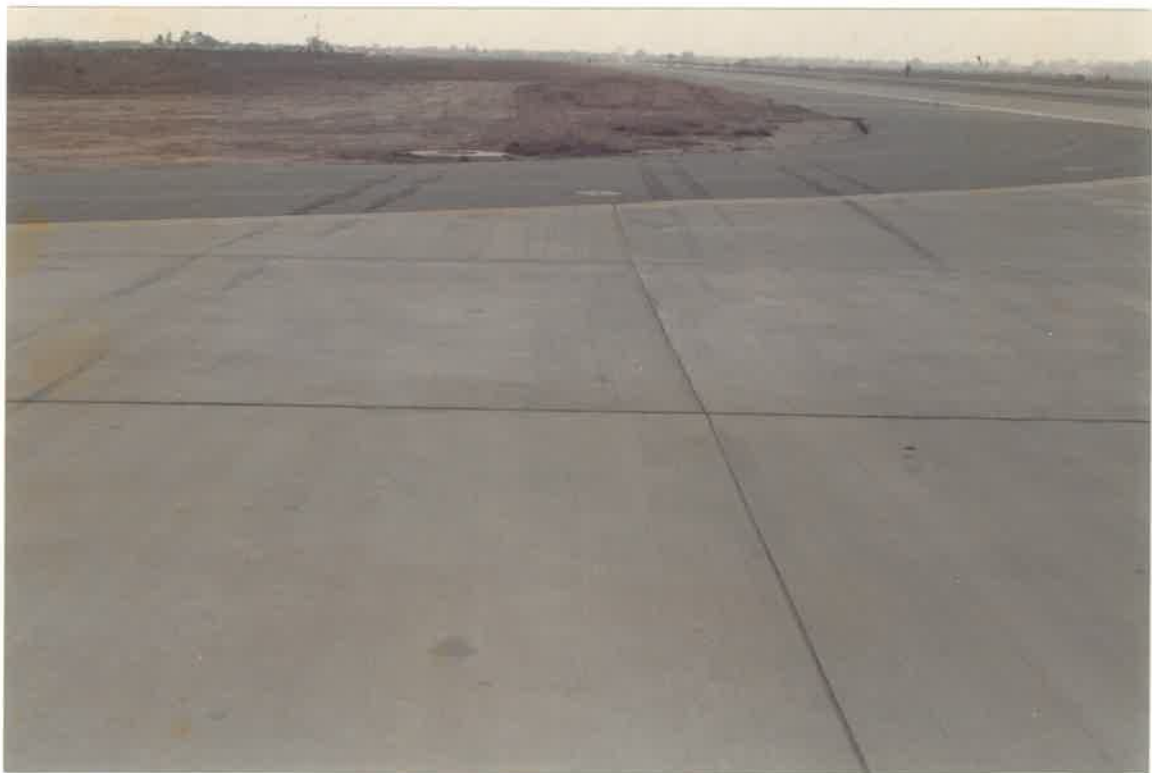
- 3.1.15 The aircraft straightened out and rolled almost parallel to the runway about 63 feet right of the runway edge line.
- 3.1.16 It crossed taxiway 'T' and over ran a taxiway designator board, which was broken completely.

AIRCRAFT CROSSING TAXYWAY 'T'

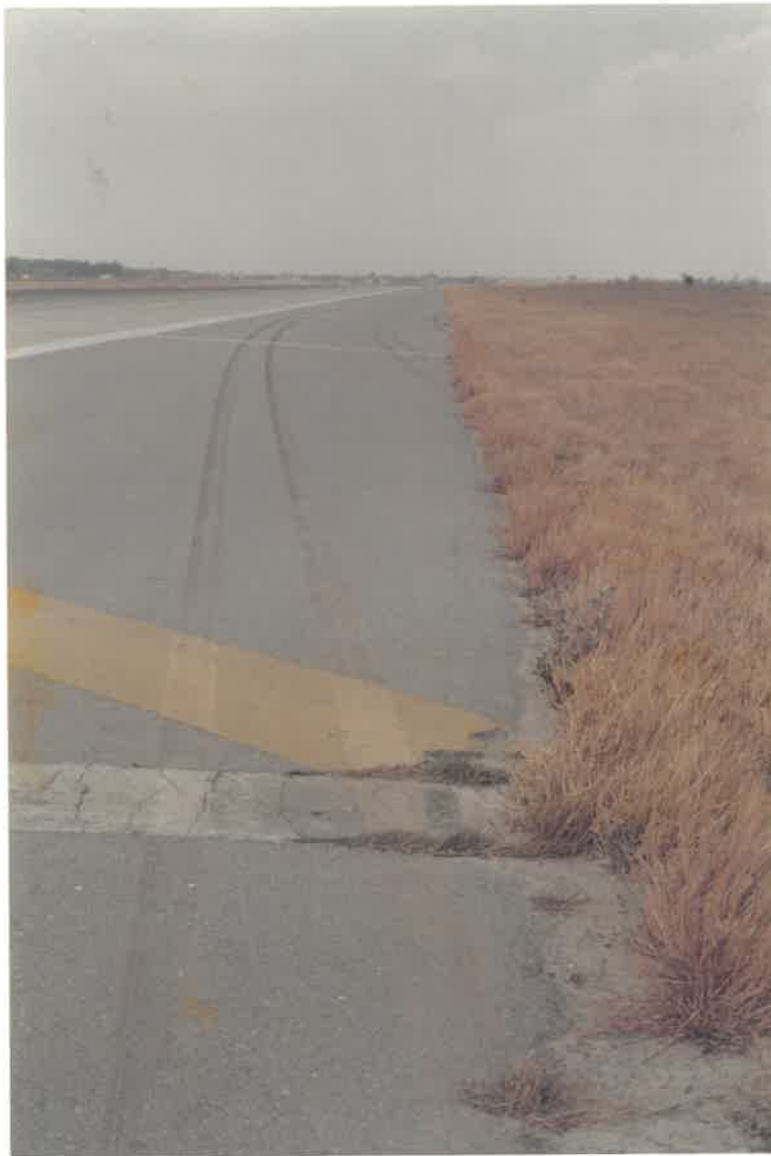
- 3.1.17 The taxiway designator board belongs to new terminal complex (NTC), a project nearing completion at Lahore.
- 3.1.18 At about 4500 feet from the threshold the aircraft came on to the hard shoulder momentarily and returned to the unprepared surface at about 4800 feet from the threshold.

**AIRCRAFT ENTERS HARD SHOULDER MOMENTARILY**

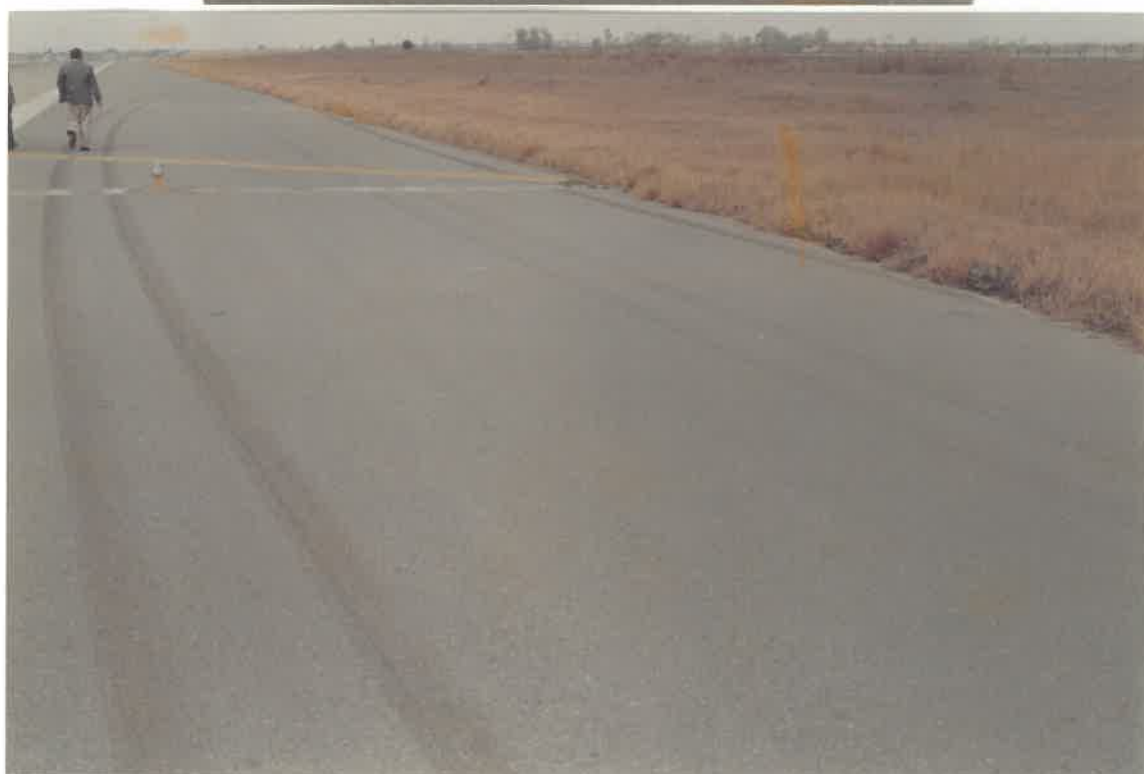
**AIRCRAFT ENTERS HARD SHOULDER MOMENTARILY**

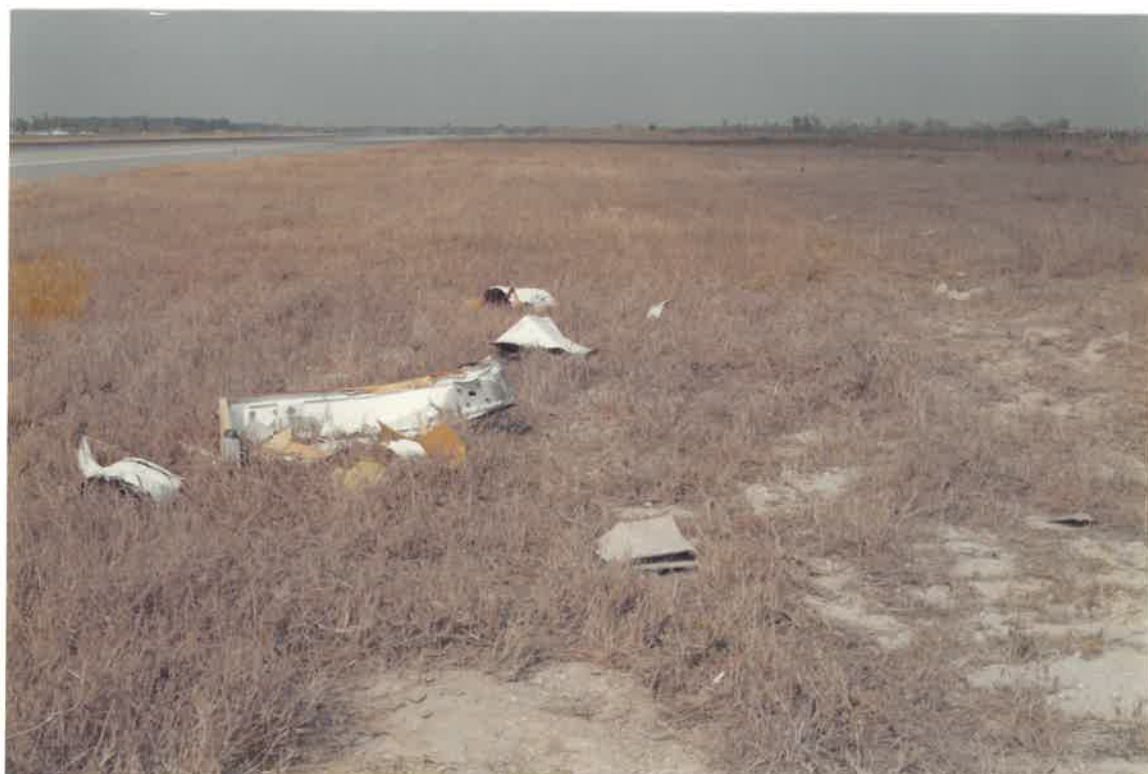
**1.4 OTHER DAMAGE:** One taxiway designator board was destroyed completely as a result of its collision with the right landing gear of the aircraft. The taxiway designator board was the property of NTCL.

DESTROYED TAXYWAY DESIGNATOR BOARD

- 4.1 Appropriate measures be taken by CAA Russia in respect of the cockpit crew involved in this incident.
- 4.2 Aero Asia to ensure that their pilots are aware of the limitations applicable to their operations in poor visibility conditions.
- 4.3 Aero Asia <sup>to</sup> compensate the new terminal complex project for the damage caused to the taxiway designator board.
- 4.4 Reporting of incidents, immediately on their occurrence, must be (re) emphasized on the crew by the operators.

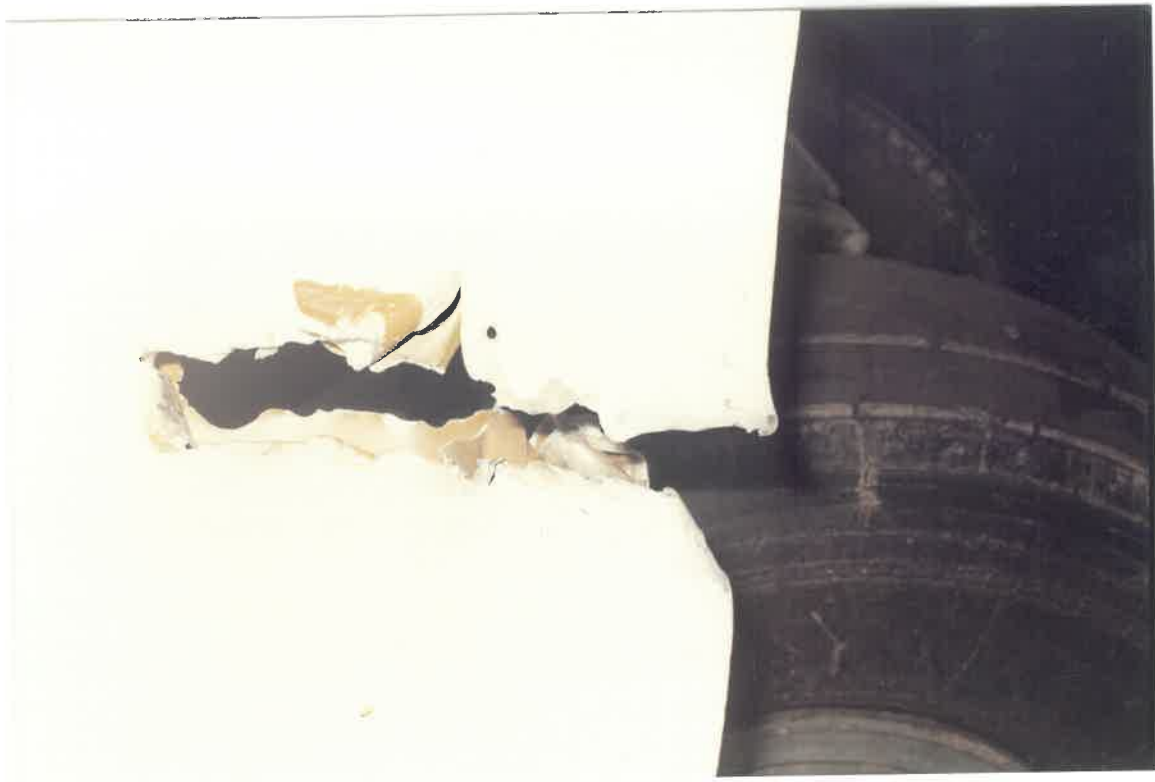
**1.3 DAMAGE TO AIRCRAFT:** The right landing gear door was damaged along with some hydraulic pipes mounted on the right landing gear. (Appendix 'B' & 'J-8').

DAMAGED LANDING GEAR DOOR (RIGHT WHEEL)

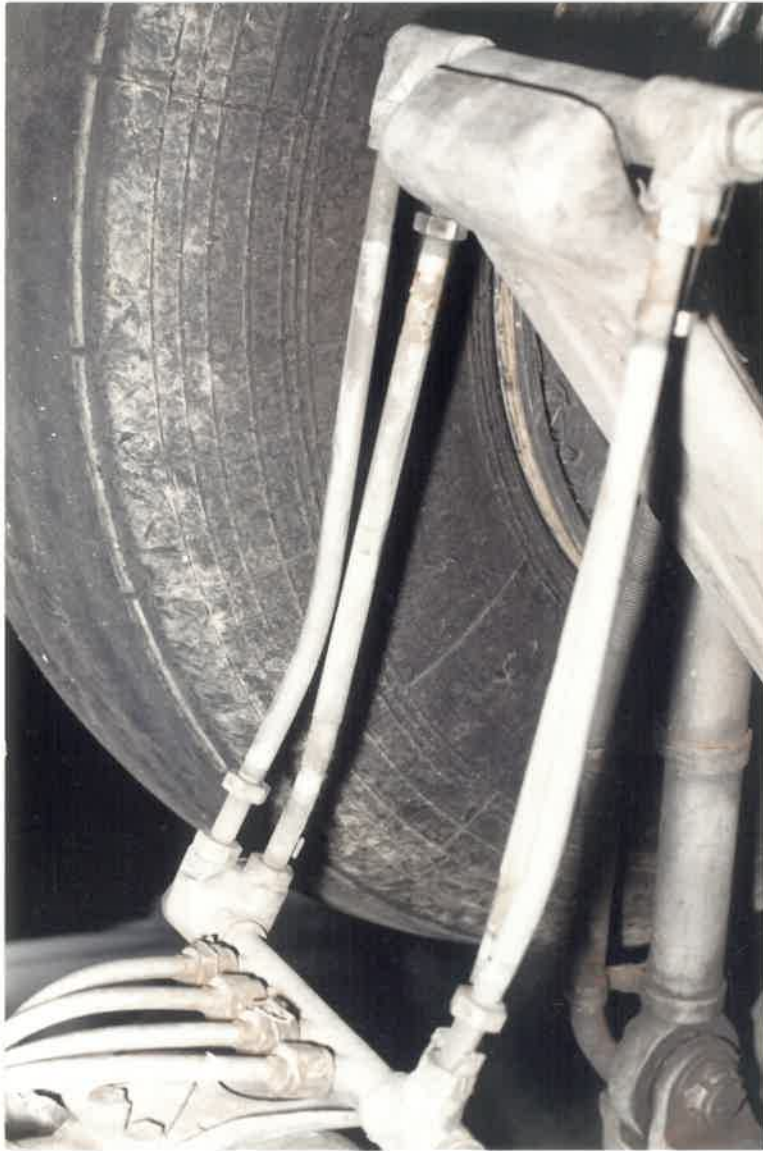
DAMAGED PIPES - RIGHT LANDING GEAR

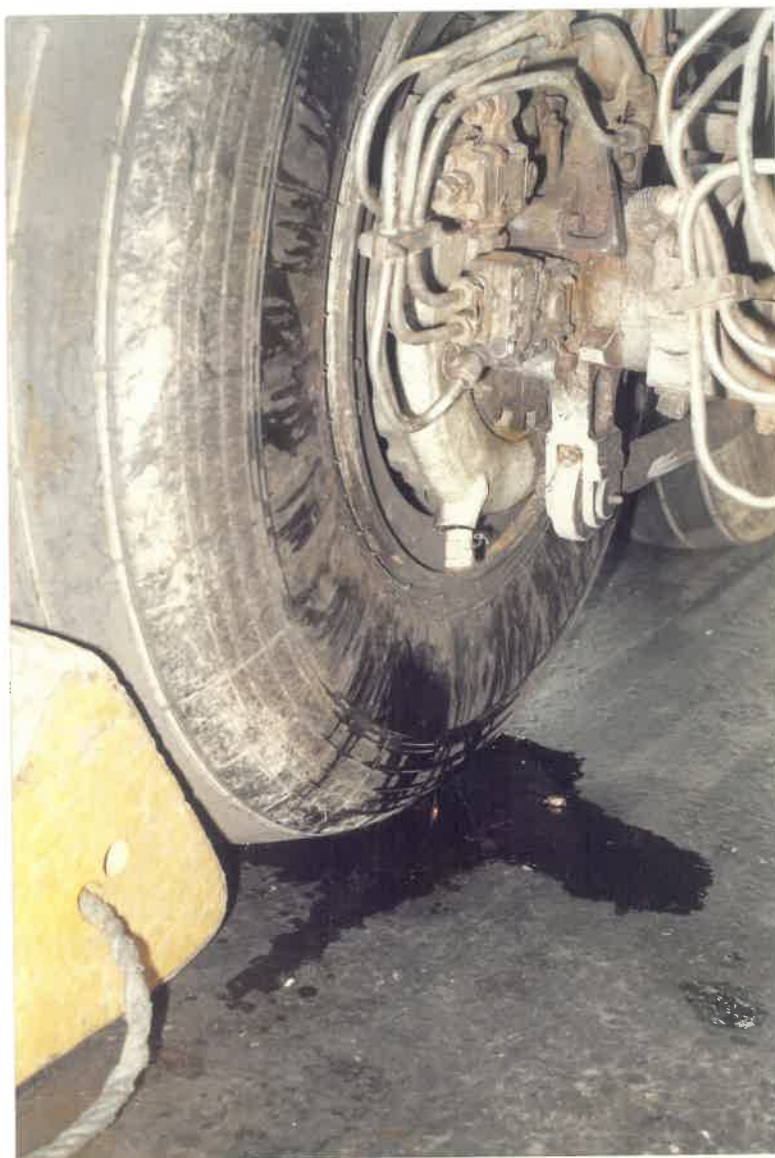
LEAKAGE FROM DAMAGED PIPES - RIGHT LANDING GEAR

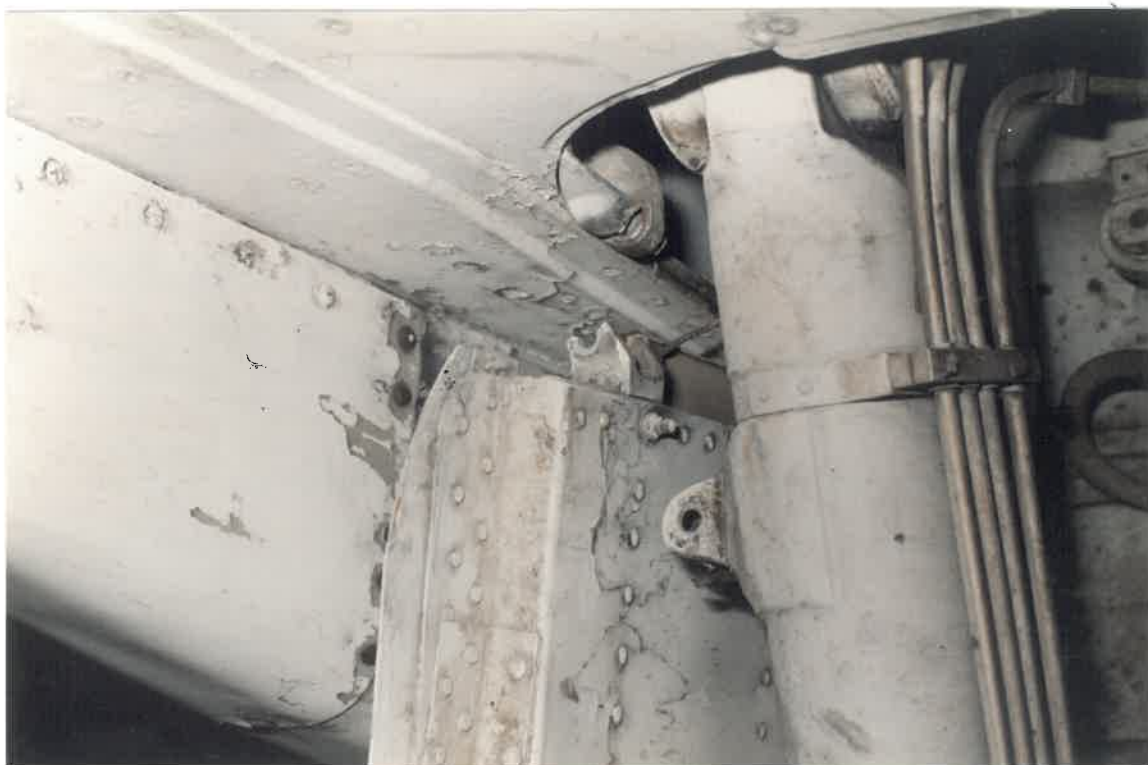
**BROKEN LANDING GEAR DOOR HINGE**
