INVESTIGATION REPORT OF CESSNA AIRCRAFT  
AP-BAW BELONGING TO RAWALPINDI FLYING  
CLUB WHICH MET WITH AN ACCIDENT ON  
2TH JANUARY, 1990

HQCAA/1901/AIB dated  
8th January 1990.

| 2. Type | Cessna -152 |
| 4. Aircraft Registration | AP-BAW |

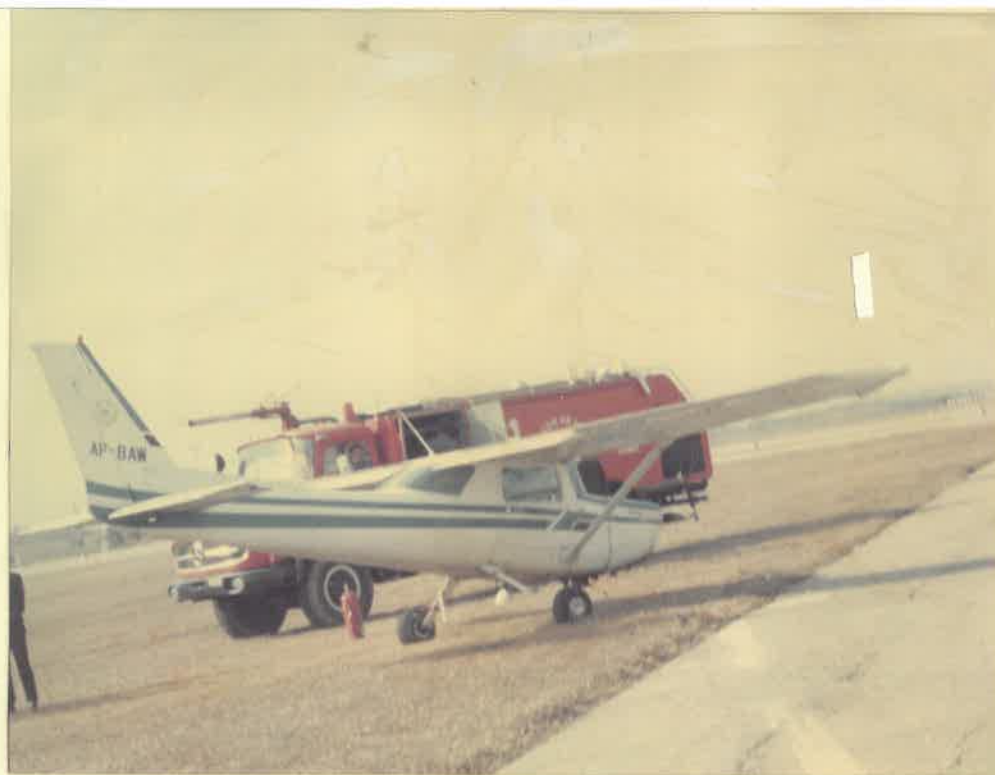
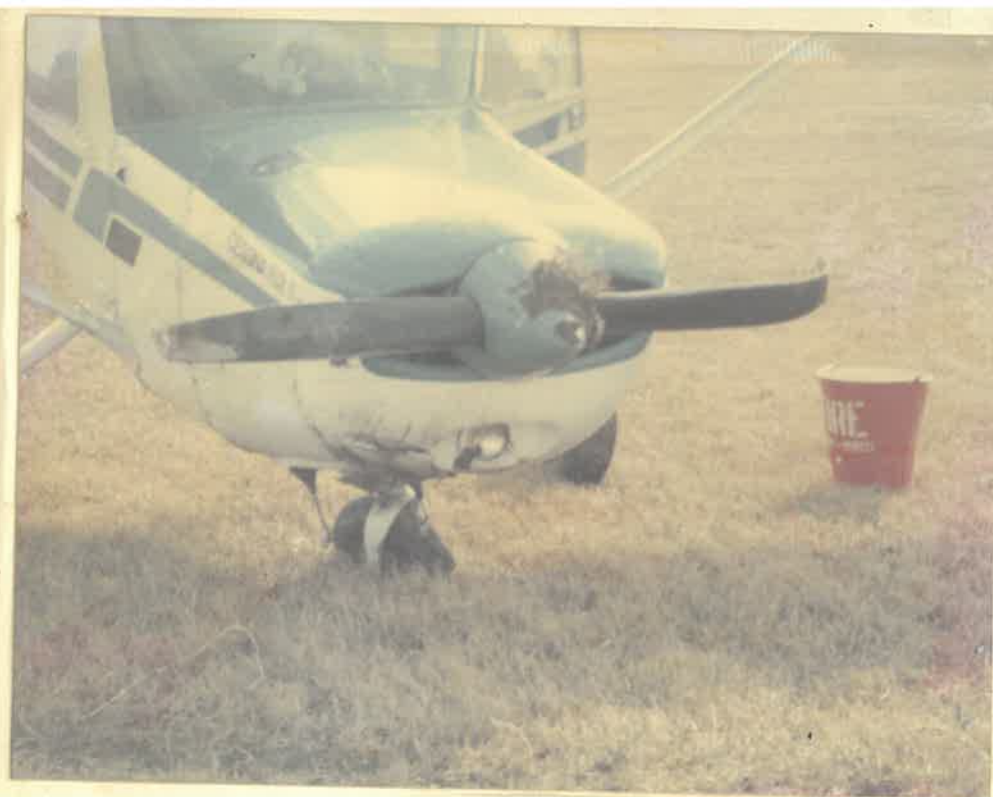
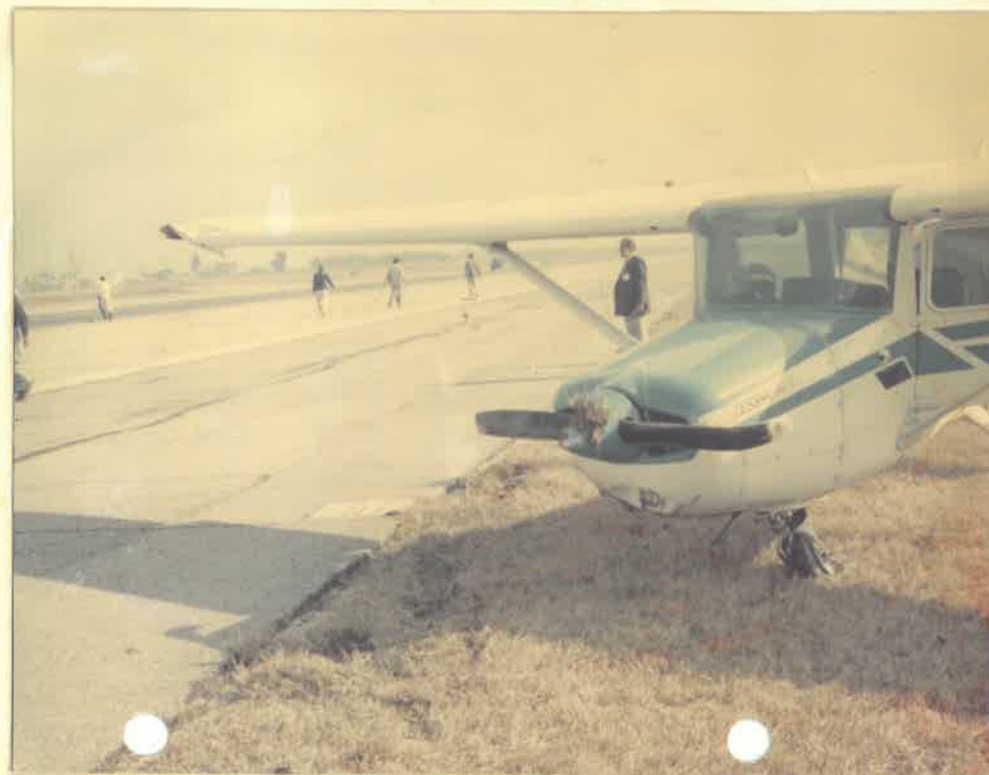
(APPENDIX-B)

1. On 7th January, 1990 at about 1250 hours, after having been cleared by the Chief Flying Instructor Rawalpindi Flying Club, for his first solo mission Mr. Musharab Amin, a student pilot at Rawalpindi Flying Club, took off in Cessna-152 aircraft (Reg. No. AP-BAW). He was briefed to take off, fly a normal circuit /pattern and execute a full stop landing. He took off from Runway-30 and flew the pattern without any problem. His approach looked steady and well controlled, however, he either rounded out slightly high or got ballooned up and then pushed the control column forward and let the aircraft hit the ground in a nose low attitude. This developed into a porpoise condition and thus causing the breaking of the nose wheel strut from close to the mounting point. The student got further confused, applied left brake, and caused the aircraft to veer sharply to the left. (refer Appendix- A ). As a sequel to this, right wing hit one of the runway lights along the left side of the runway. Runway light as well as the right wing were damaged extensively. The student pilot meanwhile, managed to switch off the engine and the aircraft came to stop after having gone off the runway on katcha (Appendix- B and B1&2 refer) with nose down attitude.

1. Right Wing Tip
2. Stringer aft out bolt.
3. Rib wing centre section right hand station 138.
4. Rib wing centre section station 156

5. Rib wing centre section station 174.
6. Stringer wing right hand lower centre and lower aft.
7. Stringer wing right hand upper forward.
8. Wing skin upto station 174.
9. Nose wheel oleo strut and nose wheel.
10. Engine mounting frame.
11. Engine crankshaft sustained shock.
12. Propeller.
13. Fuel filter screen mounting bracket.
14. Engine exhaust assey.
15. Carburettor and air box assey.
16. Shimmy dampner.
17. Nose gear steering tubes.
18. Engine lower cowling with landing light.
