TO INVESTIGATE INTO THE ACCIDENT IN WHICH  
CESSNA F 337 H, REGISTRATION NO. AP-BBT  
CRASHED AFTER TAKE OFF FROM KOHAT AIRPORT  
ON 20TH NOVEMBER, 1985 AT 1650 L.T.

| 1.1 Aircraft type and Manufacturer's Serial No. | : Cessna FA-337 H<br>Serial No. 0085 |
| 1.2 Registration Marking | : AP-BBT |

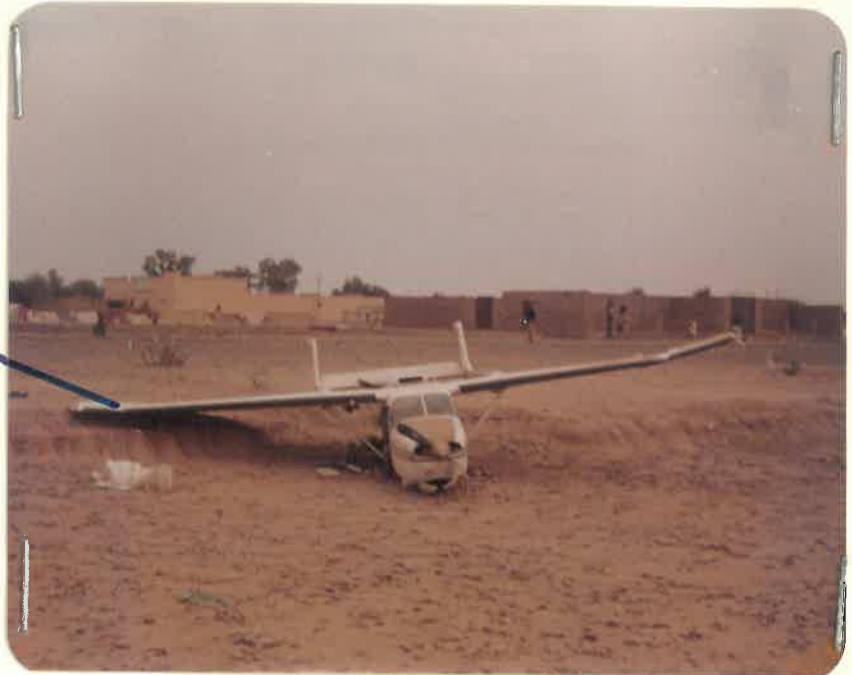
## R.I.P.

FINAL PLACE WHERE  
THE AIRCRAFT CAME  
TO REST.

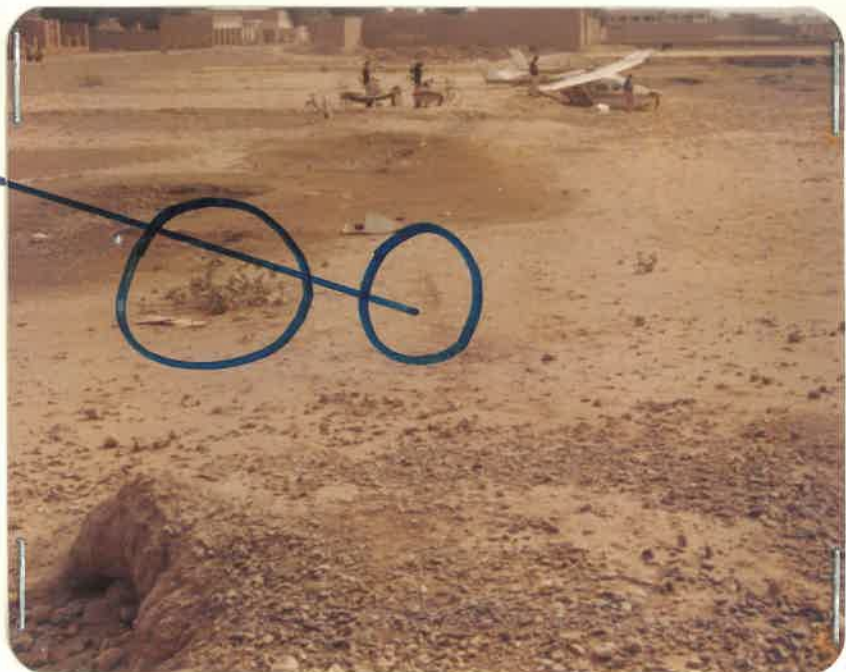
## IV POINT

LAST STAGE OF GROUND  
MARKS.

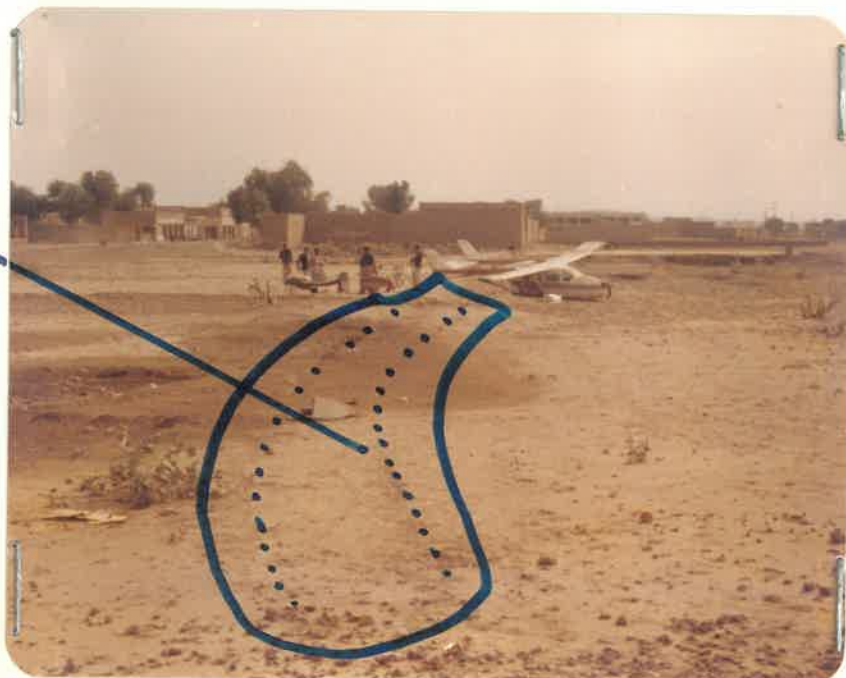
## III POINT

LANDING GEAR GROUND  
NEAR THE RIDGE, LEAVING  
BEHIND PARTS OF AIRCRAFT

ANOTHER VIEW

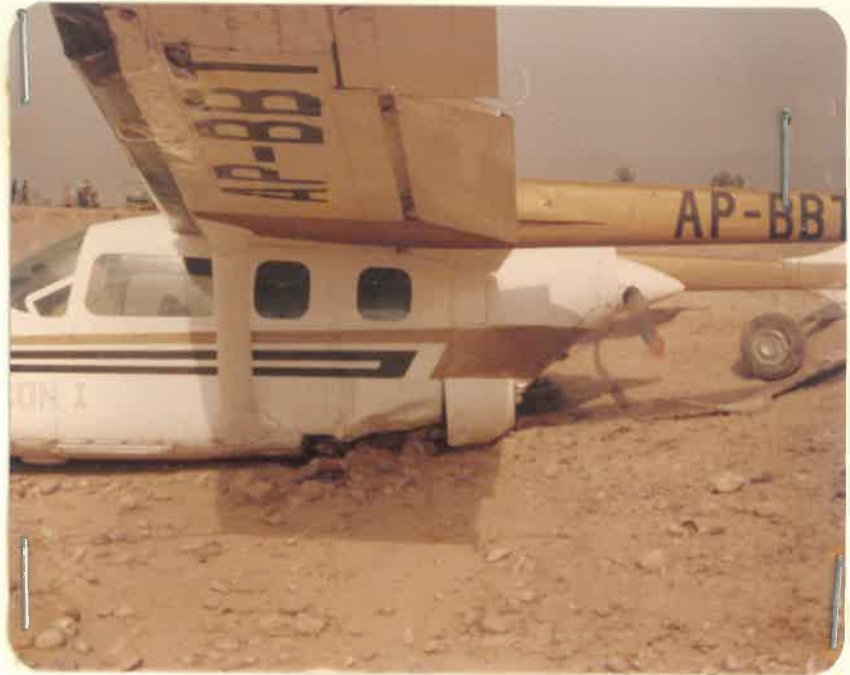
①

VARIOUS VIEWS OF CESSNA 337  
AFTER THE ACCIDENT.

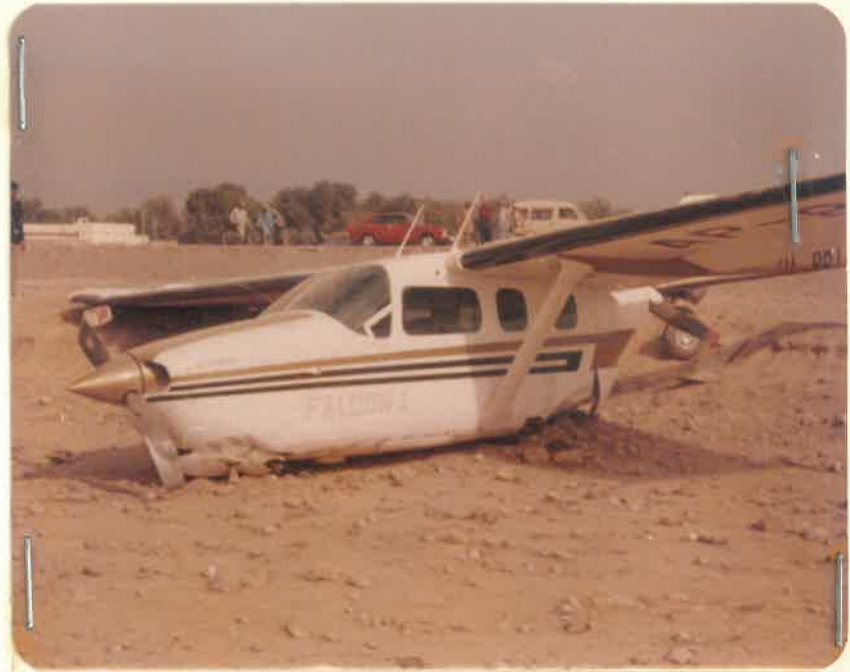
④

VARIOUS VIEWS

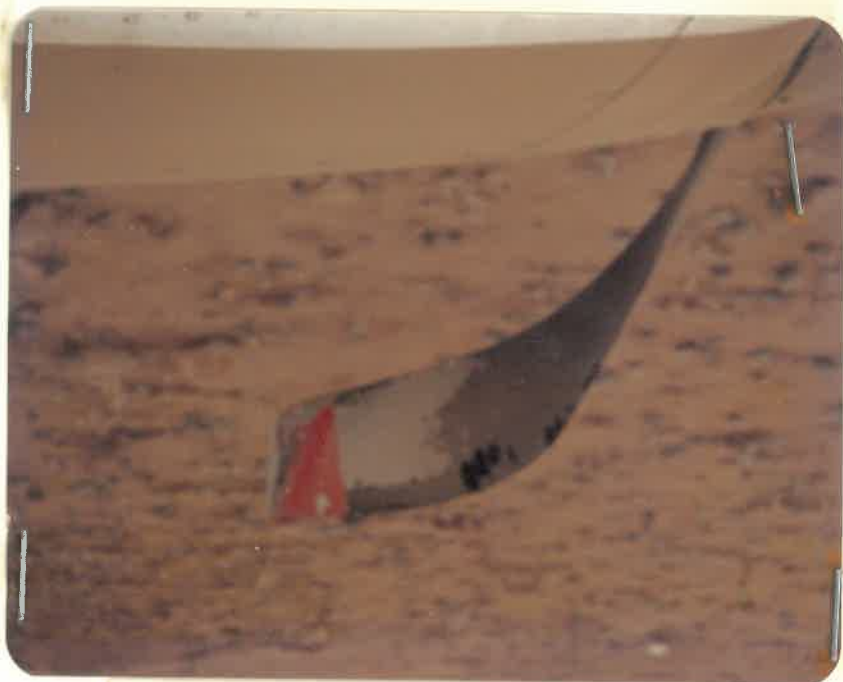
⑦

VARIOUS VIEWS OF DAMAGE OF  
PROPPULER AND LANDING GEAR.

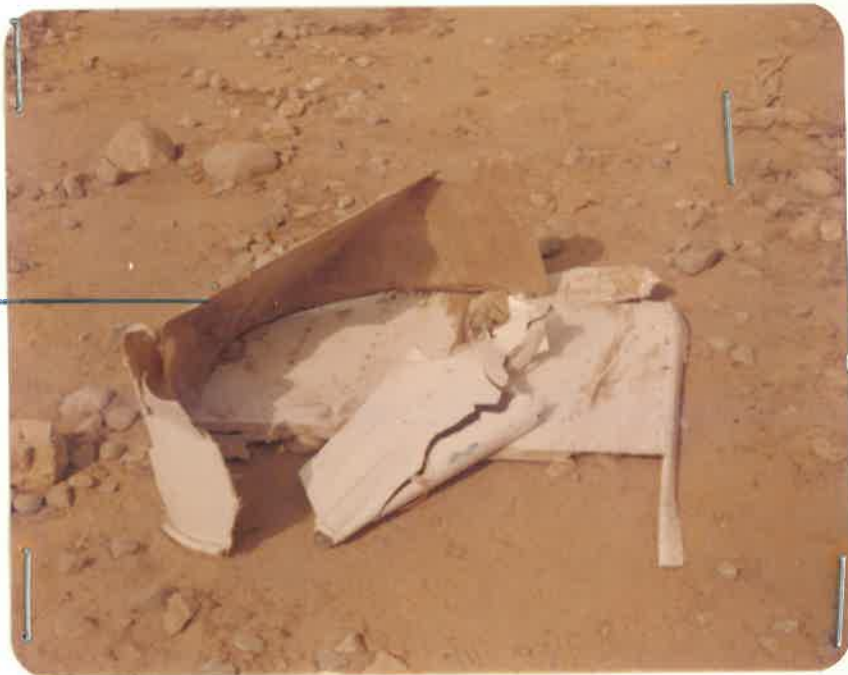
BROKEN PARTS ←  
OF CRASHED AIRCRAFT

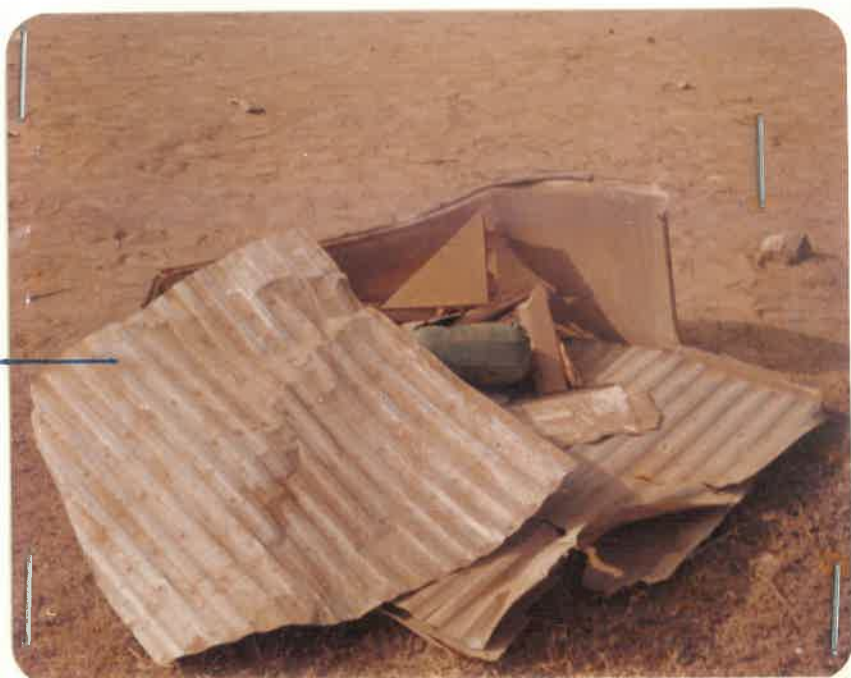
BROKEN PARTS OF ←  
CRASHED AIRCRAFT.

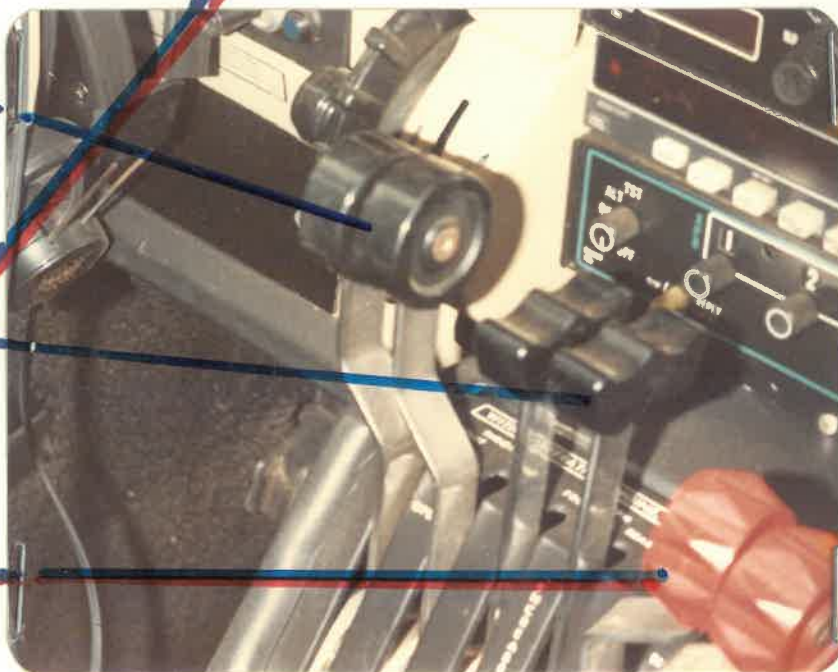
THROTTLE  
LEVER IN  
FULLY FORWARD  
POSITION

R.P.M. LEVER IN  
MAX. POSITION

MIXTURE LEVER  
3/4 RICH
