# FINAL INVESTIGATION REPORT

**ACCIDENT OF PIAC AIRCRAFT ATR 72-212A REG NO  
AP-BKW AT JIAP KARACHI DURING GROUND RUN-UP  
PERFORMANCE CHECKS ON 24 NOVEMBER 2018**

### ACCIDENT OF PIAC AIRCRAFT ATR 72-212A REG NO AP-BKW AT JIAP KARACHI DURING GROUND RUN-UP PERFORMANCE CHECKS ON 24 NOVEMBER 2018

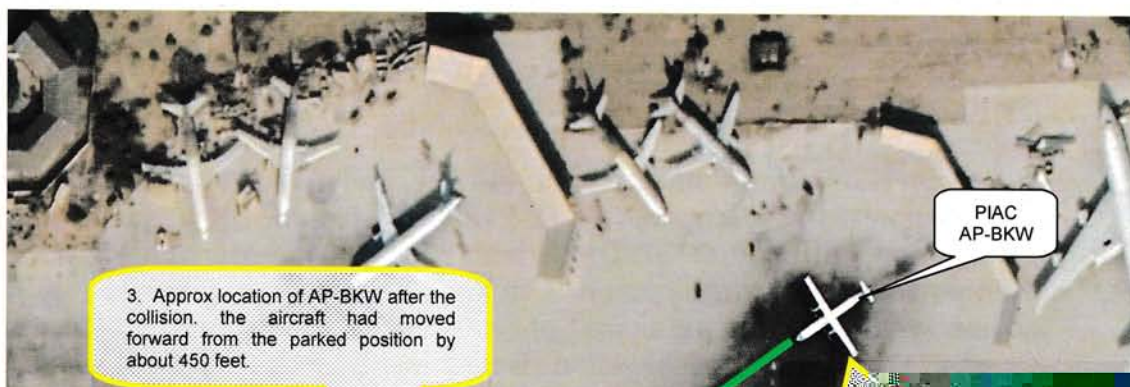
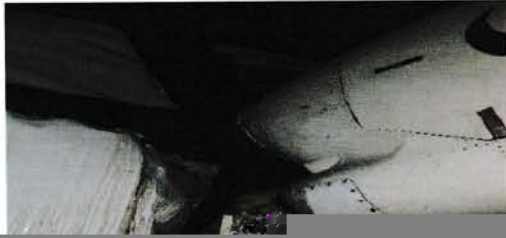
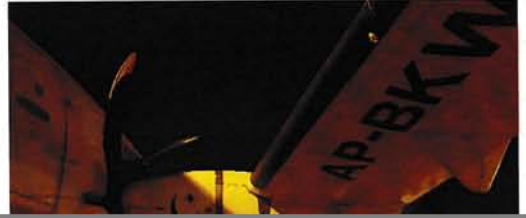
1.1.1. An overview of the accident site has been marked in the picture below:-

| S No | Description of pictures given above |
|---|---|
| 1 & 2 | AP-BKW propeller No 1 embedded into fuselage of dormant AP-BJU |
| 3 | Inner ply of AP-BKW cockpit LHS # 3 window got shattered |
| 4 | Rubbing marks observed on fuselage of AP-BKW left hand side from captain aft windshield up to cabin window # 11 |
| 5 | Left wing tip of AP-BKW which made first contact with AP-BJU |

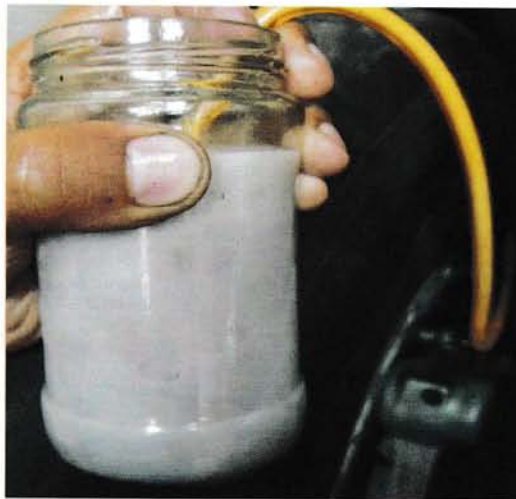
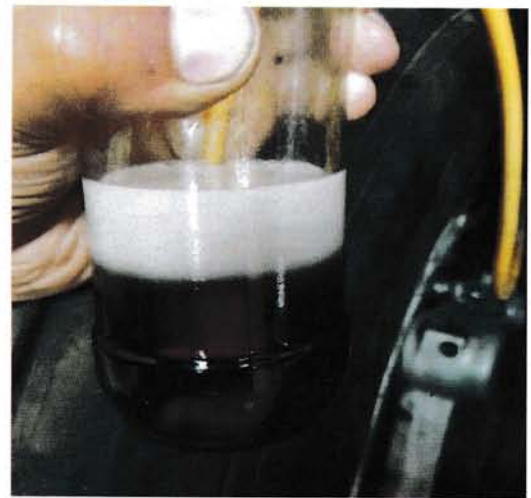
- 2.4 The mentioned bleeding / purging of the brake system after the said maintenance was either not performed at all or it was performed in an inadequate manner, and it led to brake failure during engine ground run-up checks.

- 2.5 FDR was downloaded. The brake pressure throughout engine performance run-up was recorded between 39-45 psi, whereas it was required to be 3000 psi this supports the fact that there was no or very little hydraulic in brake system thus resulting in its in-effectiveness (for both normal and emergency operation). FDR data screen snapshot is as shown below: -
