**CIVIL AVIATION AUTHORITY  
PAKISTAN**

**AIRCRAFT ACCIDENT INVESTIGATION**

**PIPER CHEROKEE REG.NO.AP-AYT**

**ON 29TH OCTOBER, 1997**

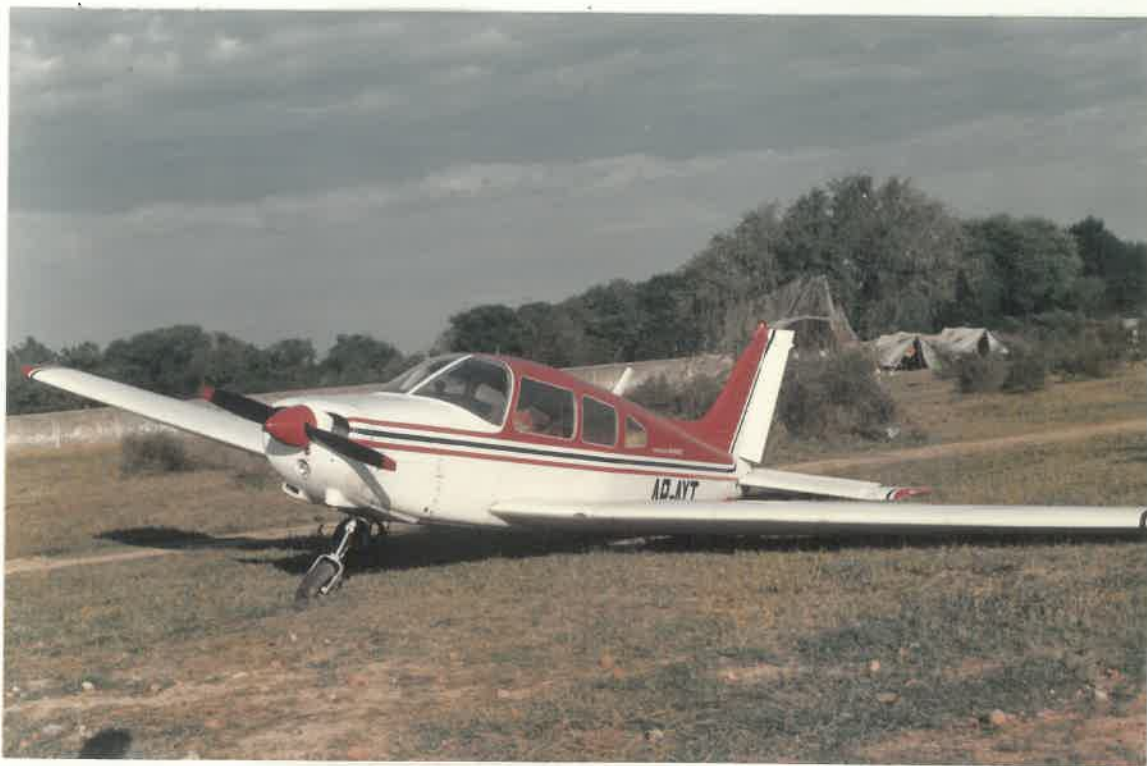
APP. 'C1'

VIEW OF AIRCRAFT IN RT FAIR WEATHER STRIP

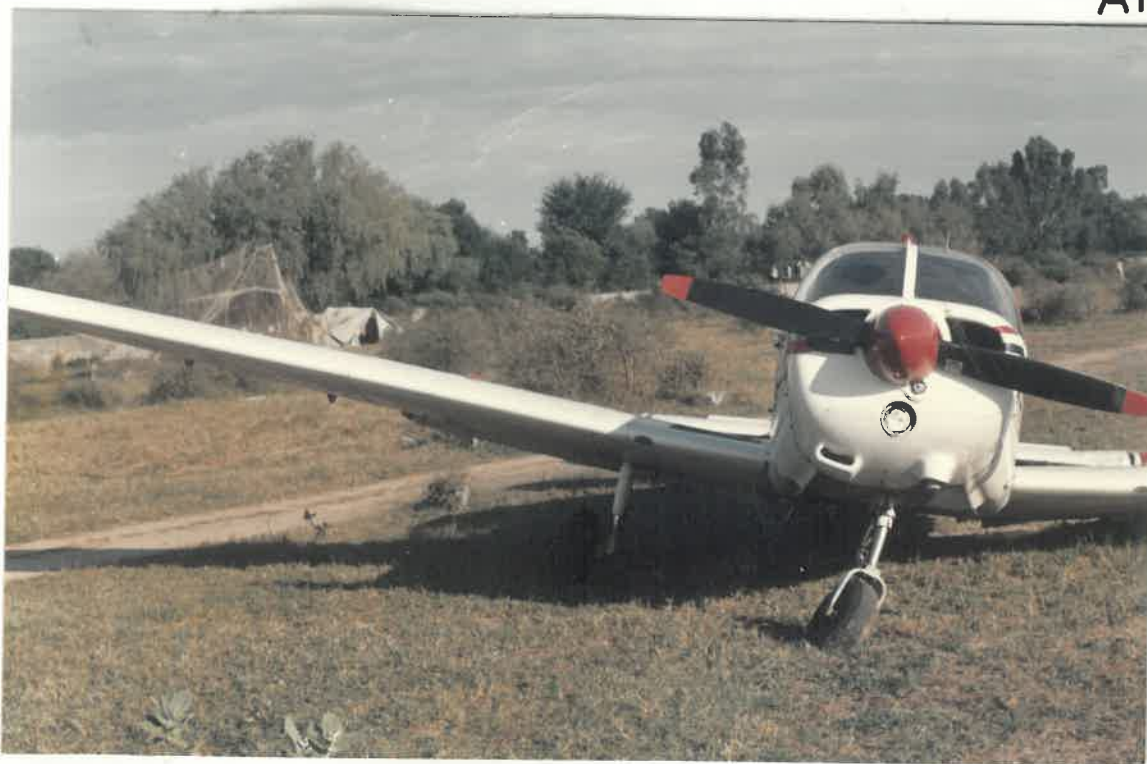
APP. 'C2'

AN OTHER VIEW OF AIRCRAFT IN RT FAIR WEATHER STRIP

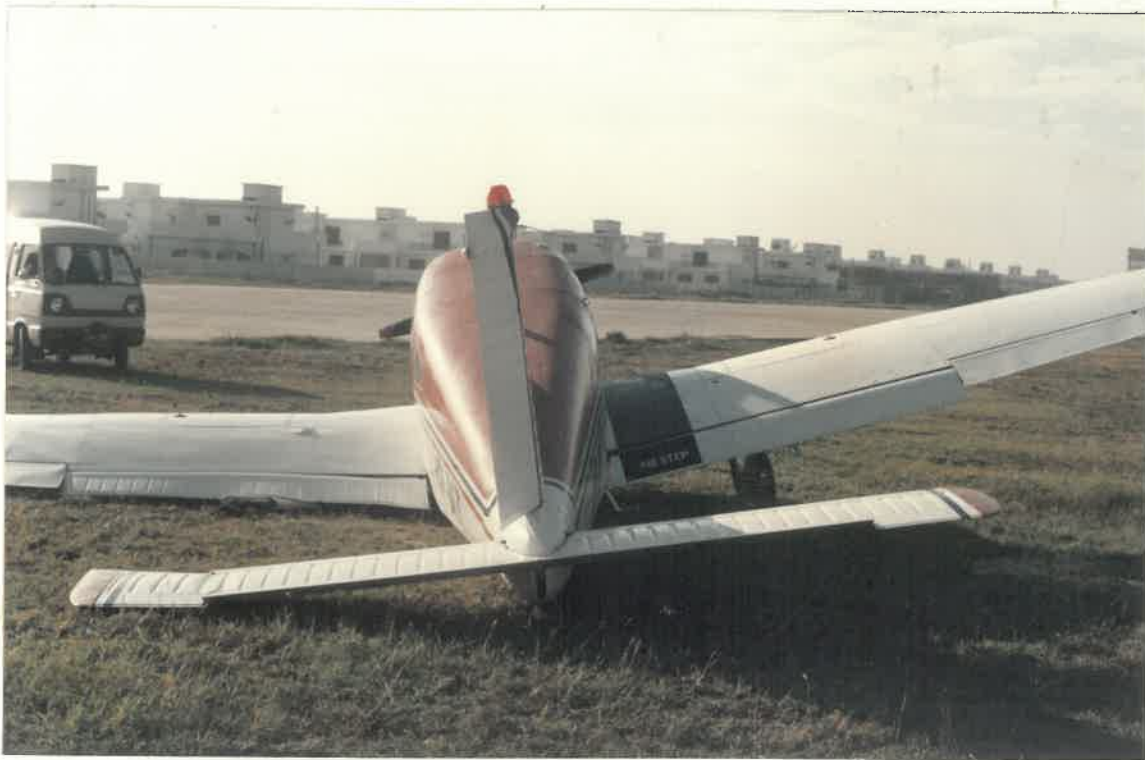
APP. C3

VIEW OF AIRCRAFT FROM THE REAR

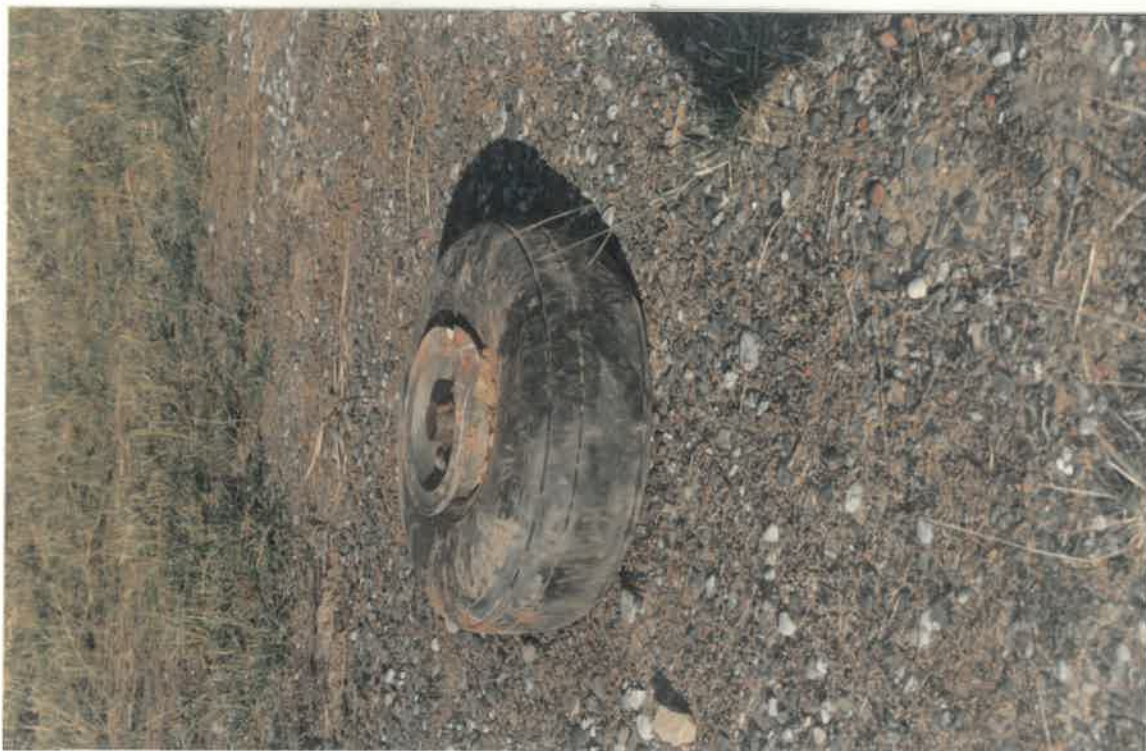
APP. C4

- 16.2. As the aircraft wheel went over the uneven edges of the runway and the raised gutter pit in the area of uneven fair weather strip, the left wheel axle broke which damaged the left brake assembly thus causing the left leg to detach from its wing joints.

LEFT WHEEL DETACHED FROM MLG

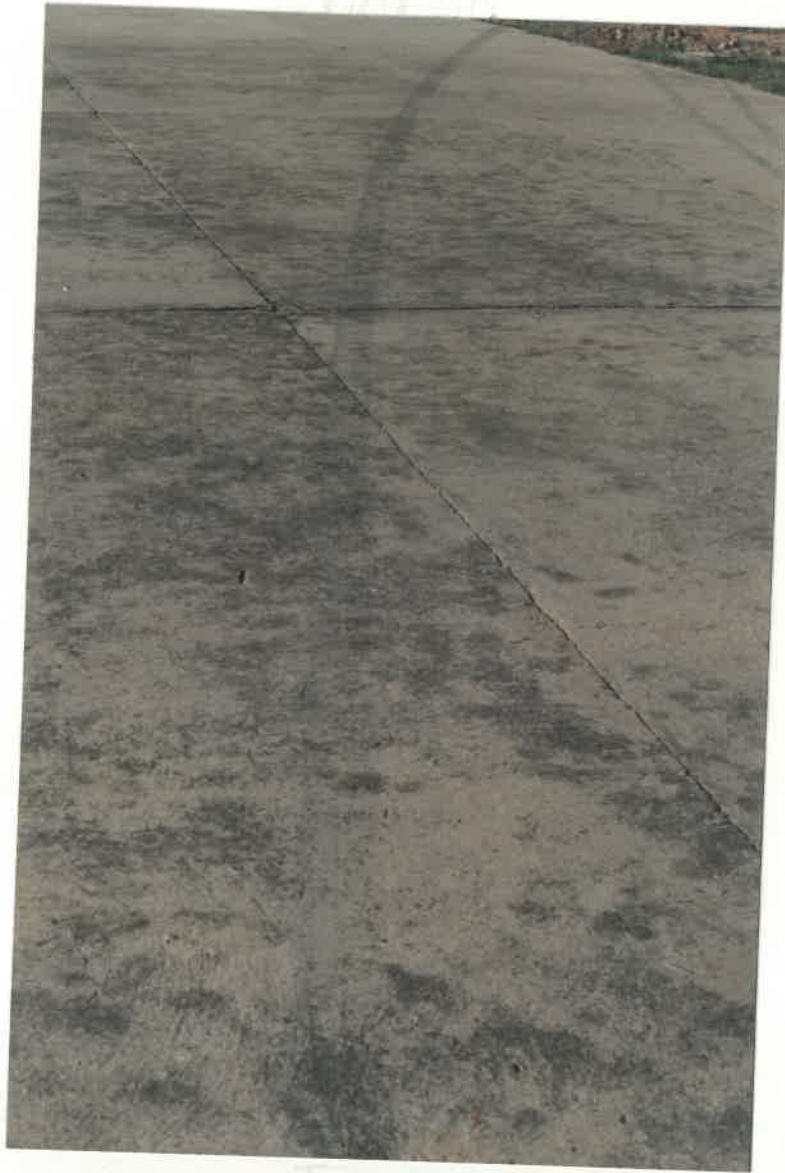
- 15.5. The tyre marks on the runway revealed an evidence of hard braking i.e. both wheel brakes were functioning properly. See Appendix 'C'.

- 16.4. The pilot had stated that when aircraft was moving towards right side, he applied left brake to control the direction of aircraft but it did not improve the situation. However, the tyre marks evidence obtained from the scene of accident revealed that pilot had applied both the brakes with a view to slow down the aircraft as it was approaching towards the right edge of the runway. Therefore, the statement of pilot could not be corroborated with other sources of evidence.

HARD BRAKE APPLICATION MARKS

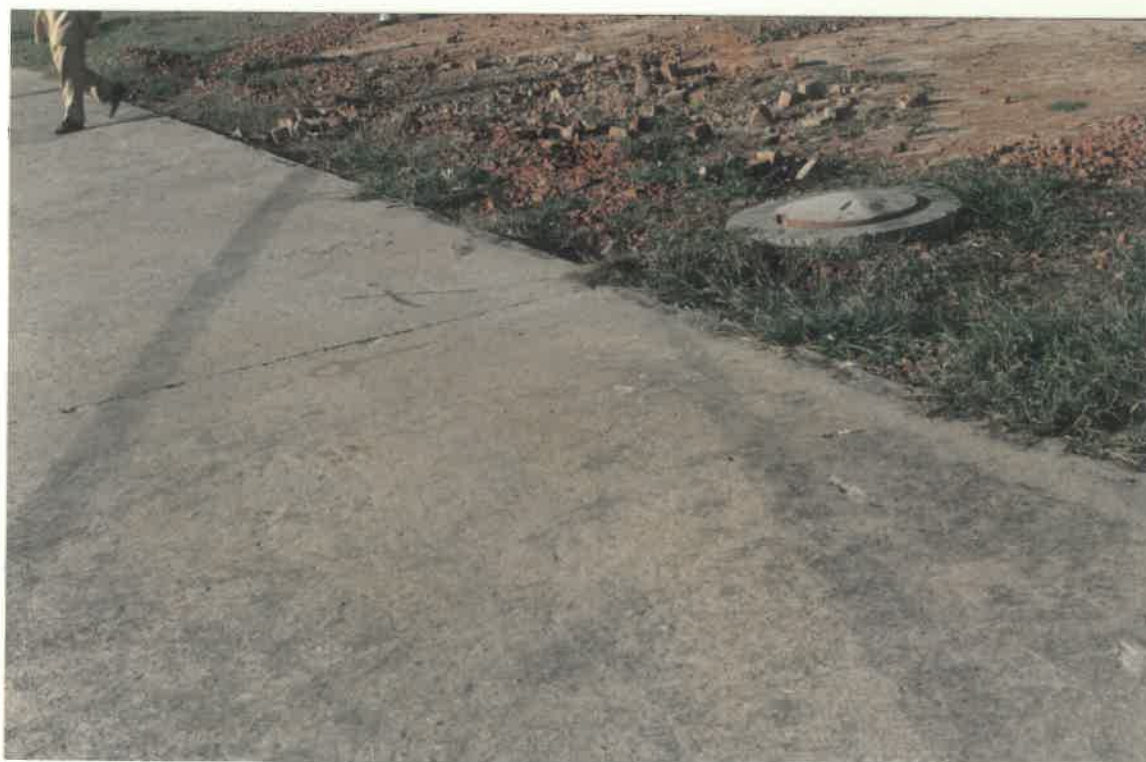
HARD BRAKE APPLICATION MARKS

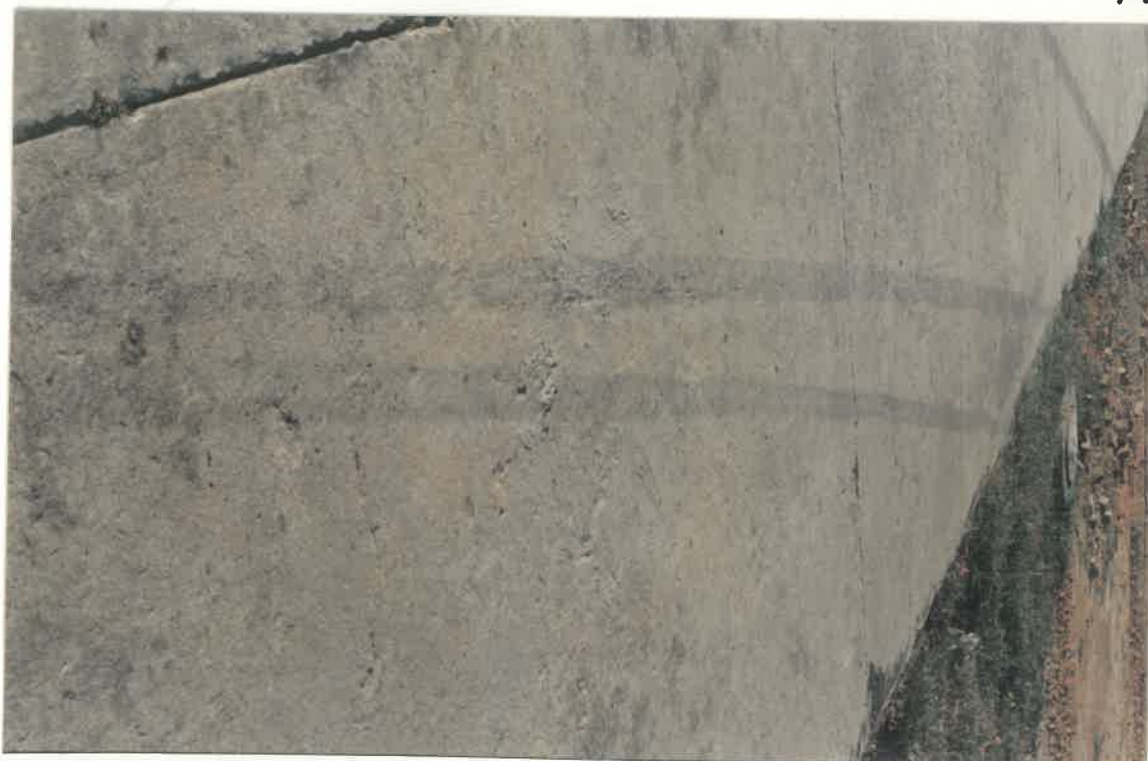
HARD BRAKE APPLICATION MARKS

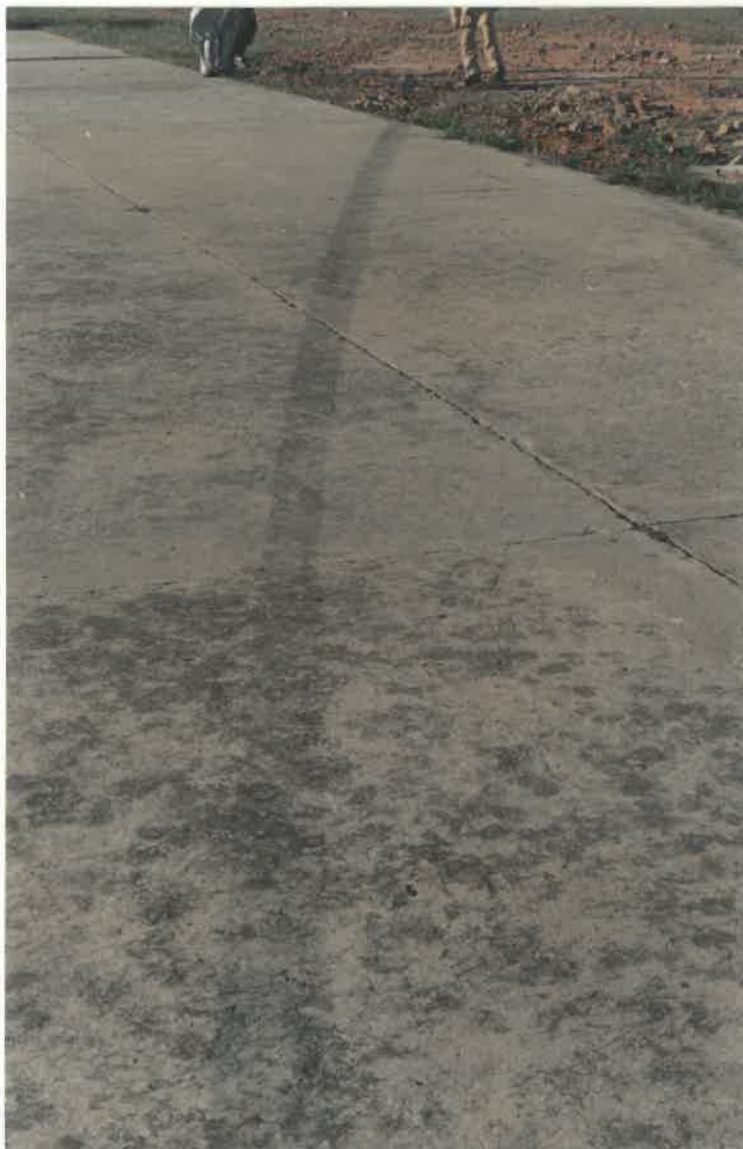
HARD BRAKE APPLICATION MARKS

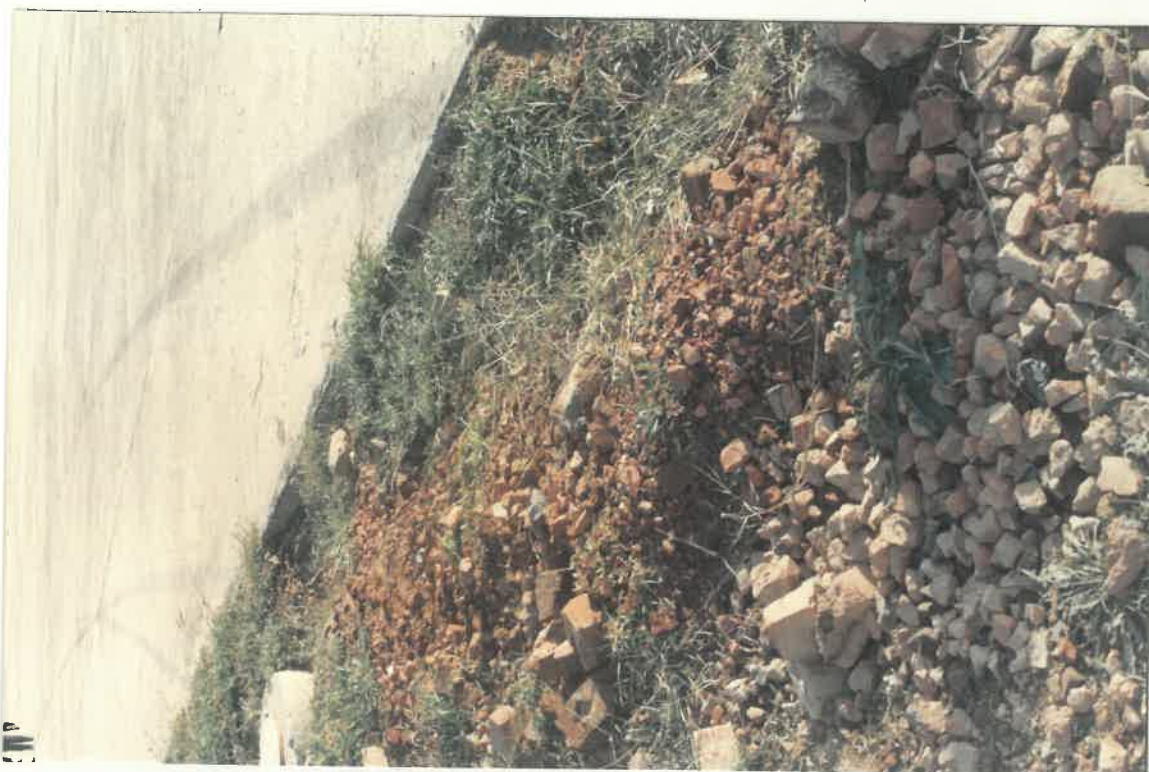
APP. C9

10.1. The right shoulder of the runway where the aircraft finally stopped is quite uneven and broken bricks are lying in the kutchra area. Moreover, the runway edges are not level and fair weather strip is not compacted as per laid down requirements.

UN EVEN RUNWAY EDGES AND FAIR WEATHER STRIP

- 19.4. APM Walton Aerodrome Lahore, is to ensure that runway edges are leveled properly and fair weather strip are prepared as per laid instructions.

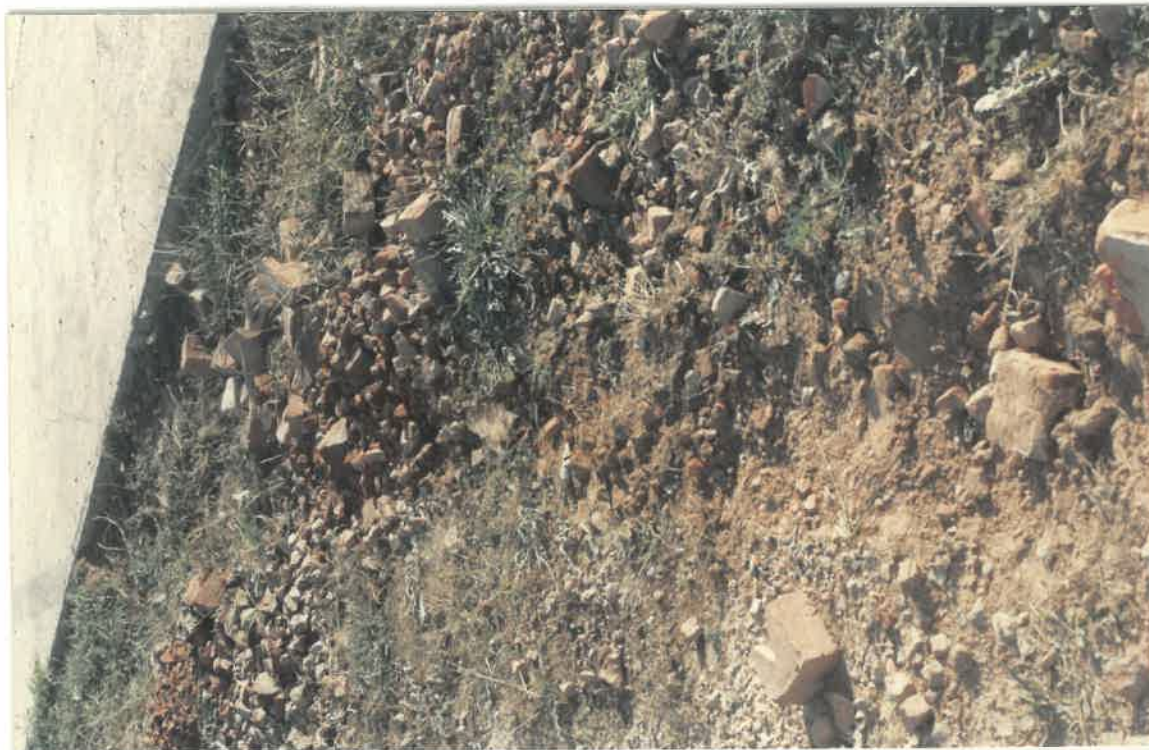
APP. C10

UN EVEN RUNWAY EDGES AND FAIR WEATHER STRIP
