## AIRCRAFT ACCIDENT INVESTIGATION REPORT

**RUNWAY EXCURSION ACCIDENT  
FOKKER-27 REG # AP-AUR AT CHITRAL ON 16 JUNE, 2004  
PAKISTAN INTERNATIONAL AIRLINE**

*Safety & Investigation Board  
Headquarters Civil Aviation Authority*

**ACCIDENT TO M/S PIAC F-27 REG # AP-AUR AT CHITRAL  
AIRPORT ON 16 JUNE 2004**

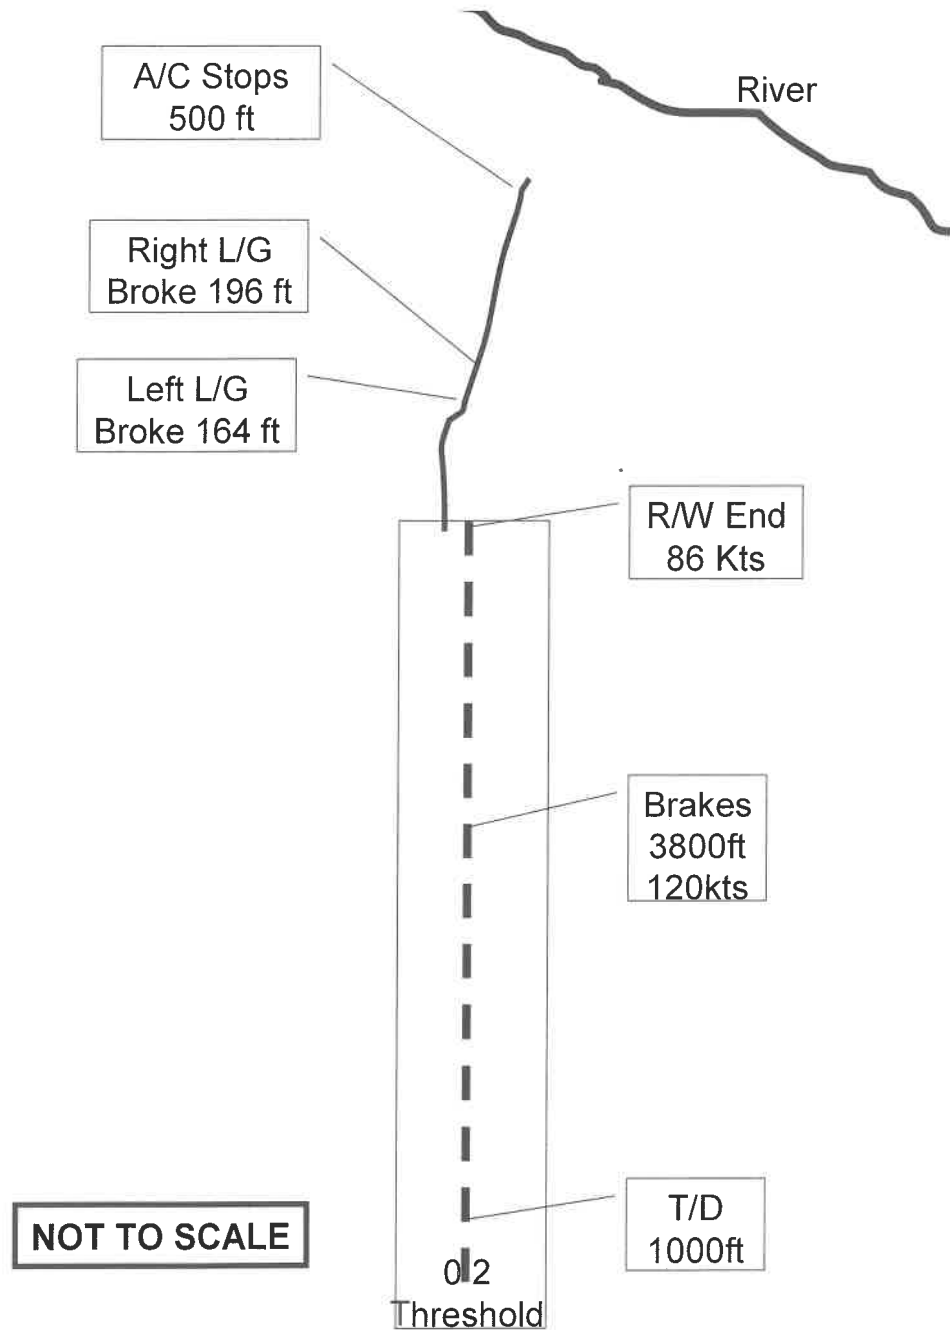
1.14.1 After landing the aircraft entered the unpaved surface beyond LDA. Since that area was not level, both the main

landing gears broke and were found 164 and 198 feet (left & right respectively) behind the point where the aircraft finally stopped. The left propeller touched the ground and was damaged. Other damages on the aircraft are listed under aircraft damages. Tyre- marks and other relevant impact / wreckage informations are given in the sketches Appendix 'H'.
