# **FINAL INVESTIGATION REPORT**

## **SERIOUS INCIDENT OF GULF AIR FLIGHT GFA 770 BOEING 787-9 AIRCRAFT REG. NO. A9C-FF AT ISLAMABAD ON 02-06-2021**

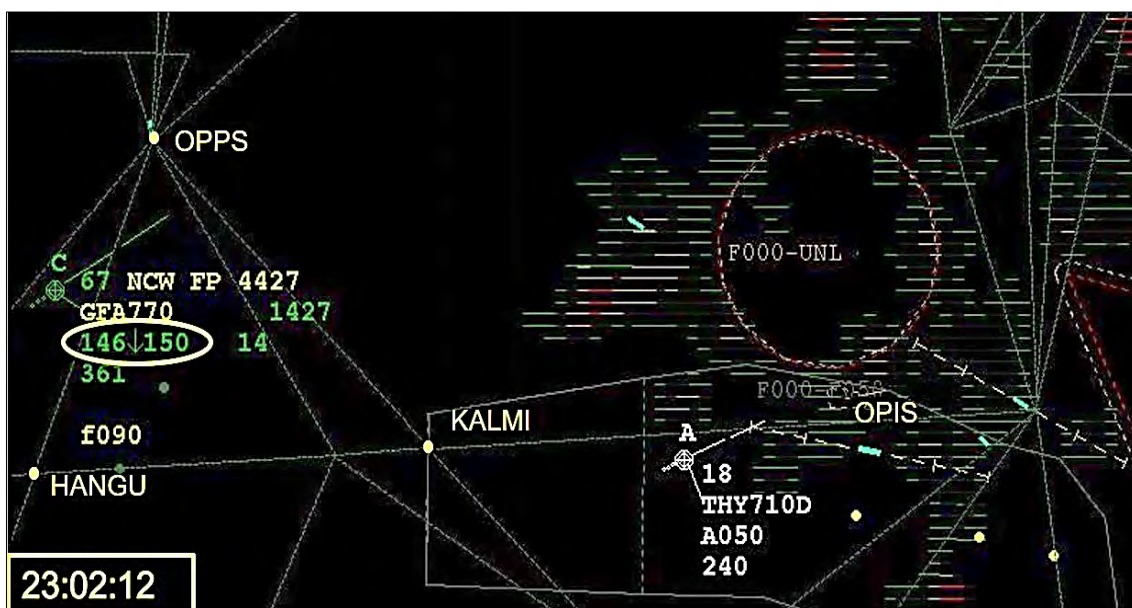
Figure 4 GFA 770 cleared 9,000 ft but not updated electronically

1.1.8. At 23:02:12 h, GFA 770 came in contact with Approach Control Islamabad crossing FL144 descending 9,000 ft on heading 050°. Approach Control Islamabad inquired whether the aircraft was turning right upon which GFA 770 informed that they would be turning right if given descent otherwise will be entering bad weather. Approach Control Islamabad advised GFA 770 to descend 10,000 ft, to which GFA 770 informed that they had been cleared to 9,000 ft. Approach Control Islamabad cleared GFA 770 to descend to 9,000 ft. The descent given by Area Control Islamabad (9,000 ft) was not updated electronically as it showed FL150 as cleared level.

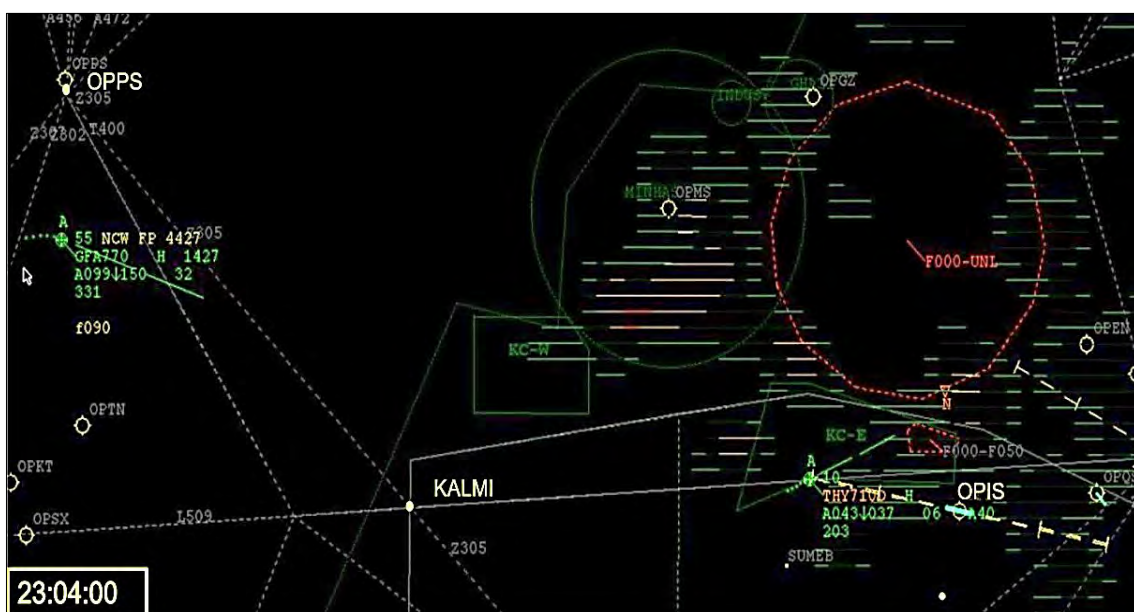
Figure 6 GFA 770 given descent to 5,000 ft

1.1.12. At 23:04:00 h, GFA 770 requested descent again to which the Approach Control Islamabad cleared GFA 770 to descend 5,000 ft on QNH 1006 and advised GFA 770 to expect further descent 25 NM short of Islamabad.

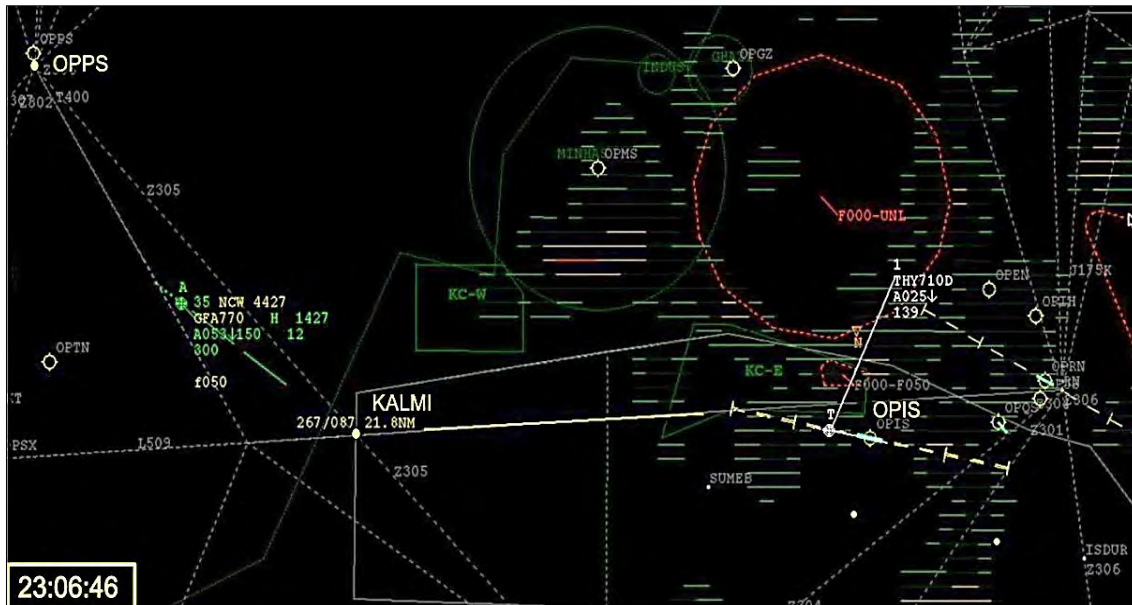
Figure 7 GFA 770 Climbing Terrain React

1.1.14. At 23:06:46 h, passing 5,300 ft, GFA 770 informed Approach Control Islamabad that “GFA 770 climbing Terrain React”.

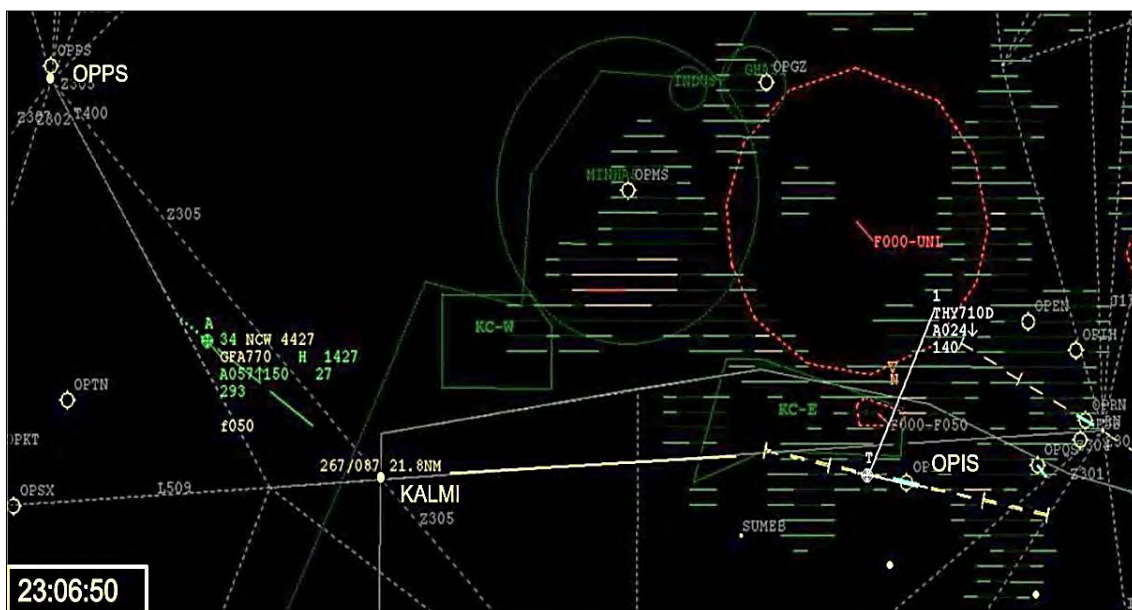
Figure 8 GFA 770 reported climbing 7,000 ft and then 10,000 ft

1.1.15. At 23:06:50 h, GFA 770 reported climbing 7,000 ft and subsequently 10,000 ft. GFA 770 informed Approach Control Islamabad that they had to climb due to GPWS warning. Same was acknowledged by Approach Control Islamabad.

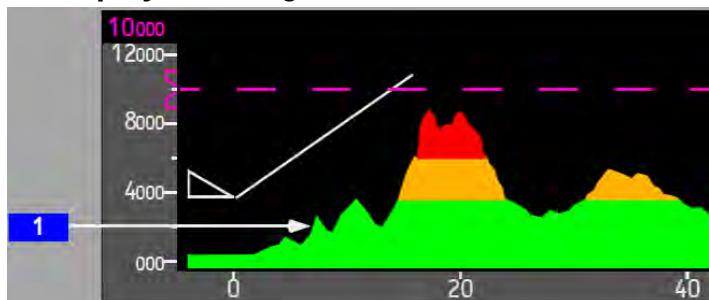
Figure 17 Aircraft Vertical Situation Display  
Copyright © Boeing, Reprinted with the permission of The Boeing Company

(g) **Aircraft Vertical Situation Display** – Boeing 787 has a Vertical Situation Display (VSD) where terrain is depicted along the projected aircraft vertical path, however; this only works in managed navigation mode (LNAV) on specified routes. Since the aircraft was off route due weather avoidance, therefore the VSD did not display any terrain.

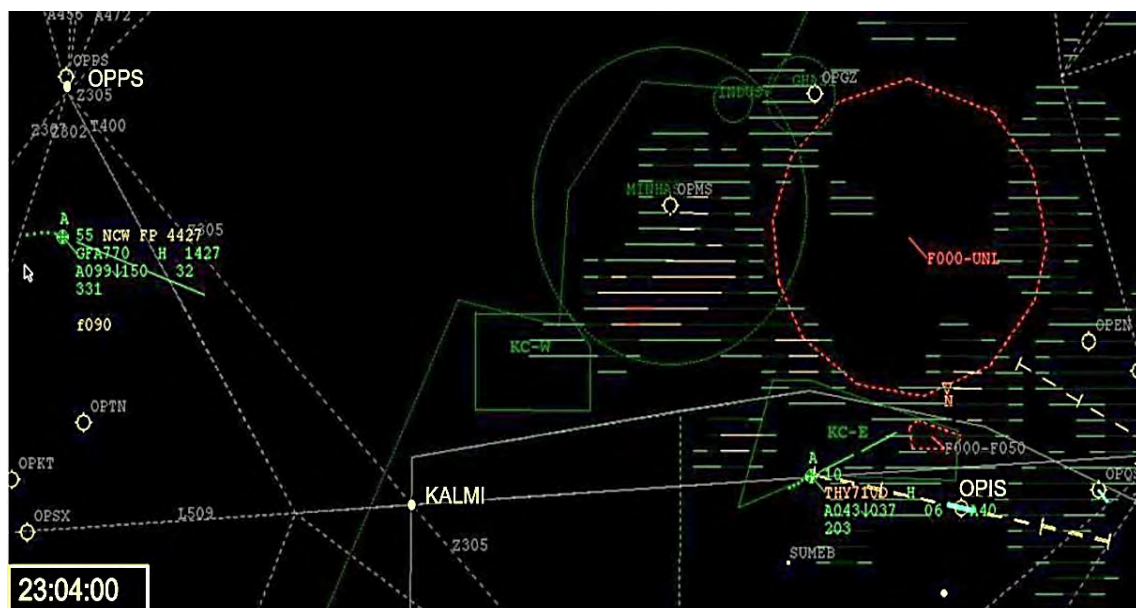
Figure 27 Descend to 5,000 ft Contrary to AMA of 10,300 ft

(e) Approaching KALMI, at 23:04:00 h, GFA 770 requested for descent twice in response to which the Approach Control Islamabad cleared GFA 770 to descend to 5,000 ft contrary to AMA of 10,300 ft and advised GFA 770 to expect further descent 25 NM short of Islamabad (KALMI). GFA 770 was at this time approximately 15 NM North West of KALMI.

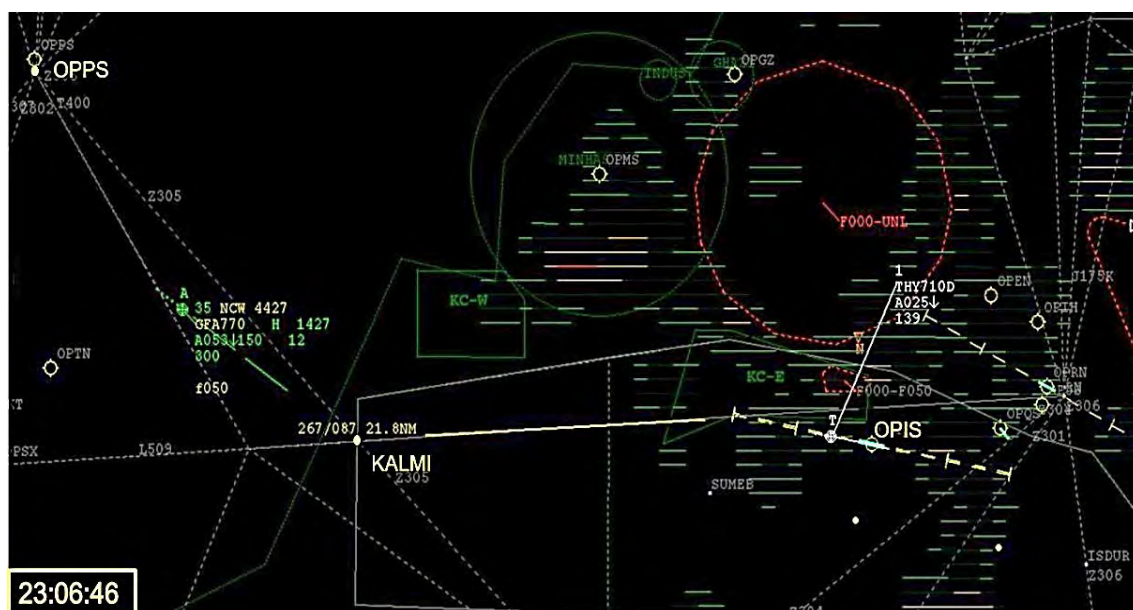
Figure 29 descending through 5,300 ft, GFA 770 received the Terrain react

- (f) At this time, the GFA 770 was still flying in AOR of Cherat Approach North.
- (g) At 23:05:36 h and 23:05:50 h, GFA 770 requested latest weather at IIAP, Islamabad which was provided by the Controller.
- (h) At 23:06:46 h, as GFA 770 was descending through 5,300 ft, it received the Terrain react (Ground Proximity warning from EGPWS). The pilot immediately discontinued descent, initiated climb and informed the controller passing 5,700 ft.

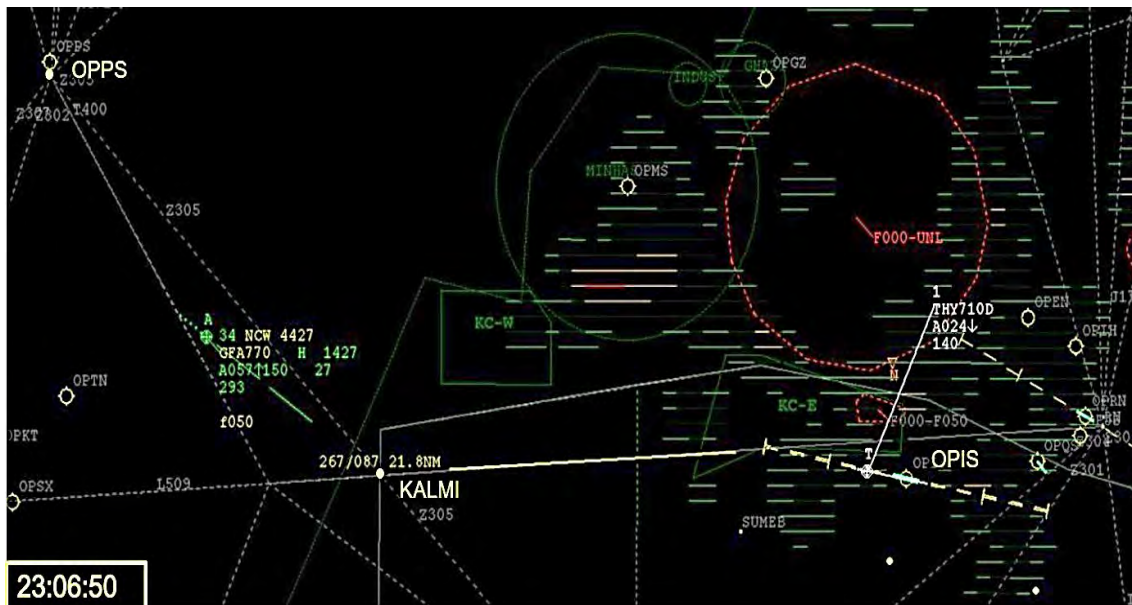
Figure 30 GFA 770 climbing 7,000 ft

- (i) At 23:06:49, GFA 770 reported climbing 7,000 ft and subsequently 10,000 ft.
