**CIVIL AVIATION AUTHORITY**

**INVESTIGATION REPORT**

**INCIDENT TO M/S PIAC TWIN OTTER AIRCRAFT REG NO AP-BCH**  
**AT MUZAFFARABAD AIRPORT ON 20TH FEBRUARY, 1996**

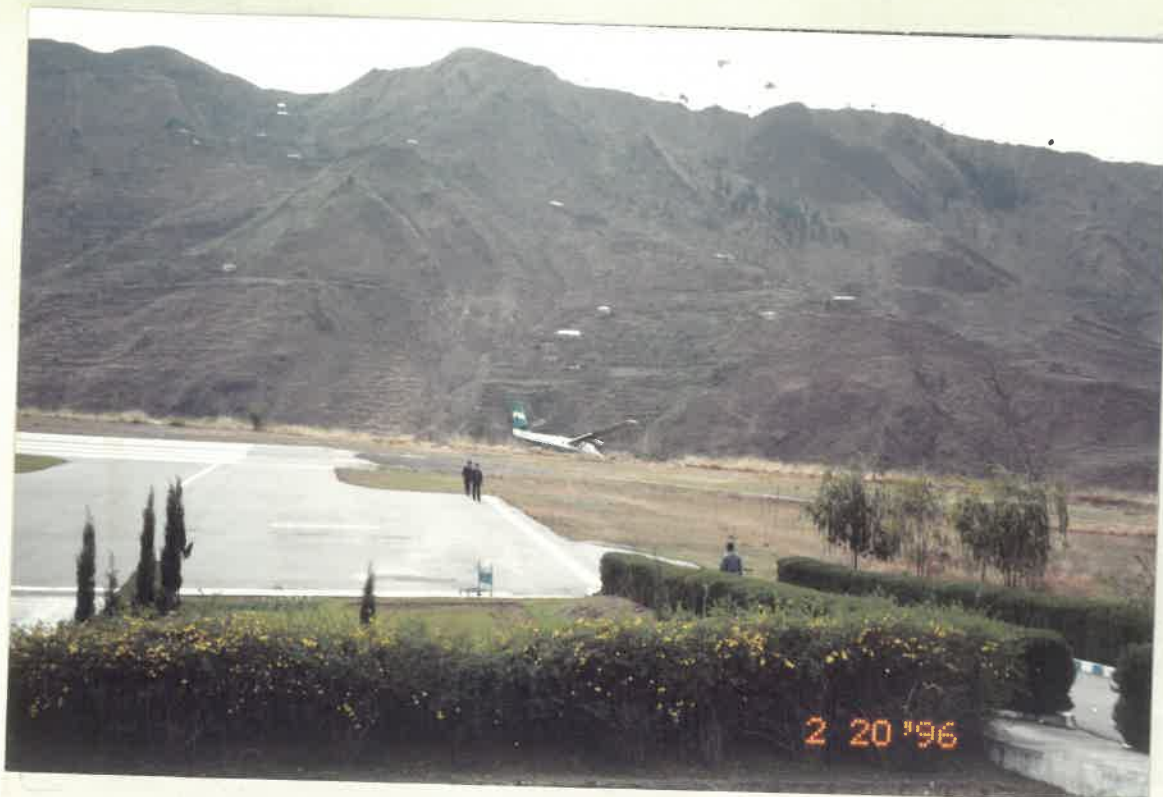
7. PIAC Twin Otter aircraft PK-425 taxied out at 1047 hours (local) from Apron (100 X 40 feet) located on the left side adjacent to beginning of RW 13. While entering the RW 13 the aircraft could not turn left to line up for take off and went straight off the Runway crossing the F.W.S. on a heading of 270 degree and kept going on a slopping down terrain and came to a stop in a ditch 178 feet from the edge of the RW 13 (Appendix 'B' and 'C'). The APM Muzaffarabad despatched the RIV to the scene of incident alongwith the Airport Staff. The APM took other actions as per existing procedures. The President Safety Investigation Board, CAA alongwith engineering staff of PIAC reached at the scene of incident at about 1000 hours on 21st February, 1996.

APRON, RW 13 AND AIRCRAFT AT SCENE OF INCIDENT.

- e. APM Muzaffarabad to survey the area around the Runway 13 and recommend measures to be taken to level the slopping down terrain.

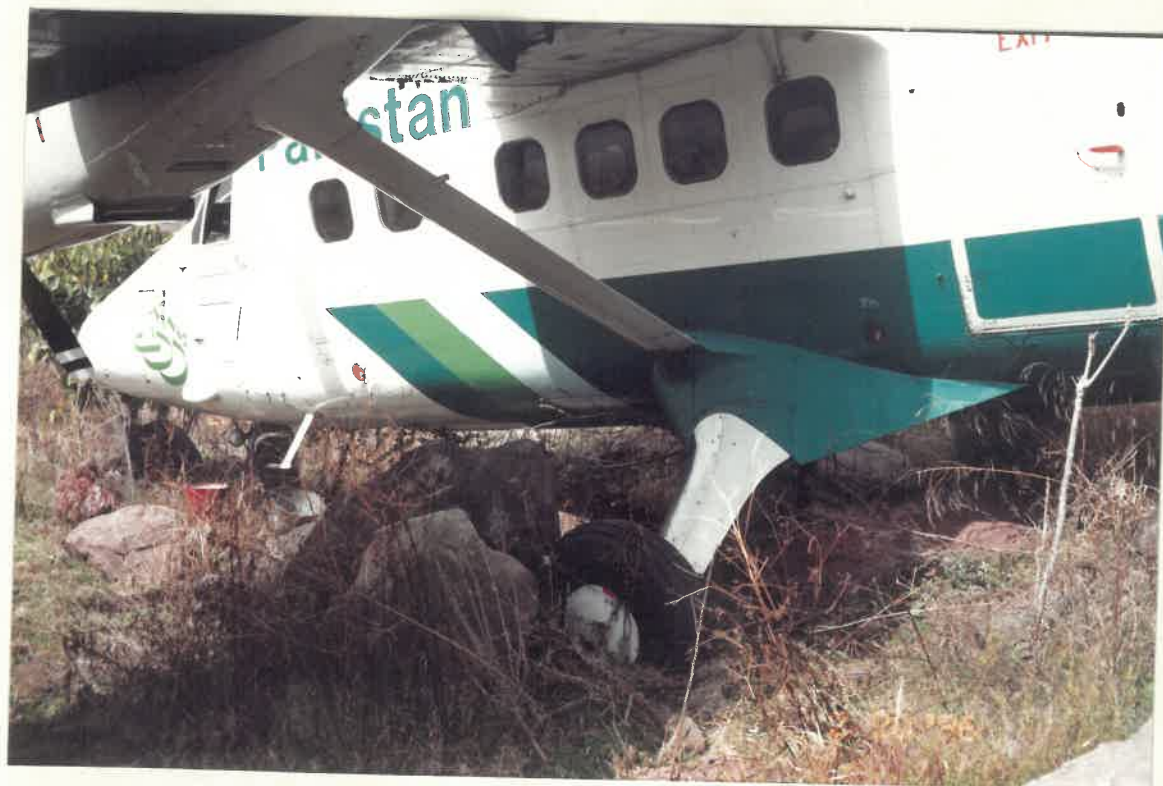
- e. The aircraft finally came to a stop in a ditch against a big stone in front of left wheel of the aircraft.
- f. All three passengers and two crew on board the aircraft were safe.

AIRCRAFT CAME TO A STOP AGAINST BIG STONE

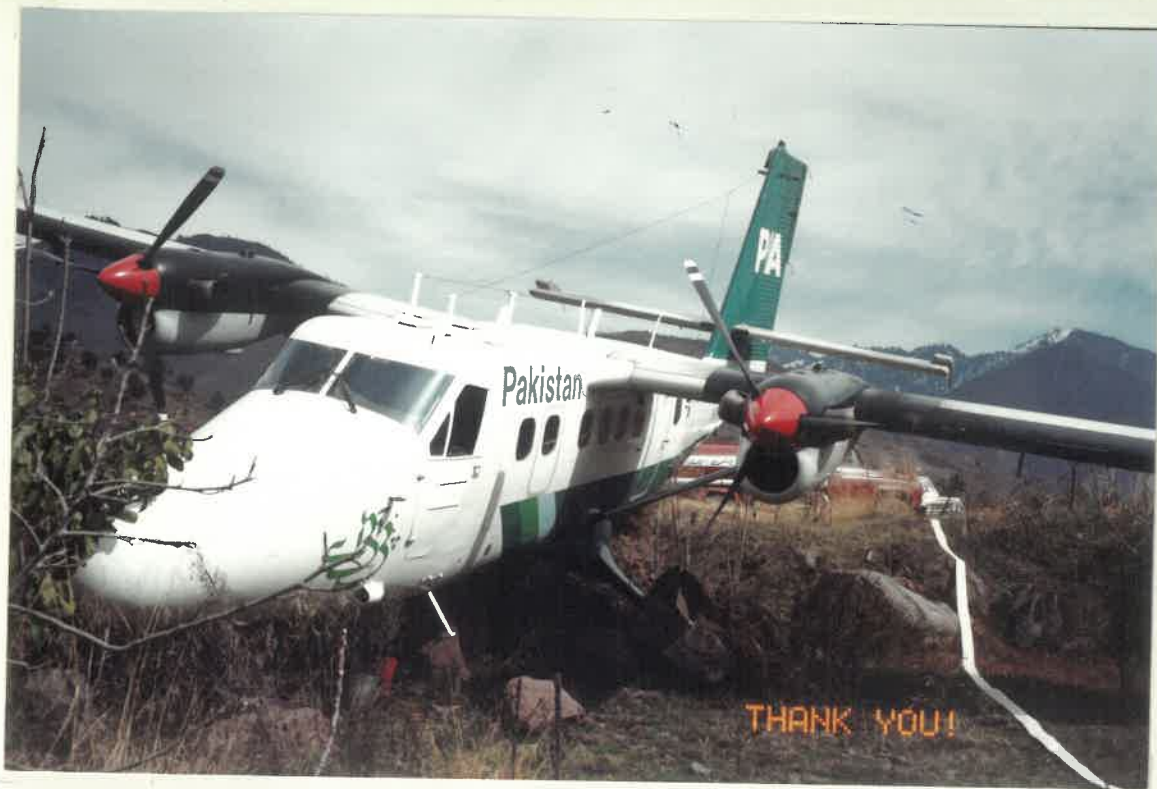
AN OTHER VIEW OF AIRCRAFT AT FINAL STOP POSITION

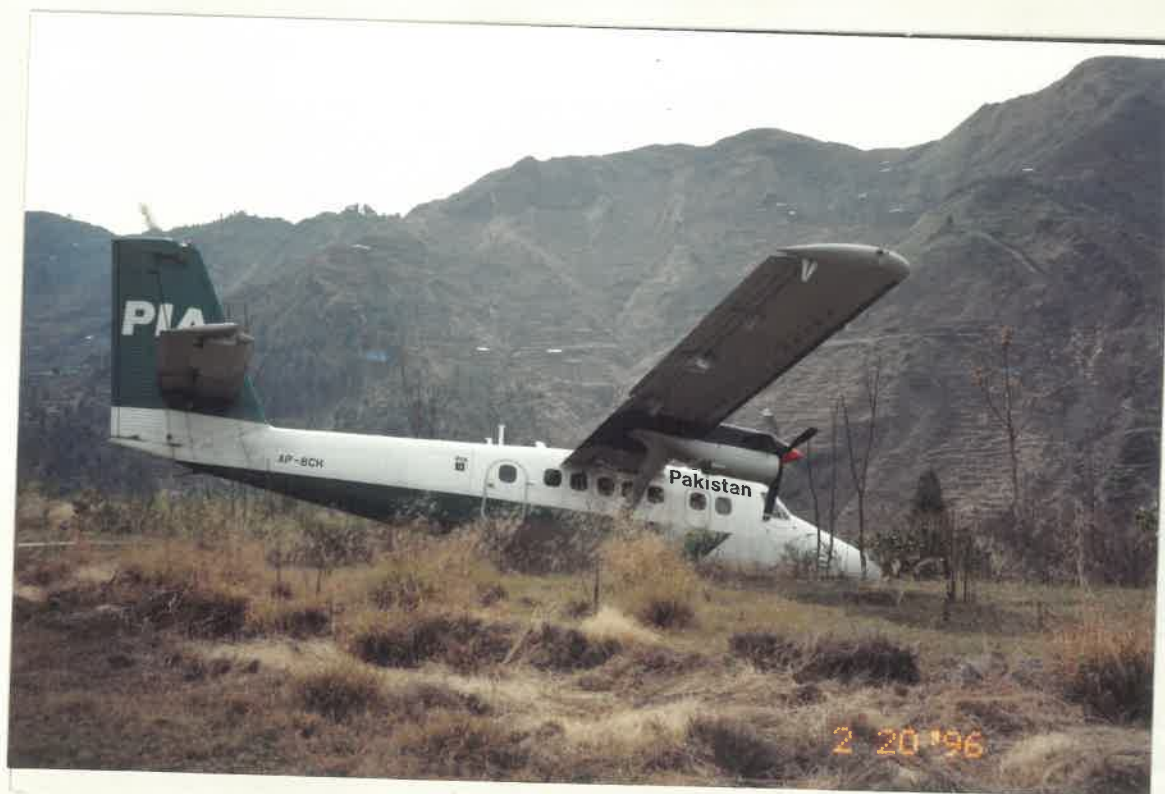
AN OTHER VIEW OF AIRCRAFT AT FINAL STOP POSITION

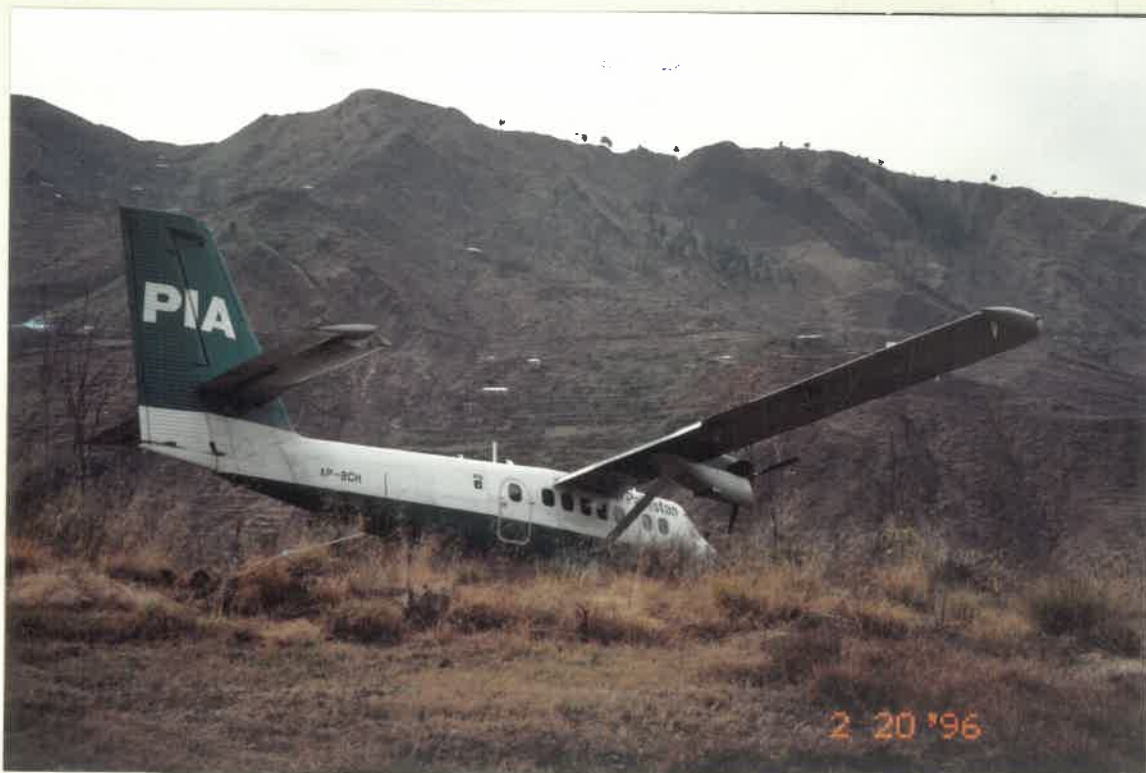
AIRCRAFT AT FINAL RESTING POSITION

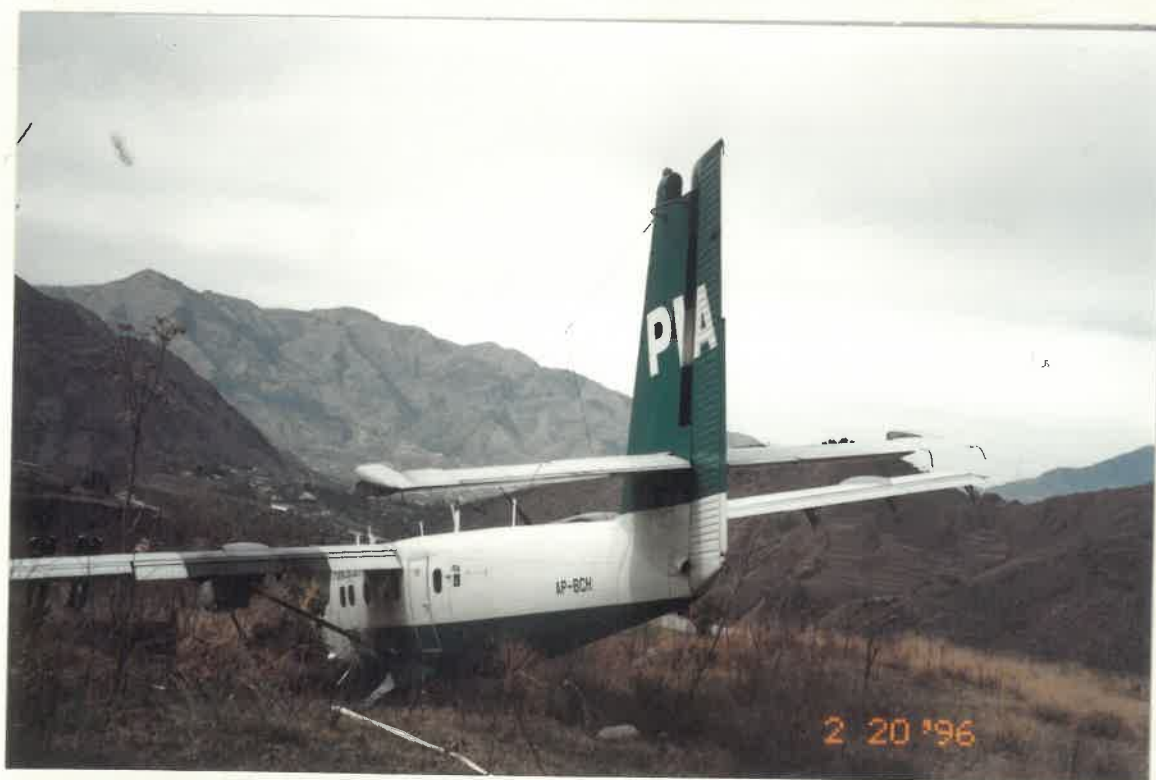
AIRCRAFT AT FINAL RESTING POSITION
