## **FINAL INVESTIGATION REPORT**

### **SERIOUS INCIDENT (TCAS – RA) BETWEEN PIAC FLIGHT PIA303, A320-214 AIRCRAFT, REG. NO. AP-BOL (OPLA - OPKC) AND MILITARY AIRCRAFT ON 04-03-2022**

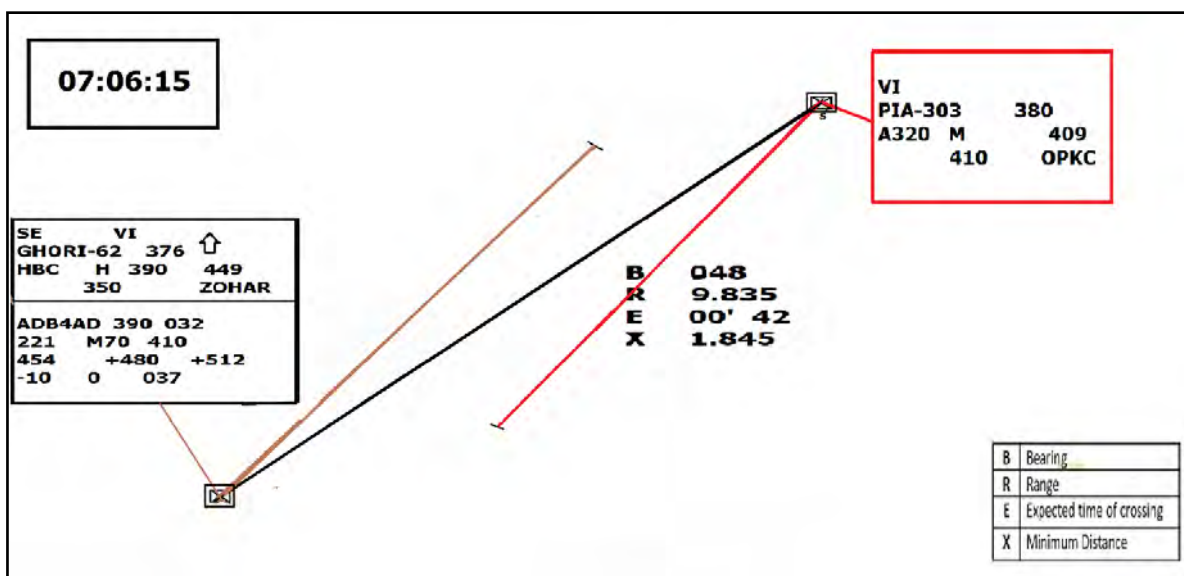
Figure 3 PIA303 Maintaining FL380

1.1.6. At 07:05:32 h, PIA303 informed Karachi ACC East that they are receiving reciprocal traffic climbing through its level. At that time reciprocal traffic GHAURI-62 was 20 NM from PIA303 climbing out of FL373 for FL390.

1.1.7. At 07:06:15 h, East Procedure Controller passed traffic information to GHAURI-62 regarding reciprocal traffic PIA303 at 9 NM maintaining FL380. At that time GHAURI-62 was passing FL376 for FL390. On response GHAURI-62 reported turning.

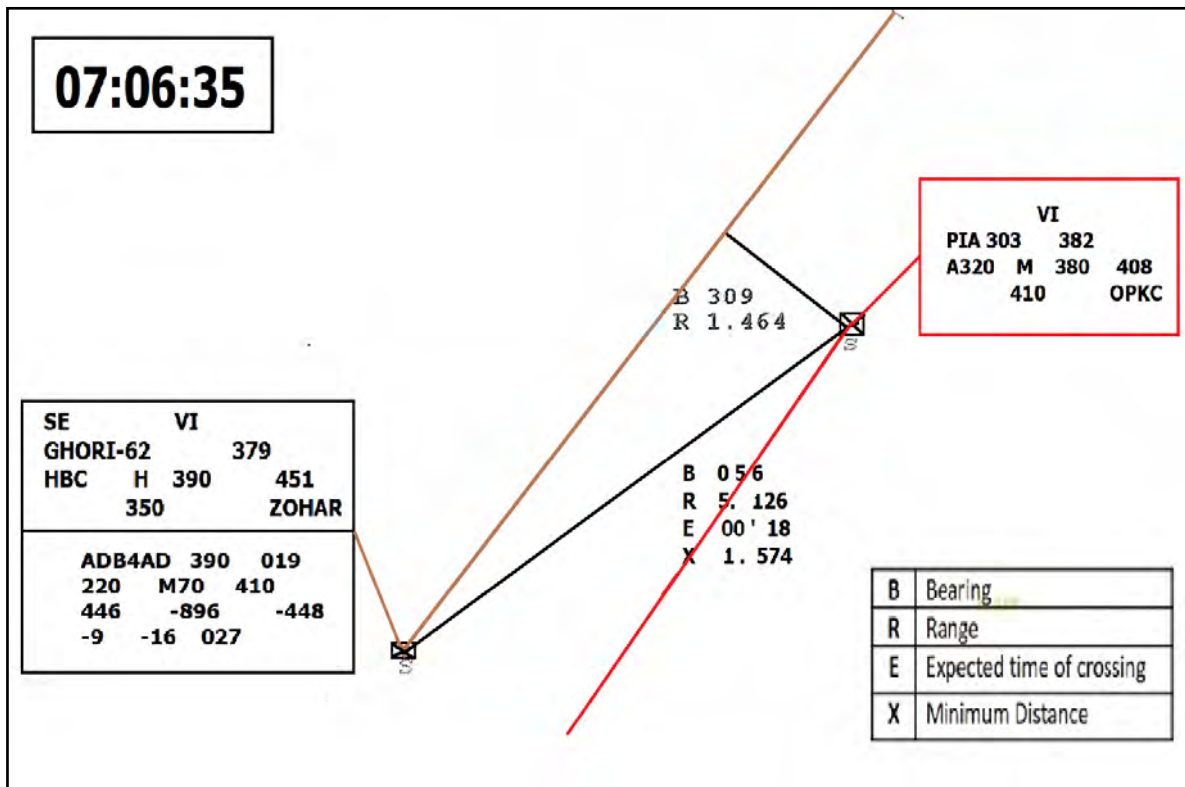
Figure 4 Aircraft initiated RA climb &amp; descend

1.1.8. At 07:06:40 h, both aircraft reported TCAS-RA 30 NM North-East of Nawabshah. PIA303 initiated RA climb to FL385 whereas GHAURI-62 initiated RA descend to FL374 respectively.

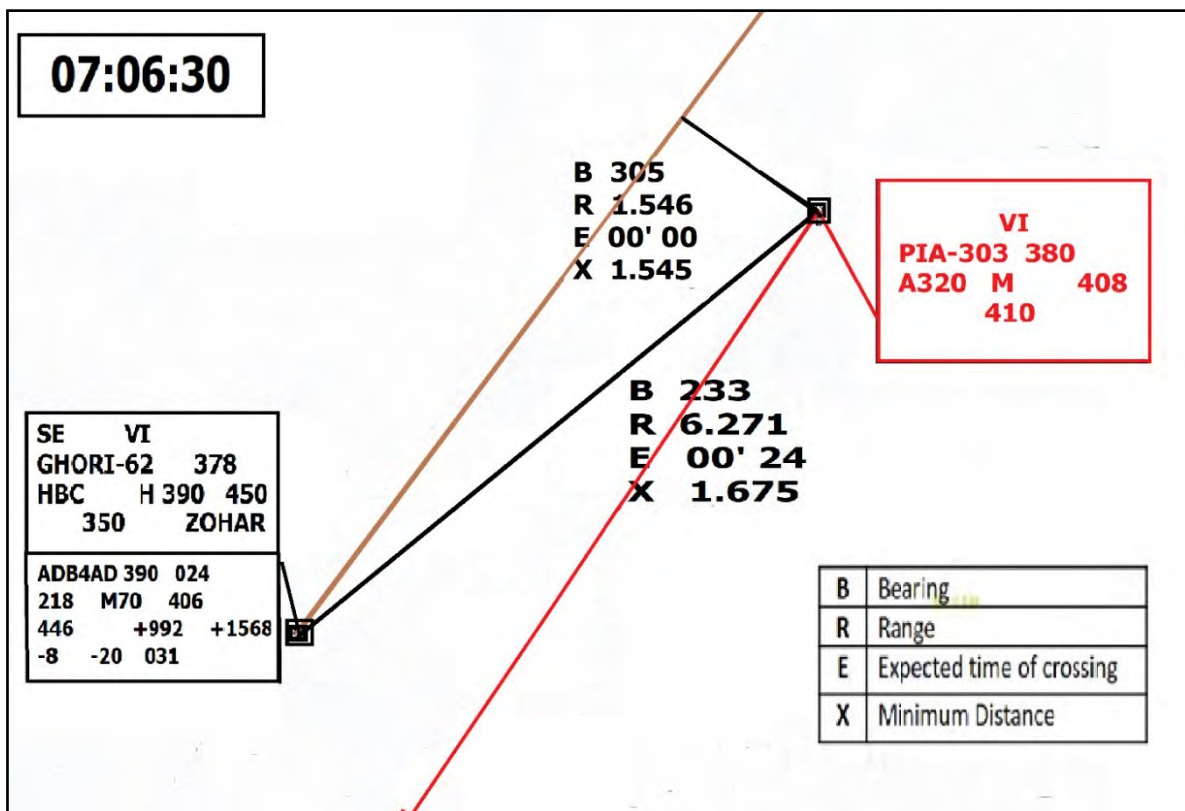
Figure 5 Vertical &amp; Lateral separation

1.1.9. At the time of TCAS-RA, there was a vertical separation of 200 ft and a lateral separation of 6.2 nautical miles between both aircraft.

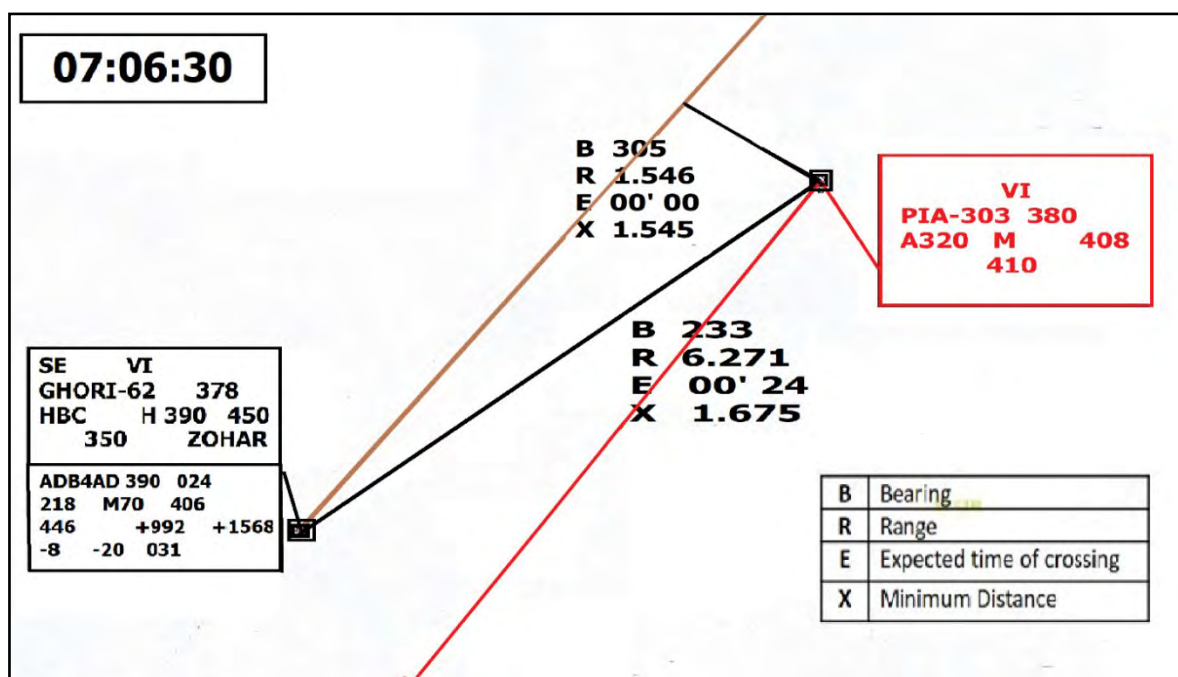
Figure 9 Vertical & Lateral Separation

2.1.10 At the time of TCAS-RA, there was a vertical separation of 200 ft and a lateral separation of 6.2 NM between both aircraft.

2.1.12 The ACC Radar Controller (East) could have handed over the radar control position to the available team leader for better traffic management, instead of leaving the seat and assuming that the procedure controller, who was already pre-occupied with coordination with other units regarding military exercise, would manage the radar traffic in his absence.

3.2.1.1. Absence of ACC Radar Controller East from his radar executive position considering that ACC Procedure Controller (East), being radar rated would manage the position during his absence.

3.2.1.2. Activation of TCAS – RA (**MAC – Mid Air Collision**) due to lack of situational awareness by the ACC Procedure Controller.

4.1.1. PAA to implement rigorous training for Procedure Controllers and OJTIs to handle simultaneous tasks effectively, especially during critical situations like military exercises or high traffic scenarios.

4.1.2. Ensure that all Radar Controllers positions are manned positively to avoid attention diversion and pre-occupation of other controllers. A dedicated controller may be deployed for coordination among units during high density traffic / Military exercises.

4.1.3. Effective involvement and supervision by Team Leaders / Supervisors may avoid such recurrences in future.
