PAKISTAN CIVIL AVIATION AUTHORITY

**AIRCRAFT ACCIDENT INVESTIGATION REPORT**

**CRASH OF ULTRALIGHT ZODIAC-CH-601 HD**

**REG. # AP-ZBB ON 29 SEPTEMBER 2006**

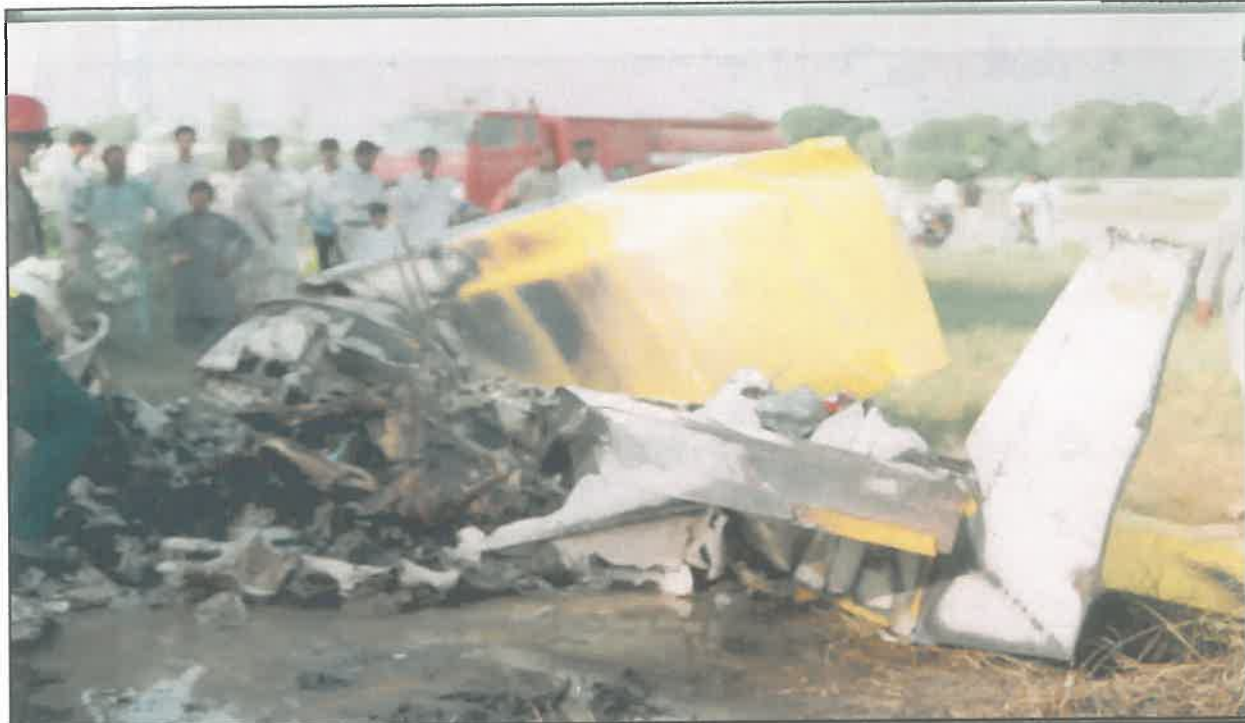
MAIN WRECKAGE EXTENSIVE BURNING IN CENTRE TAIL AND RT WING UN-  
BURNT

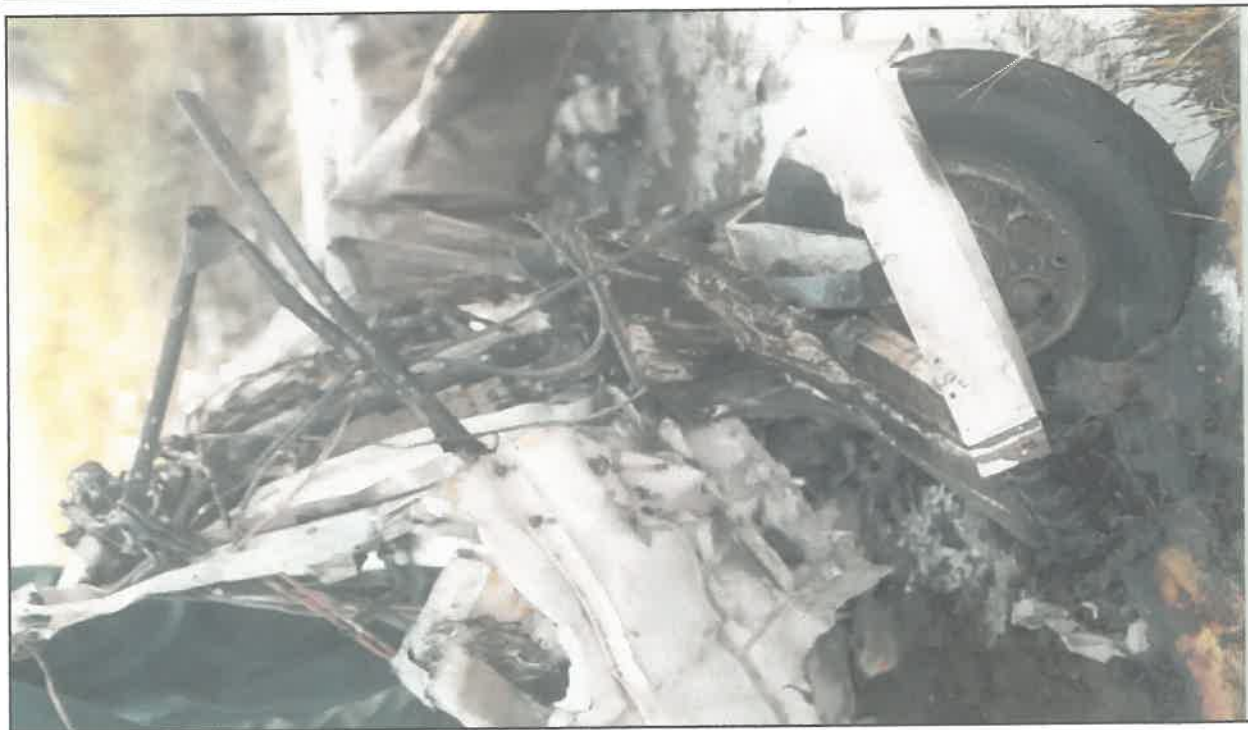
RT WHEEL AND STRUTS NO BREAKAGE OR BURSTING DURING TOUCH DOWN

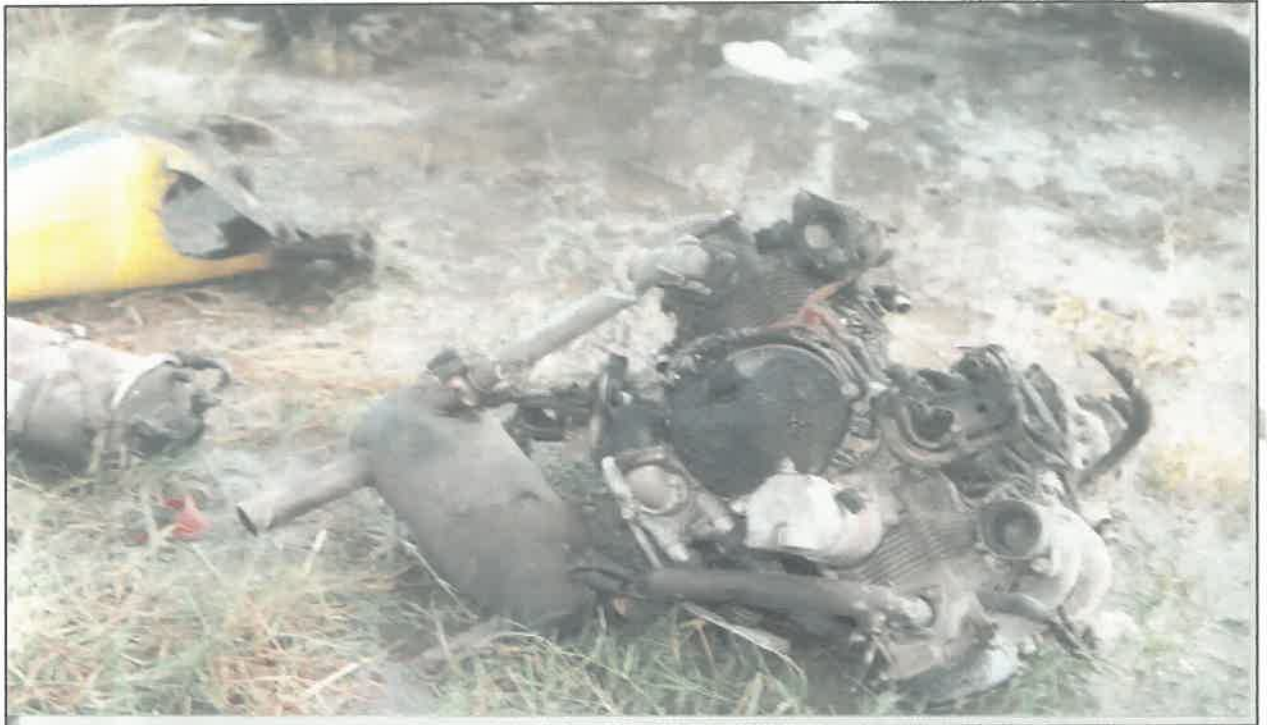
NOSE MOUNTED ENGINE SEPARATED ON IMPACT AND BURNT

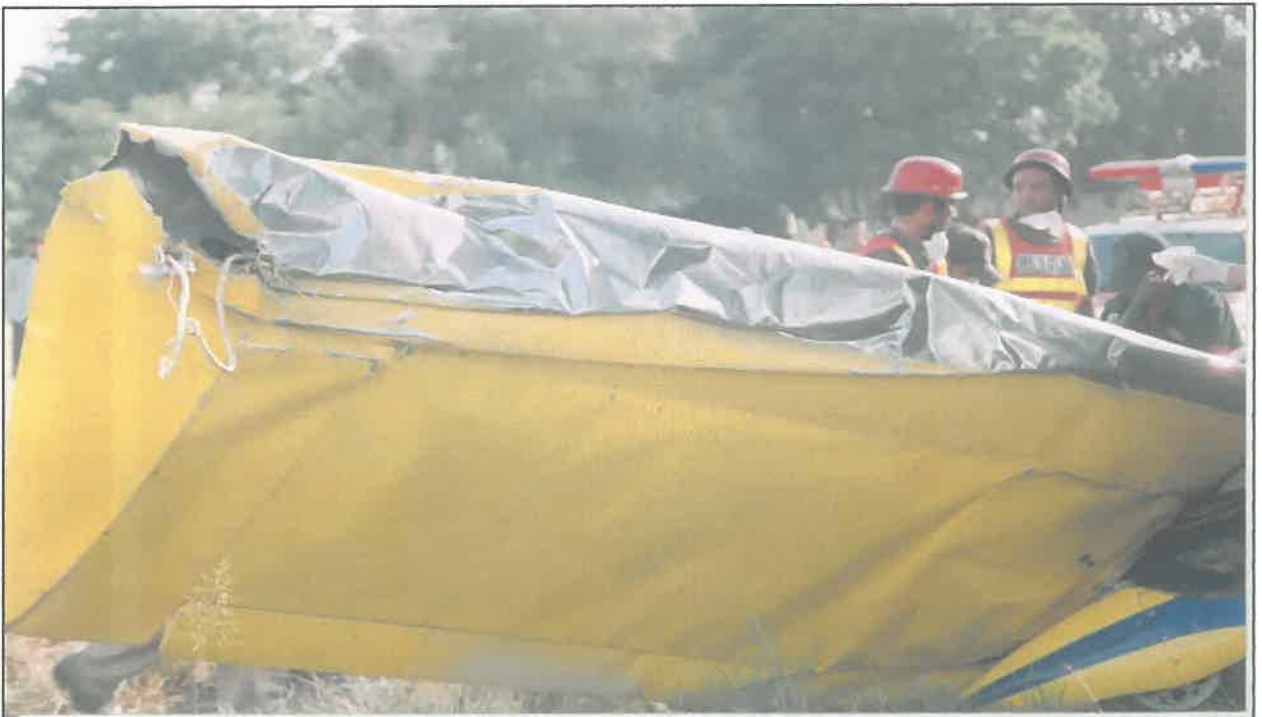
RIGHT WING LEADING EDGE PAINT FLAKED OFF BUT NO TELESOPING

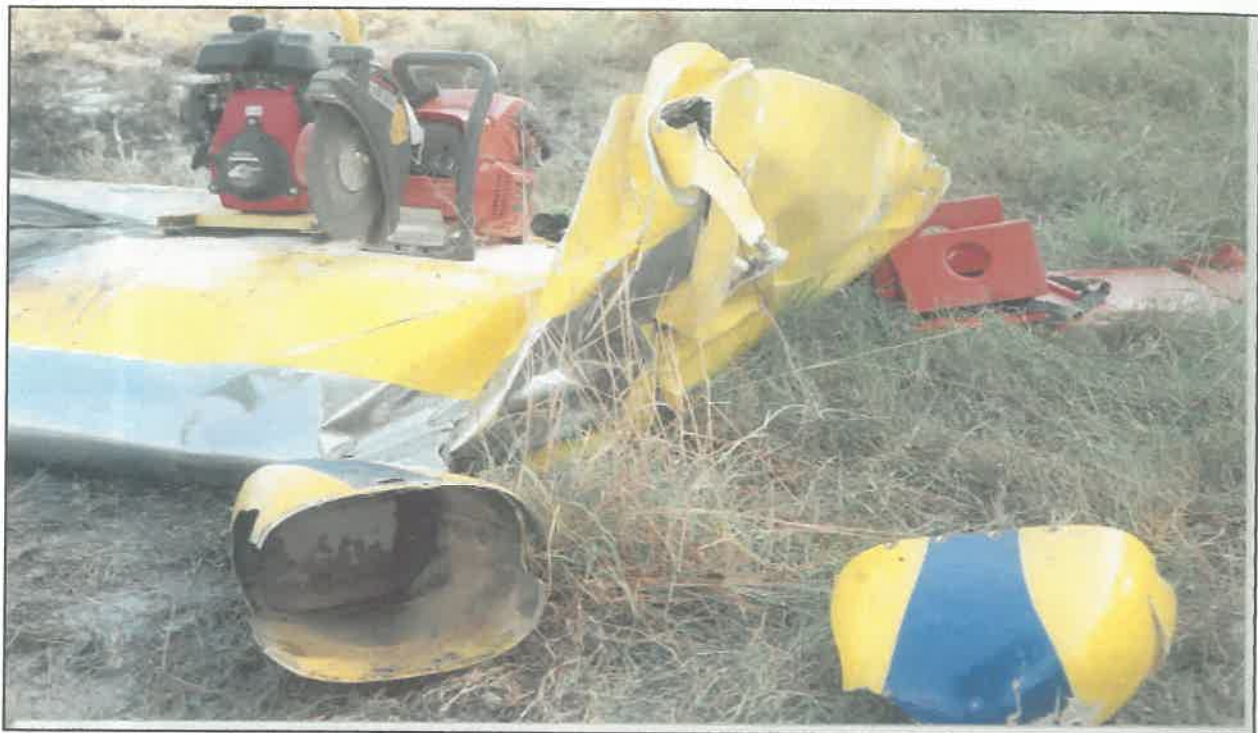
LEFT WING TIP BENT ON INITIAL IMPACT AND NOSE TIP SEPARATED
