**REPORT ON THE ACCIDENT  
OF  
PAKISTAN INTERNATIONAL AIRLINES A300  
FLIGHT PK268 (AP-BCP)  
ON  
28 SEPTEMBER 1992**

**His Majesty's Government of Nepal**  
*27 June* **1993**

**This report has been published by His Majesty's Government of Nepal as submitted by the Commission for the Accident Investigation of PK 268 Airbus, established for the purpose of advancing aviation safety, in accordance with Annex 13 to the Convention on International Civil Aviation.**

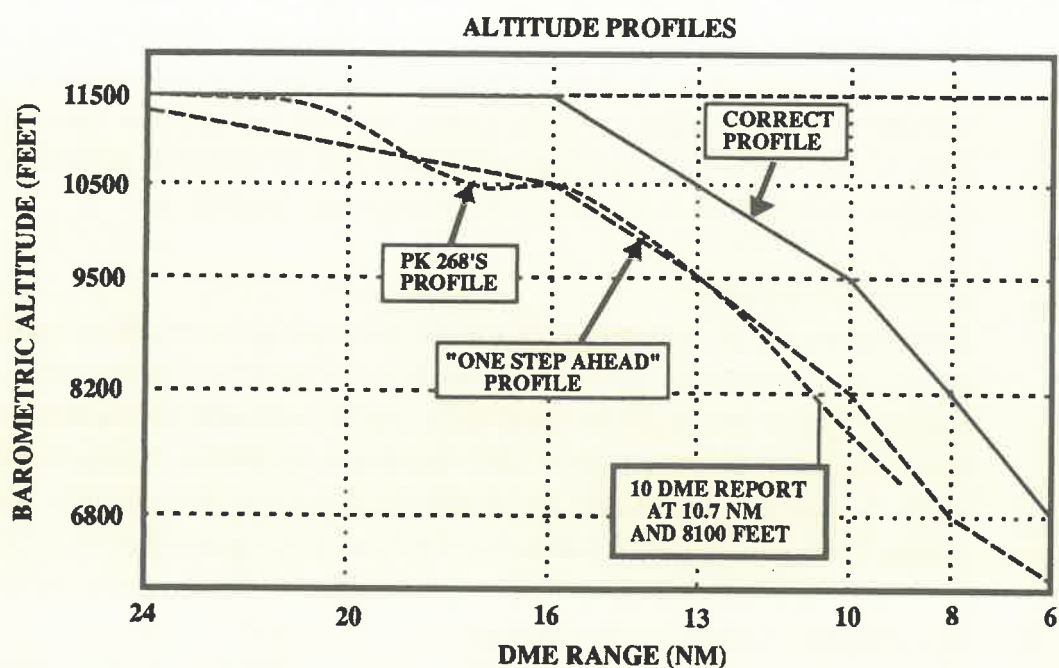
At 16 DME the crew were 'one altitude step' ahead of the correct profile. If this situation had persisted, the crew would have been aiming to be at 9,500 feet at 13 DME, 8,200 feet at 10 DME and 6,800 feet at 8 DME. The correct profile, the misinterpreted or 'one step ahead' profile, and the aircraft's actual flight profile are shown on the diagram below. From the diagram it is clear that the aircraft passed through 9,500 feet at 13 DME but then continued below the 'one step ahead' profile until impact.

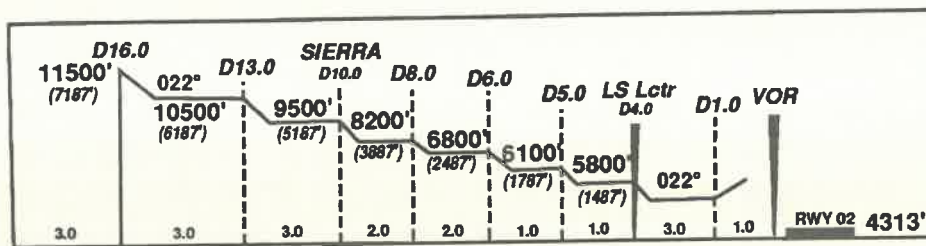
PIA crews use Jeppesen charts for all approaches to airfields within the airline's route structures. Both pilots had been employed by PIA for several years and both would have been very familiar with the Jeppesen chart conventions. Therefore, if the layout of the chart contributed to their mis-interpretation of it, it is likely that some abnormal feature or illustrative technique on this particular chart may have misled them. There was nothing abnormal in the plan portion of the chart apart from the omission of the fan marker and the presence of several notes. On the vertical profile, however, the data was unusually dense when compared to other VOR/DME approach profiles at airfields in PIA's A300 route structure. It too omitted the fan marker. The profile is illustrated below:

The omission of the fan marker from the chart was not a contributory factor in this accident. The descent profile is based on DME range and PK 268 struck a mountain before it reached the marker. However, the correct altitude at 16 DME was not printed on the plan portion of the chart; it was printed only on the elevation profile. Therefore, the initial mistake would appear to be that someone interpreted the elevation profile in such a way that the association between 16 DME and the clearly printed figure of 11,500 feet next to it was lost. As an informal trial indicated, if the altitude of 11,500 feet at 16 DME is obscured by the holder's thumb, the starting altitude is less obvious.
