# **FINAL INVESTIGATION REPORT**

**SERIOUS INCIDENT (TCAS – RA) – KUWAIT AIRWAYS  
FLIGHT KAC920, BOEING 777-369(ER) AIRCRAFT,  
REG. NO. 9K-AOE (SECTOR GUANGZHOU TO KUWAIT)  
AND MILITARY AIRCRAFT ON 01-12-2021 AI2-1Tw 1.113**

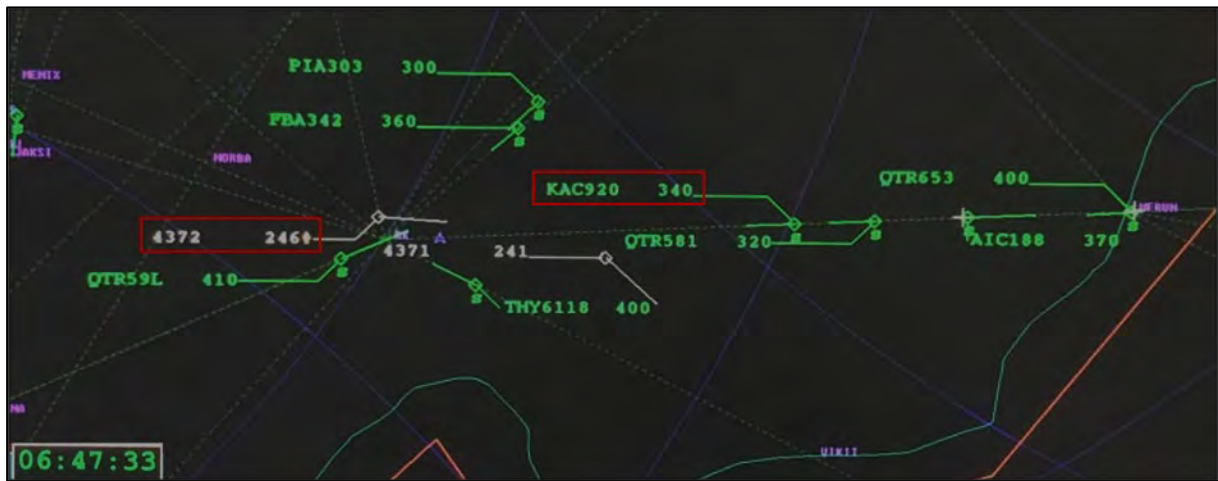
Figure 5 Military aircraft observed approx 03 NM North of RK

2.1.6. At time 06:47:33 h, one of the military aircraft, squawking A4372, was observed 3 NM north of 'RK' at FL246 in a climbing phase and subsequently disappeared from the radar.

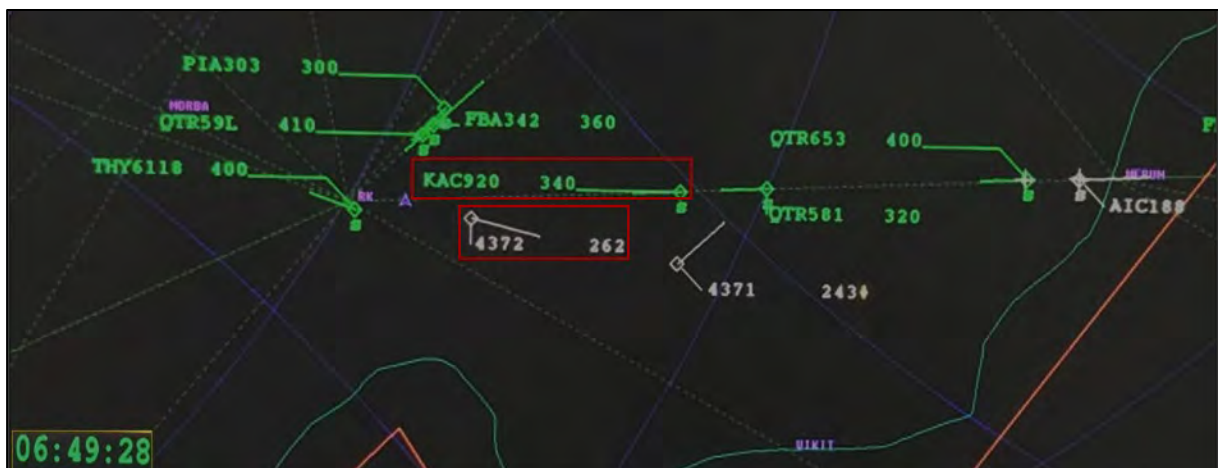
Figure 6 Military aircraft climbing FL262

2.1.7. At time 06:49:28 h, military aircraft squawking A4372 reappeared on radar display, climbing out of FL262 at a position 18 NM east of 'RK' and 20 NM on a reciprocal heading to KAC920.

2.1.9. At this time, the military aircraft was maintaining high ROC of approximately 6,000 ft / min as per controller's statement<sup>6</sup>.

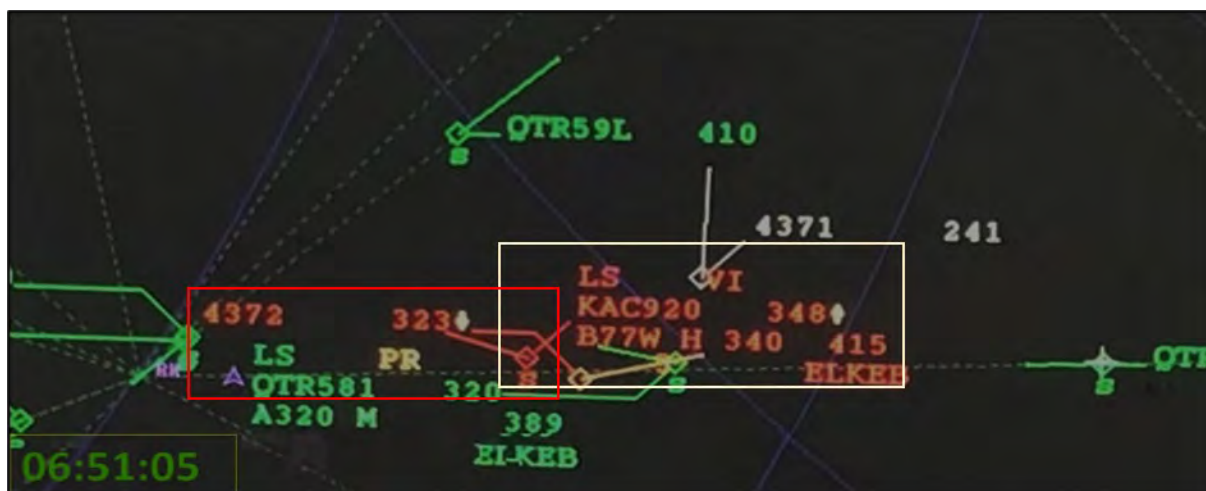
Figure 8 TCAS-RA activation

2.1.12. At 06:51:05 h, KAC920 reported TCAS – RA and initiated a climb to FL348 in response to the RA activation (Figure 7).

2.1.13. The military aircraft crossed KAC920 at its 9 o'clock position, approximately 02 NM away at FL334, which triggered the activation of TCAS – RA.

2.1.17. Vertical Separation of approximately 600 ft and lateral separation of 02 NM existed between military aircraft and KAC920 at the time of RA.

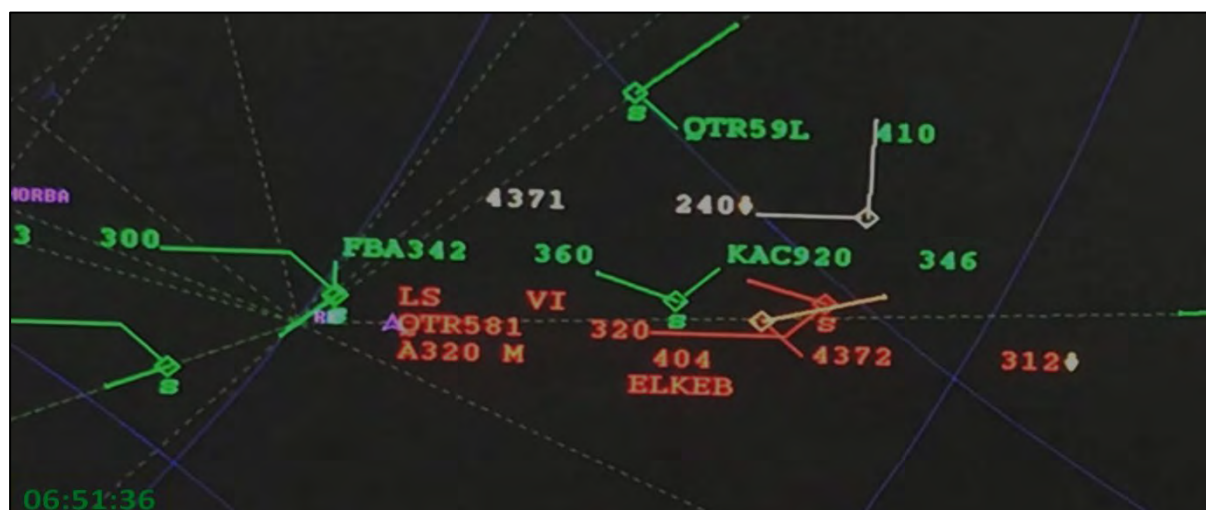
Figure 9 KAC920 reporting clear of conflict

2.1.14. At 06:51:36 h, KAC920 reported it was clear of traffic and descended back to FL340 from FL348 while the military aircraft was descending through FL312 (Figure 8). The other fighter aircraft remained within the coordinated block between FL260 and FL200 throughout the event.
