INVESTIGATION REPORT INTO THE CIRCUMSTANCES  
AND CAUSE/S OF THE GROUND OCCURRENCE INVOL-  
VING PIAC BOEING 737 AIRCRAFT REGISTRATION  
AP-BCA THAT OCCURRED AT LAHORE INTERNATIONAL  
AIRPORT ON 22ND APRIL 1987 AT 1440 HRS. (P.S.T)

Authority:- Director General C.A.A Telex dated 23rd  
April 1987 reference HQ CAA/2651/25/Legal  
(Appendix "A").

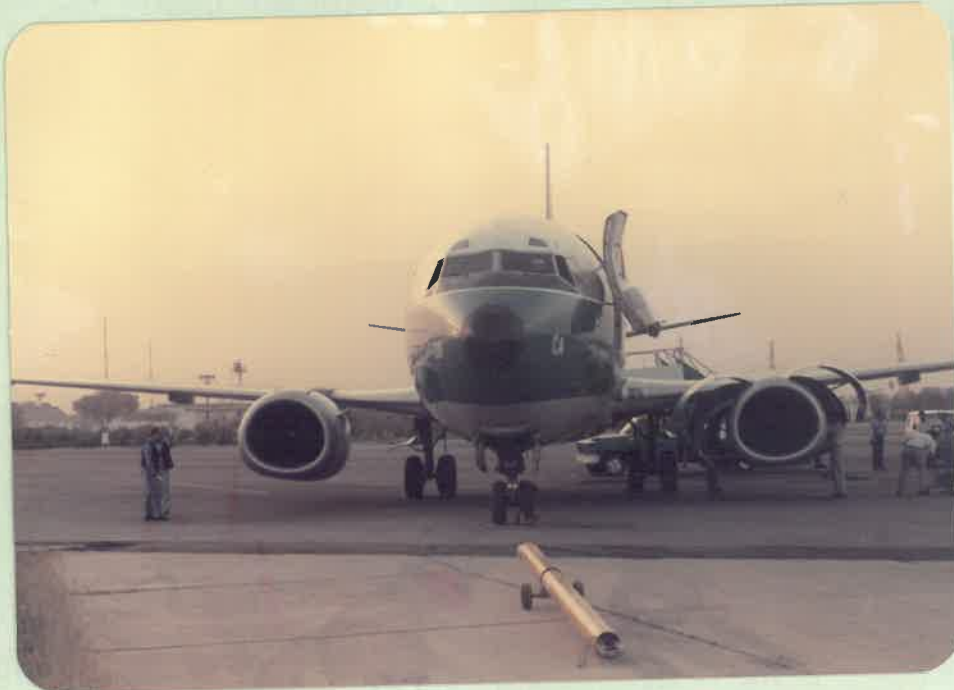
APP. B<sub>1</sub>

FRONT VIEW OF B. 737 AP-BCA SHRTLY  
AFTER THE OCCURRENCE

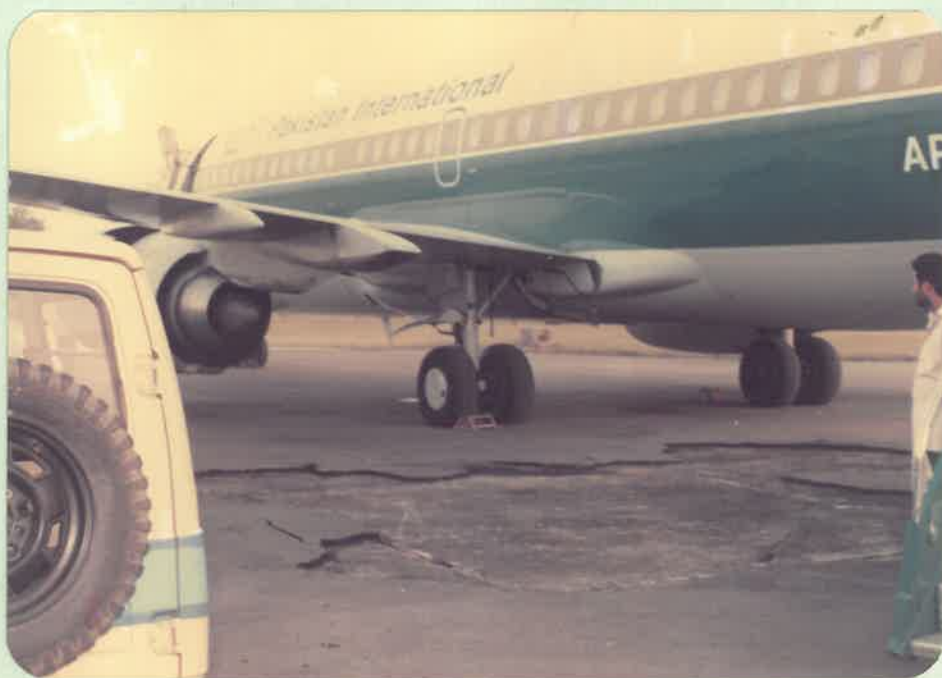
APP. B<sub>2</sub>

- 19.1.22. The bituminous overlay initially melted and instantaneously was ripped off due to the blast getting between the overlay and the concrete, thus causing damage to the airframe of the aircraft which was struck by pieces of the asphalt.

VIEW FROM THE LEFT SHOWING PEELED OFF  
OVERLAY ARROW POINTS MELTED BITUMIN

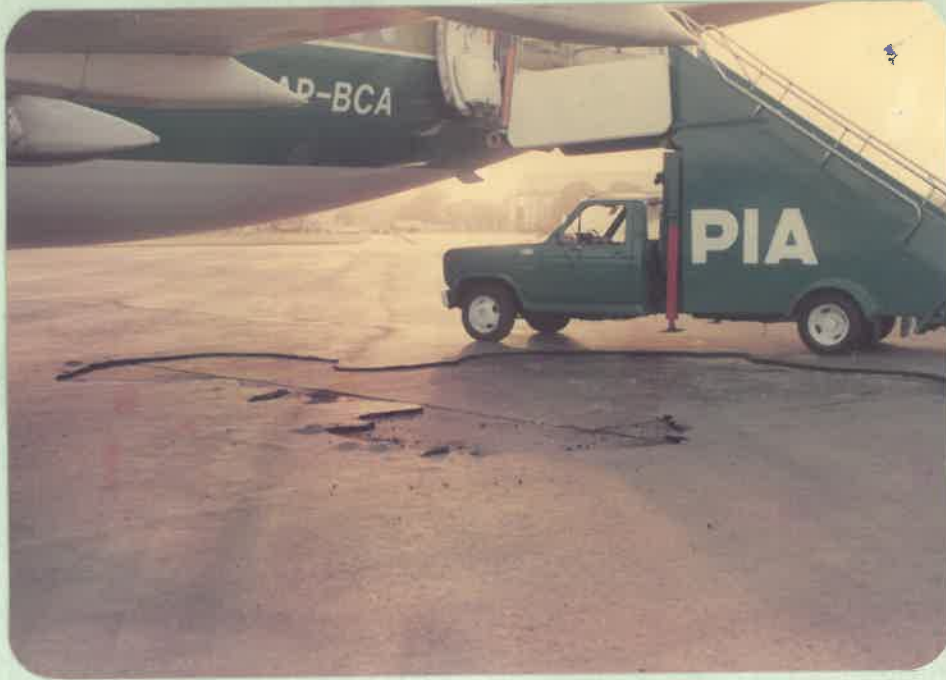
APP B<sub>3</sub>

THIS VIEW SHOWS THE PEELED OFF OVERLAY

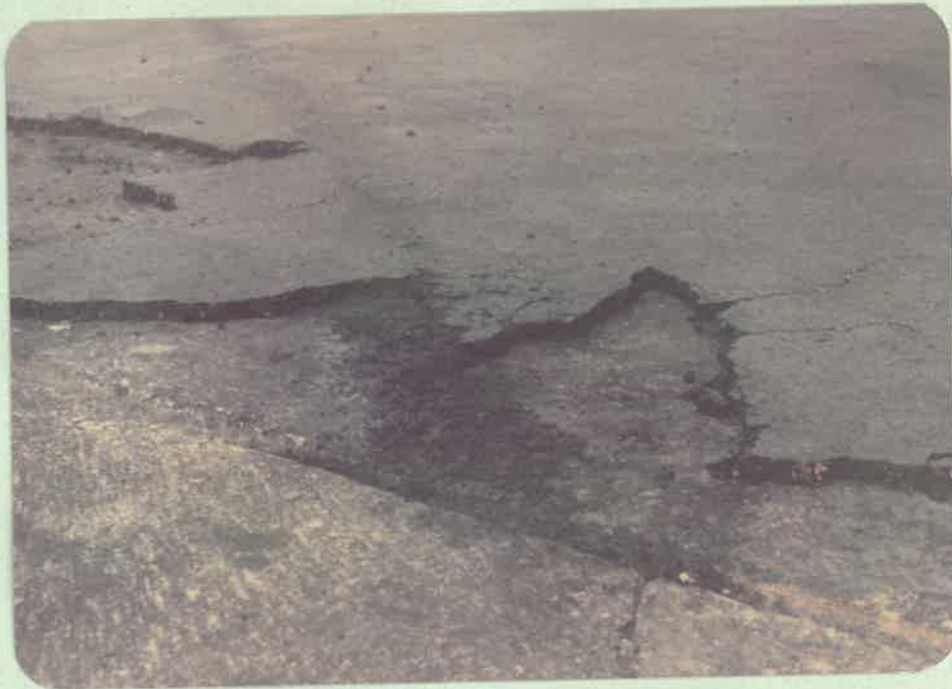
APP. B<sub>4</sub>

THIS VIEW SHOWS THE MELTED BITUMIN.  
SHOWN AT APPENDIX "B<sub>2</sub>"

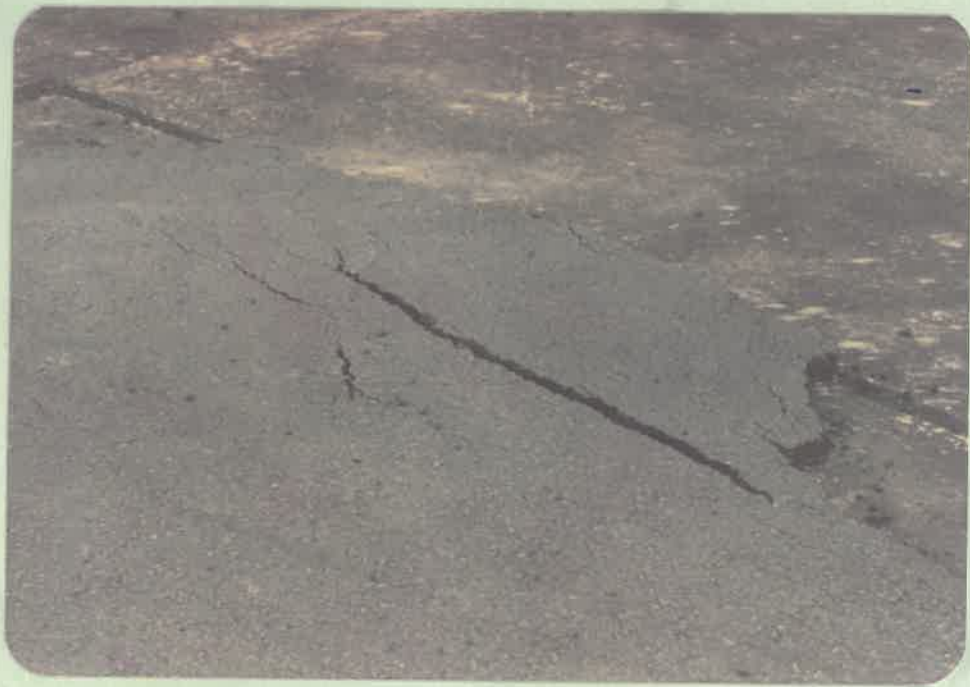
APP B5

ANOTHER VIEW OF THE FAILED OVERLAY

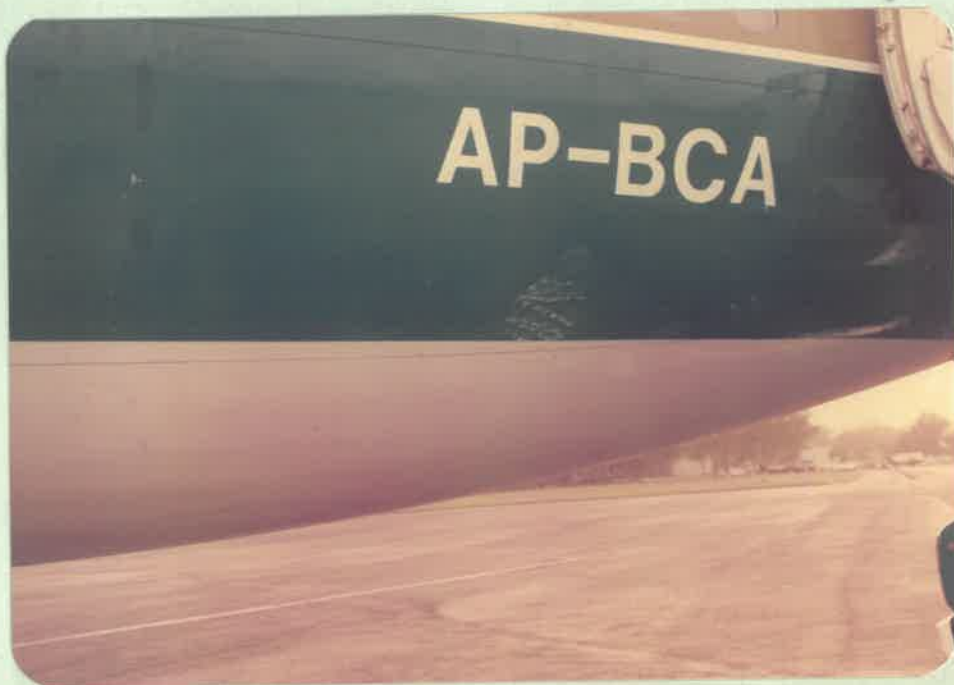
APP B6

5.1. Fuselage Port - Side at station 727C and W/L 190 had skin ruptured of about  $\frac{1}{2}$ "X $\frac{1}{2}$ " area.

5.2. Fuselage port-side at Station 847 and W/L 190 had skin ruptured of about 1"X  $1\frac{1}{2}$ " area. Around this ruptured spot about  $1\frac{1}{2}$ ' X  $1\frac{1}{2}$ ' surface area was dented.

VIEW OF THE LEFT SIDE OF THE AIRCRAFT.  
DAMAGE CAN BE SEEN IMMEDIATELY BELOW  
THE REGISTRATION MARKING.

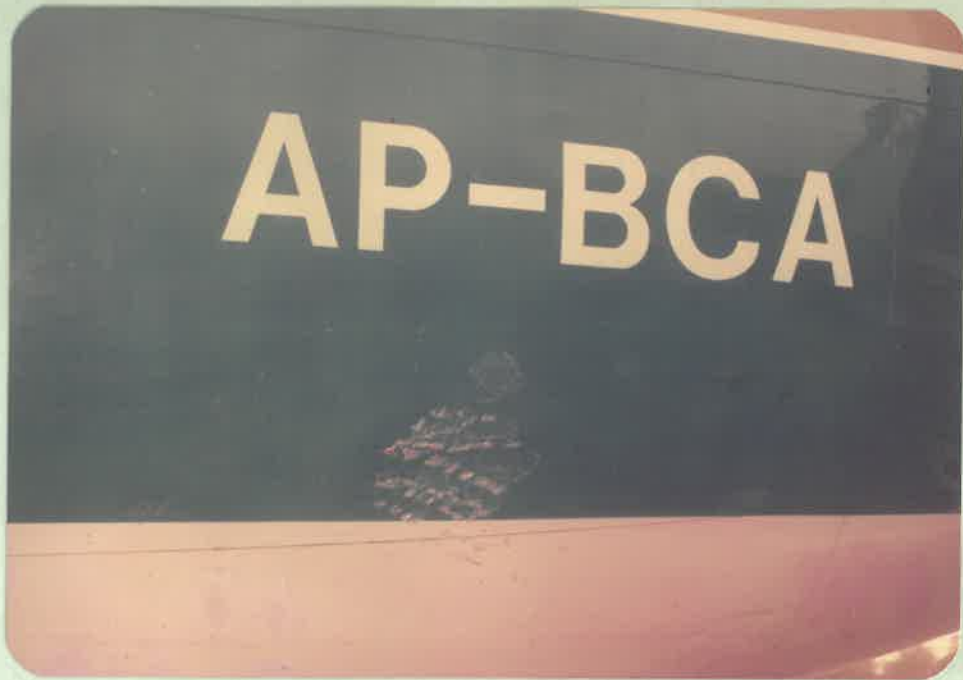
APP. B<sub>7</sub><sup>+</sup>

CLOSE VIEW OF ONE AREA OF DAMAGE

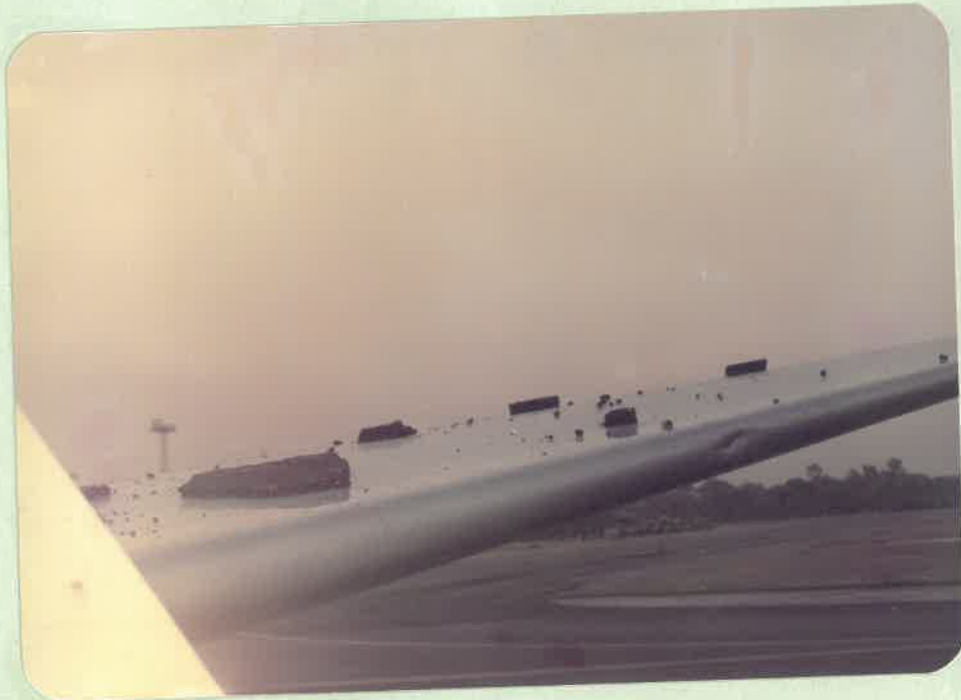
APP. B<sub>8</sub><sup>+</sup>

5.4. Port side stabilizer sustained dents of approximately 4 inches and 2 inches in length on its leading edge surface.

VIEW SHOWING ASPHALT PIECE ON TOP OF  
LEFT HORIZONTAL STABILIZER. DENT ON  
LEADING EDGE CAN BE SEEN

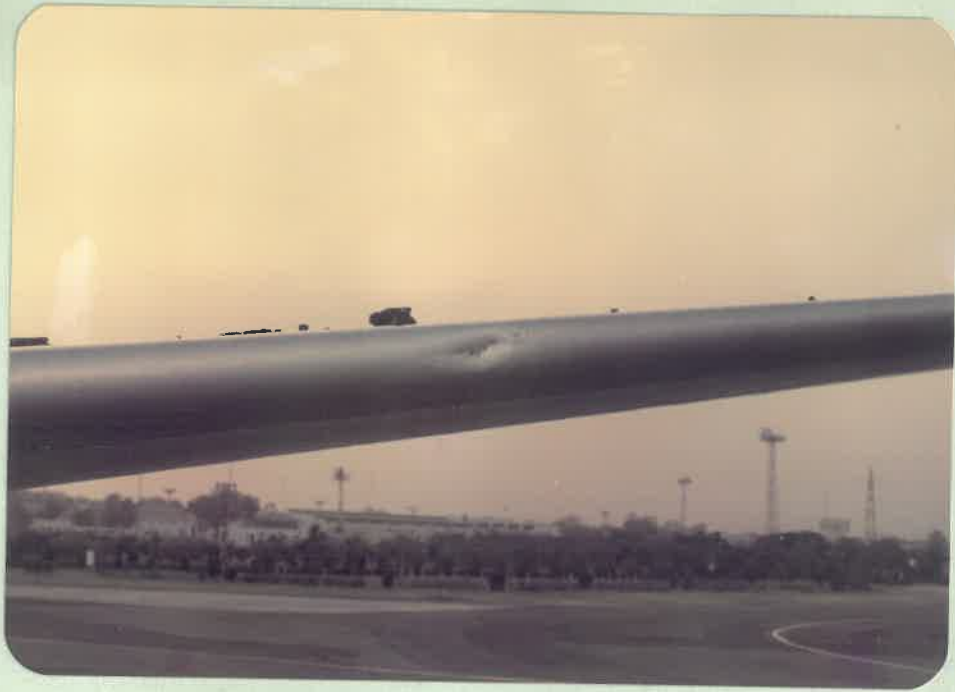
VIEW OF DENT ON LEADING EDGE OF  
LEFT HORIZONTAL STABILIZER.
