**CIVIL AVIATION AUTHORITY**

**AIRCRAFT INCIDENT INVESTIGATION M/S PAK AVIATORS**

**CESSNA- 337 REG.NO.AP-BDW WHICH OCCURRED**

**WALTON AIRPORT LAHORE**

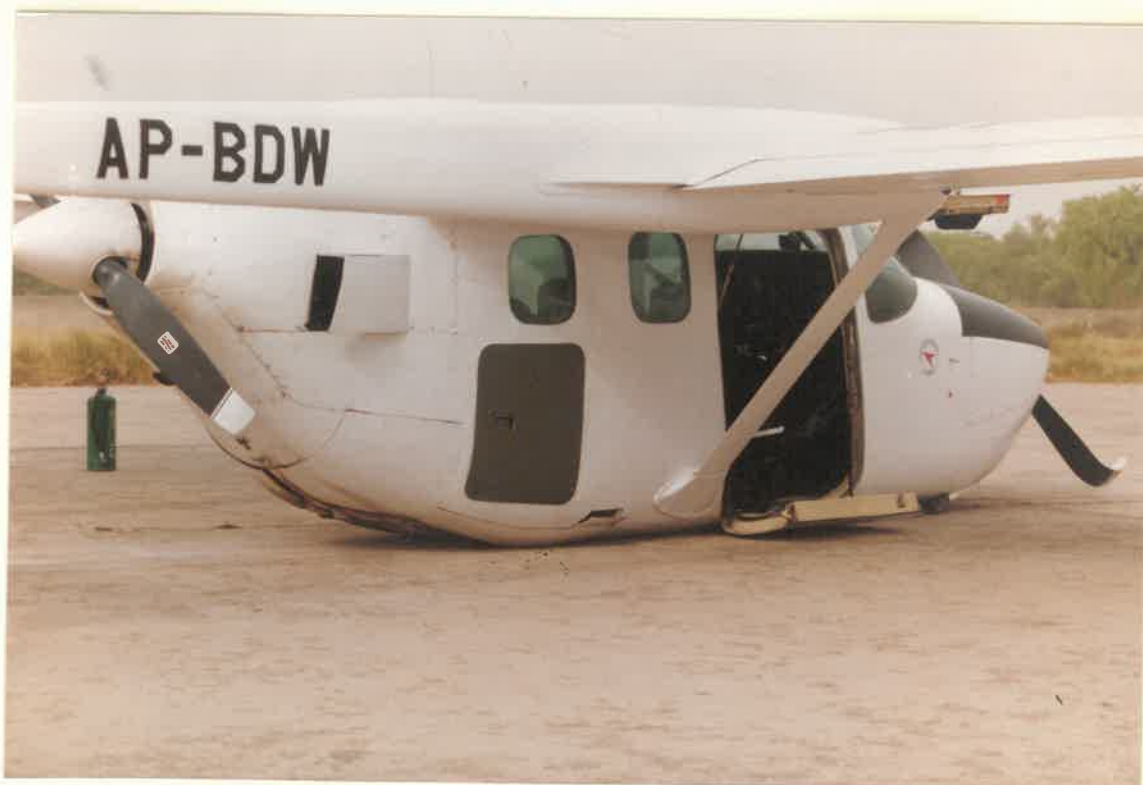
APP. B2

BELLY LANDING - ANOTHER VIEW
