# FINAL INVESTIGATION REPORT

ACCIDENT OF M/S PIAC FLIGHT PK-259 (SECTOR SKT- MCT)  
B737-300, AP-BEH AT MUSCAT ON 11<sup>TH</sup> FEBRUARY, 2013

**Synopsis**

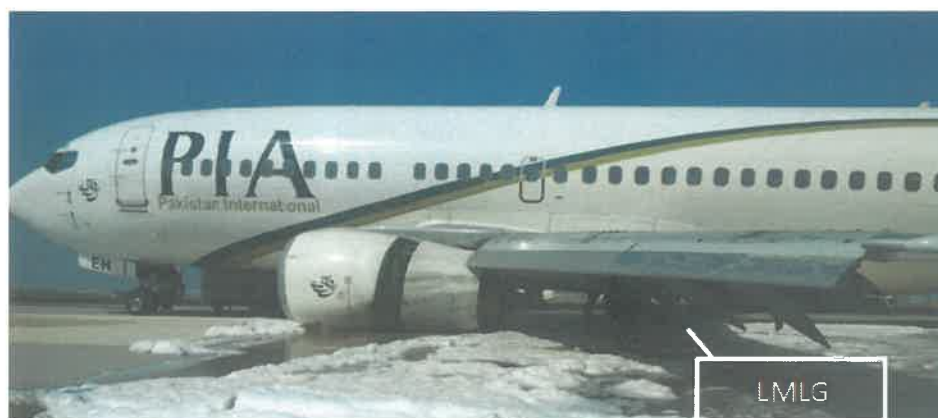
1.3. **Damage to aircraft.** The aircraft left wing sustained substantial damage around landing gear attachment points due to landing gear collapse. The shimmy damper piston and torsion link also fractured. The left engine cowling came in contact with ground and dragged along on the runway resulting in damage to engine cowling, lower engine parts, thrust reverser blocker doors and honey comb structure.

Aircraft on runway after final stop

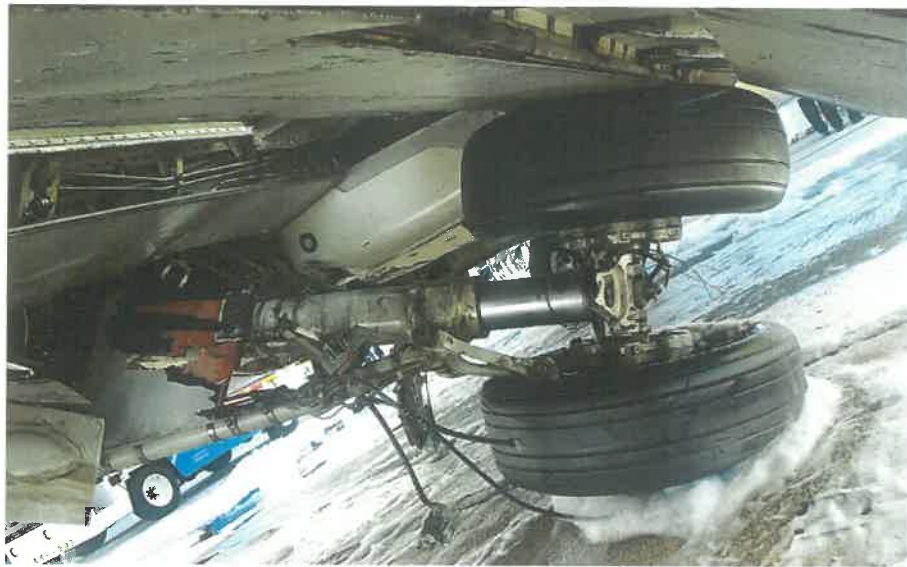
Close up of the collapsed left main landing gear

3.1.7 The large amplitude torsional vibrations resulted into failure of lower torsion link and shimmy damper actuator. After failure of the torsion link and shimmy damper actuator the LMLG wheels pivoted and were not able to rotate with forward motion of aircraft, thus resulting in collapse of the LMLG.

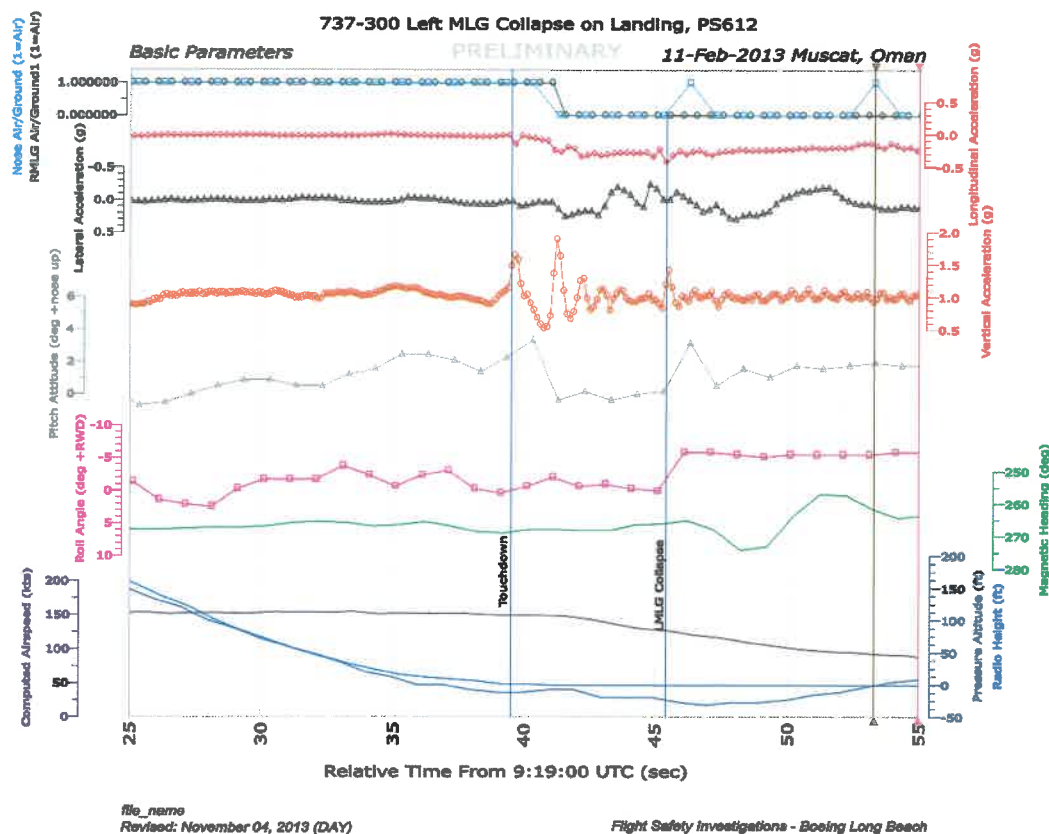
2.2 The first contact of the aircraft with the runway occurred at 9:19:39.5 hrs and was indicated by the jump in vertical acceleration and a dip in longitudinal acceleration. The roll angle 0.5 seconds before touchdown was +0.4 degrees and 0.5 seconds after the beginning of the vertical acceleration spike was -0.7 degrees. Since the roll attitude during this time frame is predominantly negative (left wing down) and the pitch angle is positive (nose up) it was inferred that the touchdown was on the LMLG.

2.3 There is a spike in the vertical and longitudinal accelerations at 9:19:41.1 hrs. This coincides with a pitch angle near zero and a roll angle of -1.5 degrees. This is probably the time where the nose landing gear and right main landing gear tires contacted the runway. The next previous samples on the nose and Right Main Landing Gear (RMLG) air/ground sensors recorded "in air". The subsequent samples recorded "on ground".

2.4 At 9:19:45.4 hrs the abrupt left-wing down roll to about -6.0 degrees was most probably due to LMLG collapse.

2.5 The Boeing FDR analysis report stated that 4-6 seconds between touchdown and Main Landing Gear (MLG) collapse (in this recording) is consistent with the timings of similar shimmy events that Boeing has seen in the past.

2.6 The variation of lateral accelerations after touchdown corroborates with the presence of shimmy.

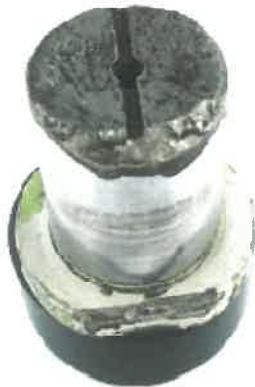
2.9 The fractured Connecting Pin of Universal Link of LMLG was also submitted for failure mode and fractographic analysis to FAC. The FAC report (**Appendix 'G'**) concluded that overall failure mechanism of the Connecting Pin was fast ductile fracture due to overload in bending/shear. The evidence of fatigue failure was not found during analysis of the available portion of the failed part.

Fractured Connecting Pin

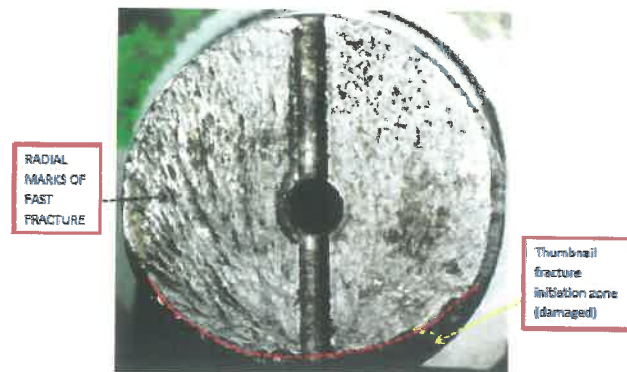
Close up view of fracture surface

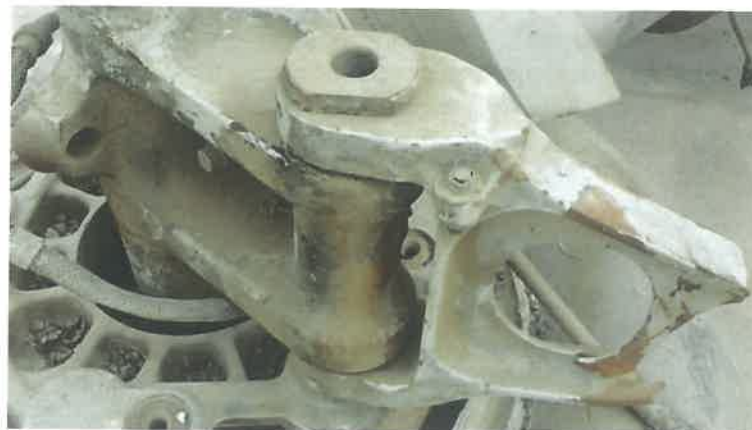
2.10 The lower torsion link also got fractured. Part of the torsion link towards the shimmy damper could not be retrieved by the investigation team. Most probably this part separated after failure of torsion link and shimmy damper actuator and got thrown off the runway. However, part of the lower torsion link attached with the inner cylinder was available. It was visually examined and it also indicated an overload fracture.

Fractured Lower Torsion Link

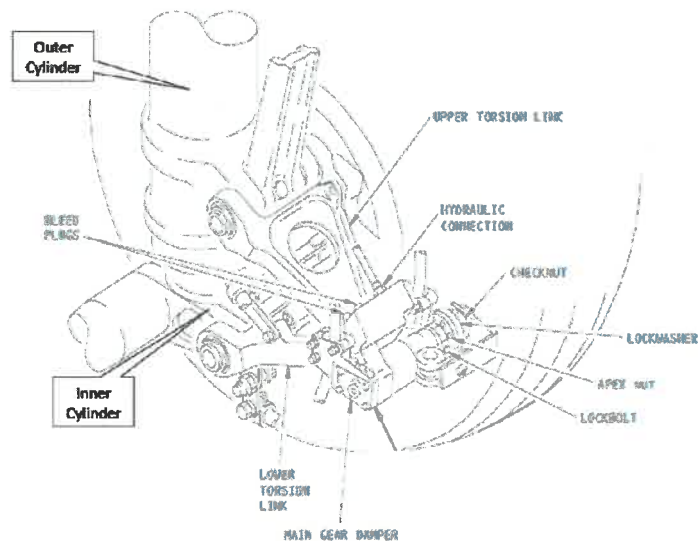
2.11 The axel of the wheels is mounted on the inner cylinder. The torsion links and shimmy damper assembly prevents pivot of the inner cylinder inside the outer cylinder (torsional movement). The torsional vibrations are prevented by the shimmy damper. It is pertinent to mention that clearances of linkages of the shimmy damper are detrimental in

effectiveness and efficiency of the whole mechanism to prevent torsional vibrations of the wheel assembly.

Torsion Links and Shimmy Damper Assembly

2.12 Ineffective shimmy damper mechanisms due to trapped air, internal leaks/failures of damper, and more than specified clearances of the associated joints results in torsional vibrations, which are termed a shimmy event. If the vibrations approach the natural frequency of assembly then resonance phenomenon is excited which results into very large amplitude vibrations. The large amplitude vibrations exert excessive load on associated linkages, resulting into failure of the torsion links/shimmy damper actuator.

2.16 The dimensional checks of the bushings in attachment point of upper and lower torsion links and corresponding bushings of the lugs on the inner and outer cylinder were performed. The measurements indicated excessive wear of bushings leading to more than specified clearances of the joints (**Appendix 'H'**).

3.1.5 The dimensional measurements of torsion links attachment point bushings and corresponding lug bushings on the inner and outer cylinder of LMLG were found out of specified limit, indicating excessive wear which resulted in excessive play in the assembled shimmy damper and torsion link mechanism.

3.1.6 The excessive play in the shimmy damper mechanism was responsible for reducing the effectiveness of the mechanism and leading to shimmy event on LMLG just after the landing.

4.1.1. One time gap check/adjustment of apex joint of main landing gear torsion link, torsional free play check, shimmy damper bleeding and NDT of the upper and lower torsion links.

4.1.2. Reduction of interval of task cards 32-011-02-01, 32-011-02-02, 32-011-03-01, 32-011-03-02, 737-32-11-81-LH and 737-32-11-81-RH from check-C (4000 flight hrs) to check-4A (1000 flight hrs).

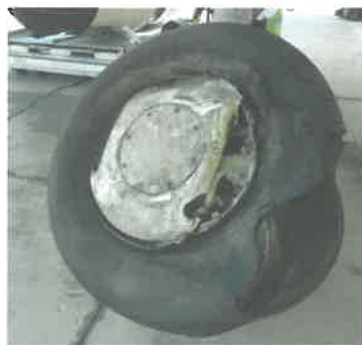
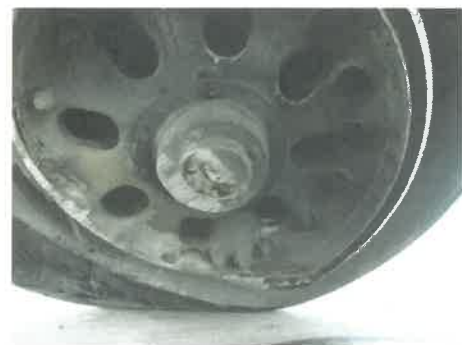
2.13 After failure of the torsion link or shimmy damper actuator the inner cylinder is no more restrained against torsional movement inside the outer cylinder. The rubbing marks on the wheel hub with runway surface indicated that wheel assembly pivoted almost perpendicular to aircraft movement direction, thus the wheels could not rotate with forward motion of the aircraft. The resultant friction force between the runway surface and tires pulled the landing gear rearward from lower side, while the aircraft was moving in forward direction thus causing failure of upper attachment fittings and collapse of the landing gear.

Rubbing marks on wheel hubs

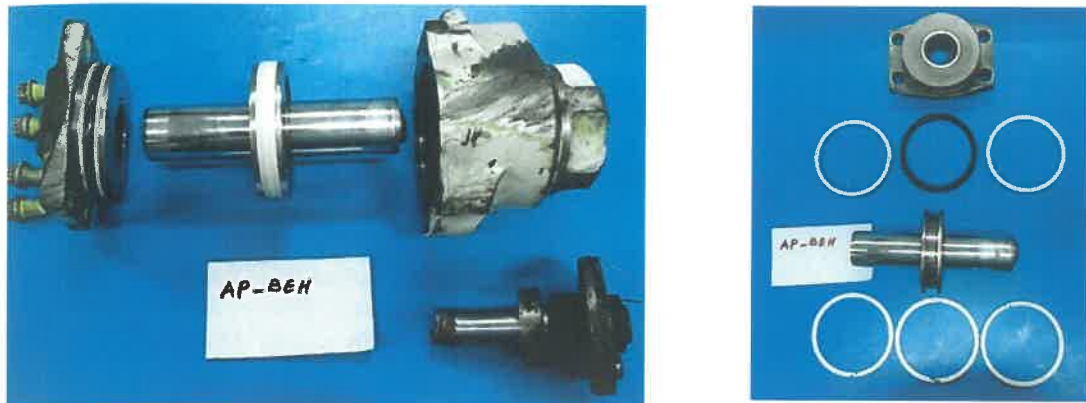
2.14 The tear down examination of the shimmy damper was carried out and no evidence of damage to seals and internal mechanism was found, which if damaged can adversely affect the damping efficiency.

Shimmy damper internal seals and mechanism were found intact

3.1.4 The shimmy damper internal mechanism was intact and there was no evidence of damage to its seals and piston, which if damaged can adversely affect the damping efficiency.
