HQ CAA/1901/173/81B

**INVESTIGATION REPORT**  
**ON**  
**AIRCRAFT ACCIDENT TO PIAC**  
**F-27 REG. MKS AP-ALN**  
**AT**  
**D.I. KHAN ON 5TH JULY 1994**

**AIRCRAFT ACCIDENT INVESTIGATION REPORT ON THE FORCE**  
**LANDING ACCIDENT INVOLVING PAKISTAN INTERNATIONAL AIRLINES**  
**AIRCRAFT F-27 REG- MK. AP-ALN ON 5TH JULY, 1994 NEAR**  
**DERA.ISMAIL.KHAN AIRPORT**

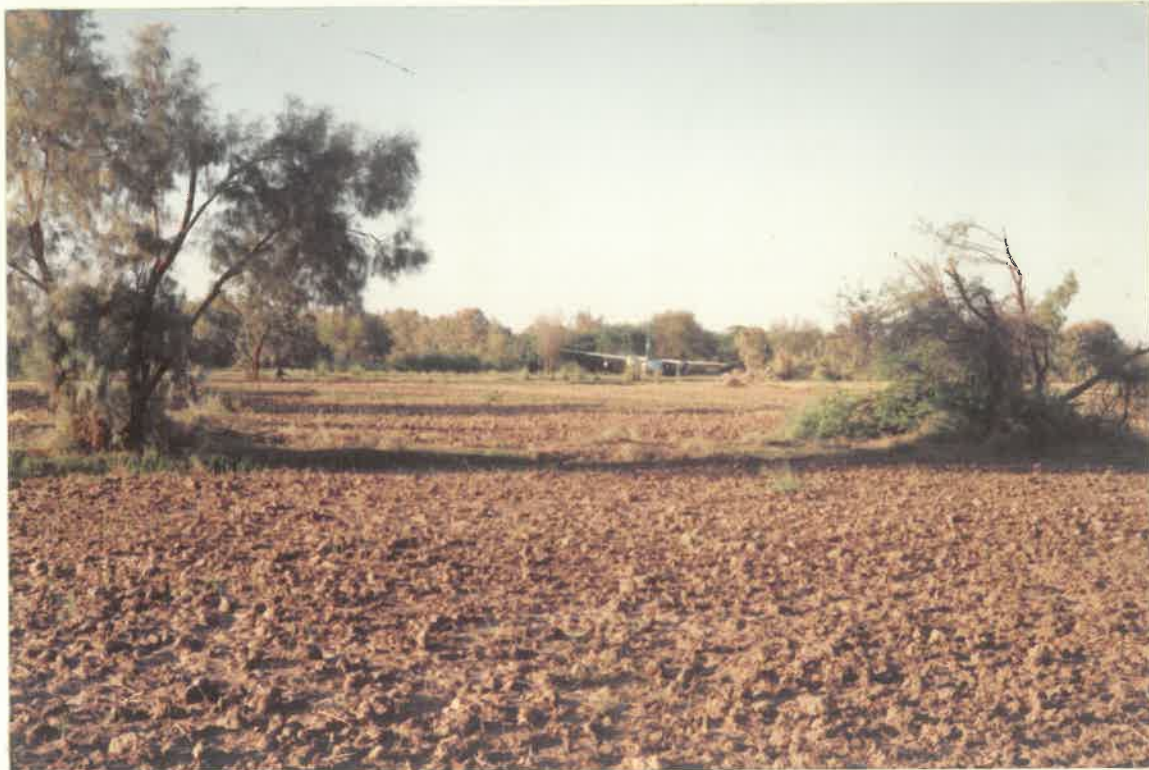
D-1

- 17.3. The aircraft had touched down in almost wings level attitude, on a muddy field. Just prior to touch down the port wing tip of the aircraft passed through the tops of 20 feet high tree breaking off the branches, and the bottom of the fuselage at the same place hit another tree at about 12 feet height from ground. The examination of the breaks on these trees indicated that the aircraft approached touch down at a shallow angle estimated to be 4 to 5 degrees. (See Appendices "DI" and "L"). This indicated that the aircraft was not in a stalled condition just prior to impact and was under control till touch down.

AIRCRAFT HIT TWO TREES BEFORE CRASH LANDING

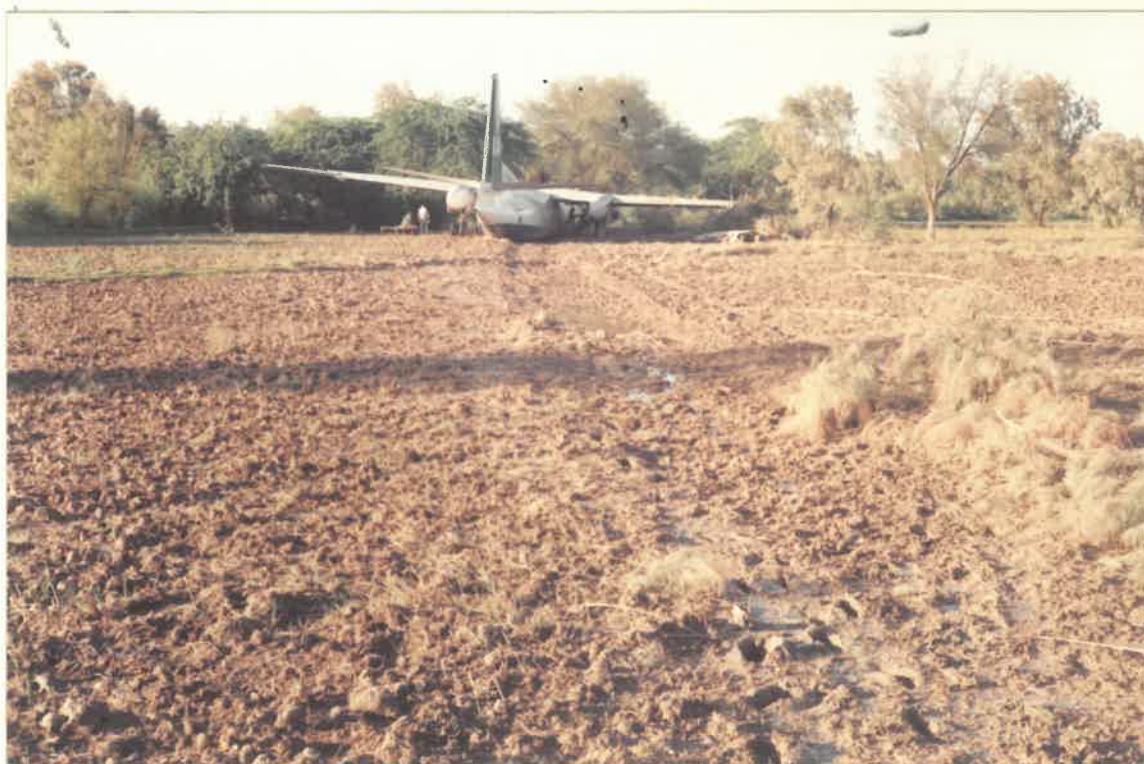
D-2

AIRCRAFT CAME TO FINAL RESTING PLACE

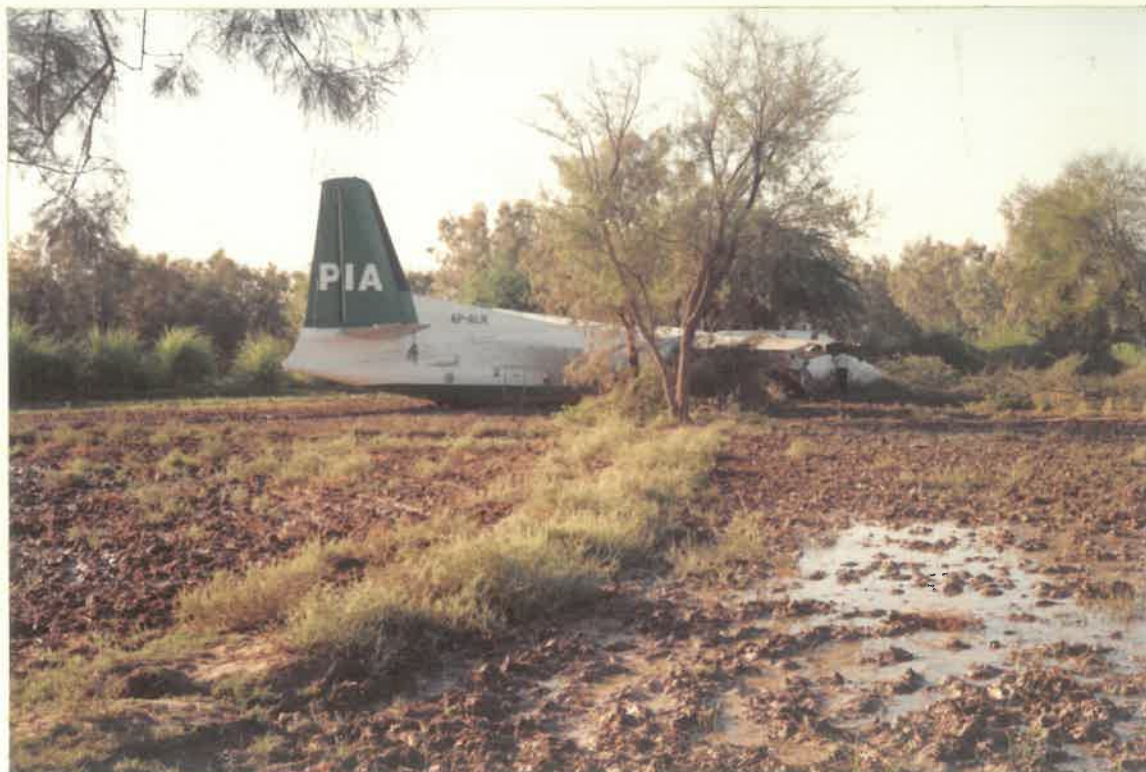
APP. D-3

SIDE VIEW OF AIRCRAFT AT FINAL STOP

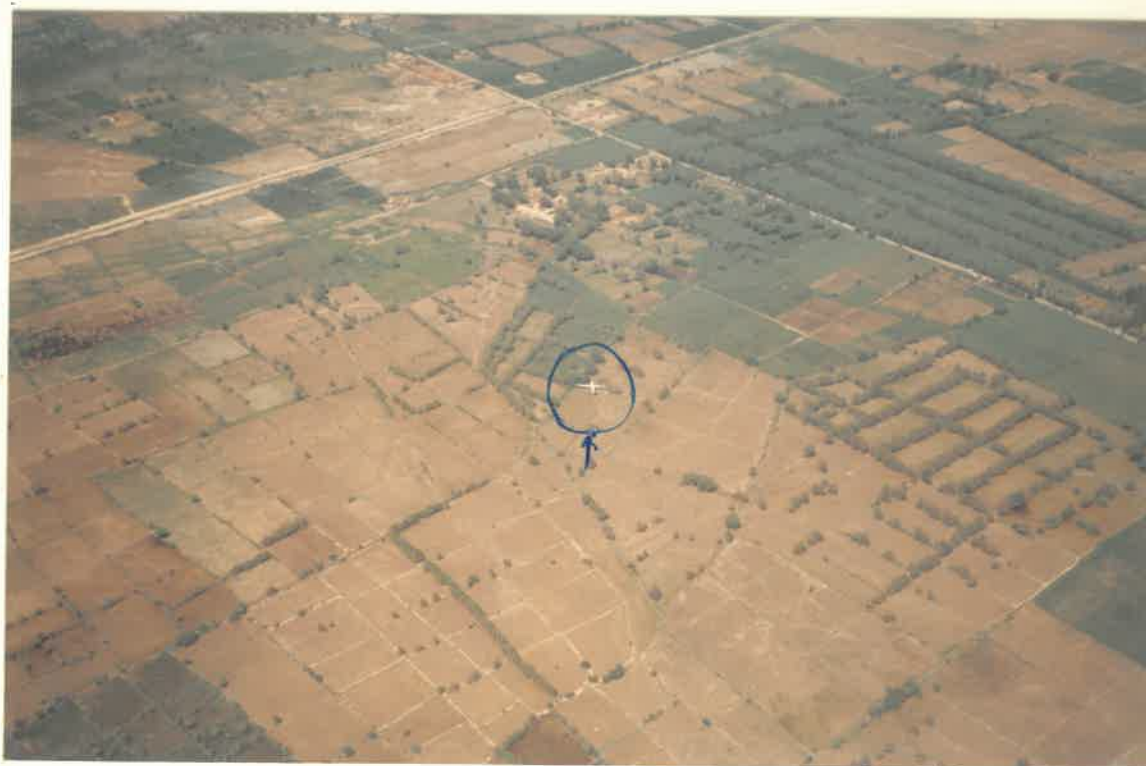
APP. D-4

AERIAL VIEW OF AIRCRAFT CRASH LANDING SITE

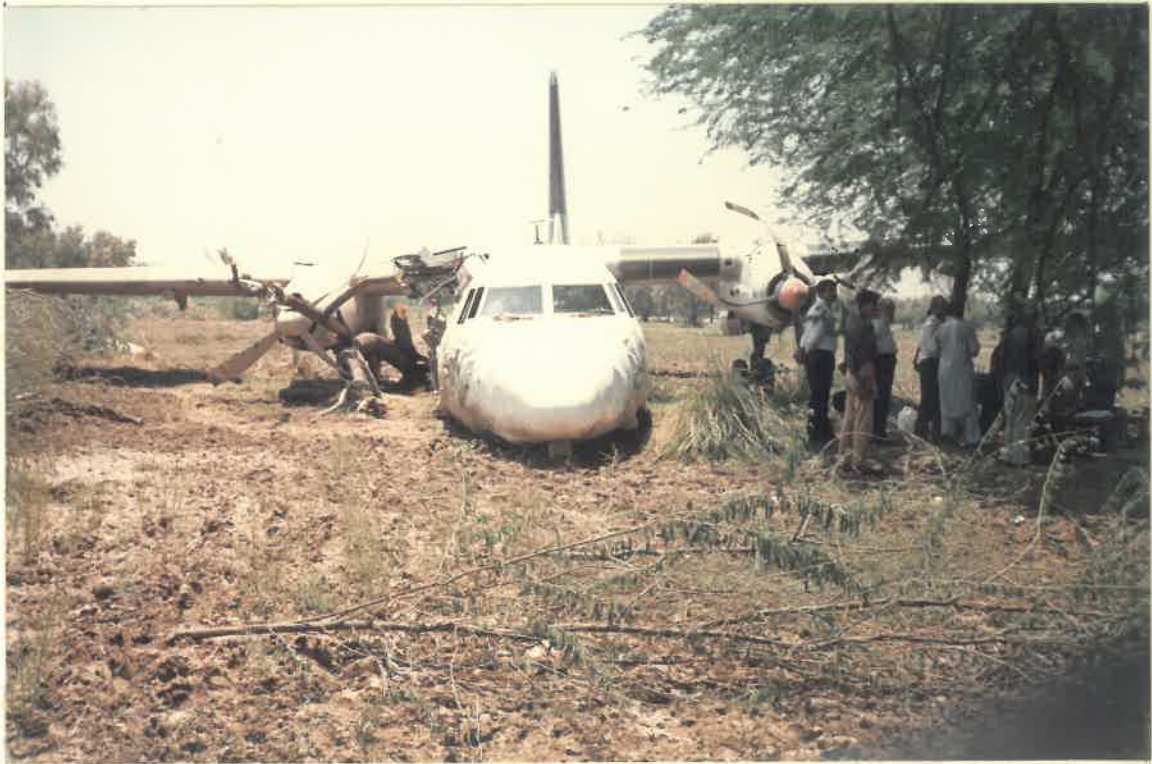
D-5

FRONT VIEW OF AIRCRAFT AT FINAL STOP

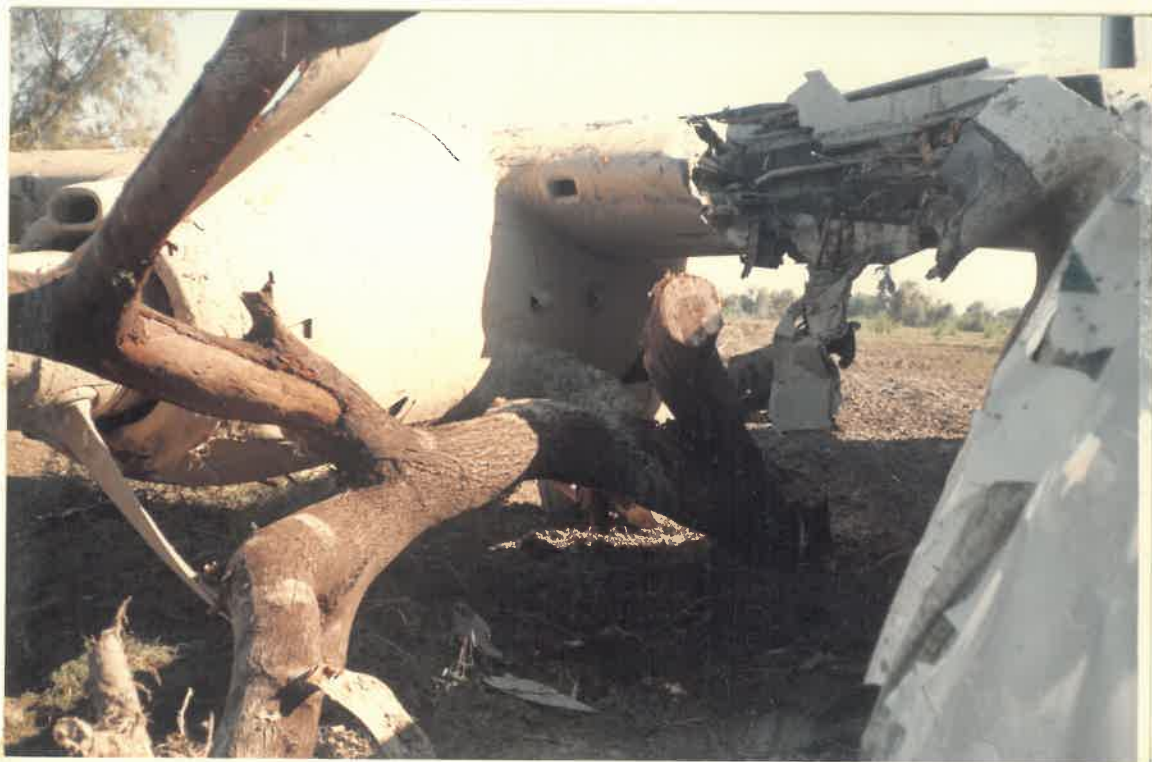
D-6

STARBOARD WING ROOT L.E. DAMAGED BY TREE

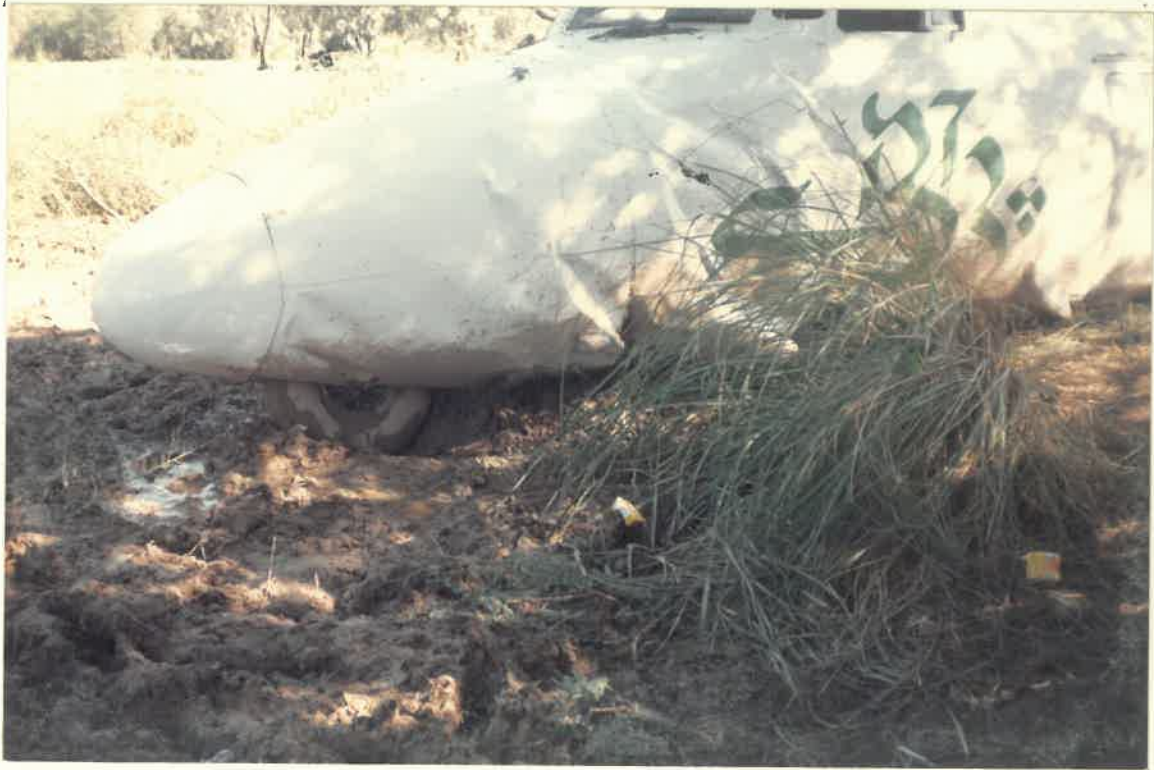
D-7

- 18.2. At the final resting position of the aircraft both Main Landing Gear doors were found in fully open position and both main landing gears were resting on the ground giving an indication as if they had come out of their nacelles. The nose gear was also not in fully retracted position and half of the nose wheel was out of its wheel bay. The main landing gear UP LOCKS were examined to see if they had been forced open due to impact forces. They did not reveal any indication of forced opening of UP LOCKS. The examination of both main landing gear doors revealed that they had passed through branches of trees while they were still in the open position. Some of the freshly cut branches were stuck with the forward edge of the left landing gear door and inside of right landing gear door. The position of nose wheel also indicated that it was not in a fully retracted position. Had it been in retracted position the impact forces would have jammed the nose landing gear in UP position. It therefore, appears that the landing gears had not locked in UP position at the time of initial impact with the ground. (see Appendix "D7" to "D10").

NOSE WHEEL NOT FULLY RETRACTED

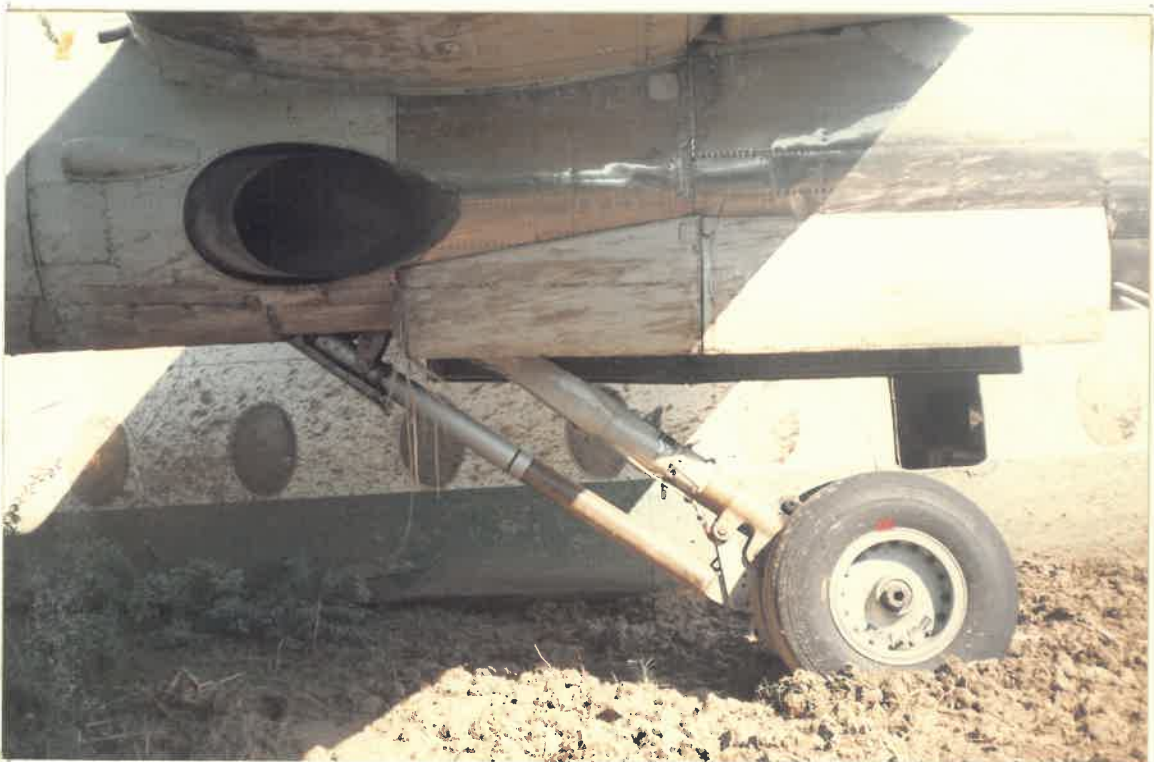
APP. D-8

TREE BRANCHES STUCK IN LEFT MAIN GEAR DOOR

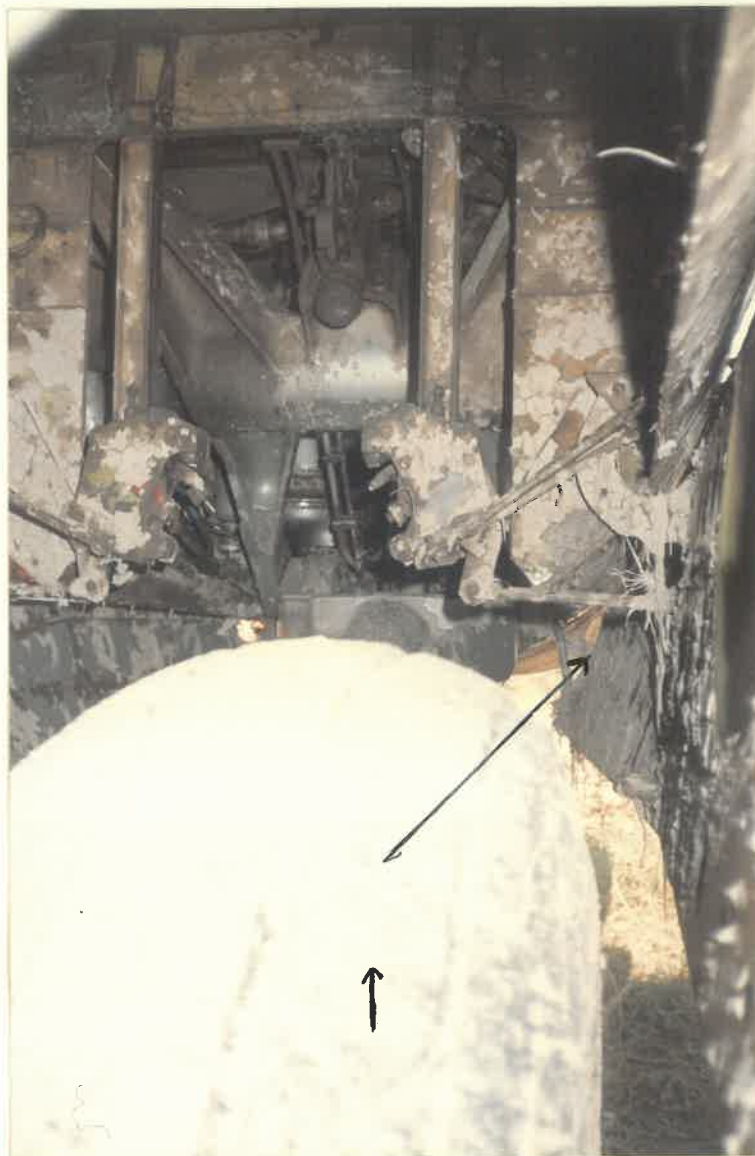
APP. D-9

RIGHT MAIN GEAR UP LOCKS IN OPEN POSITION  
AND TREE BRANCHES STUCK INSIDE THE DOOR

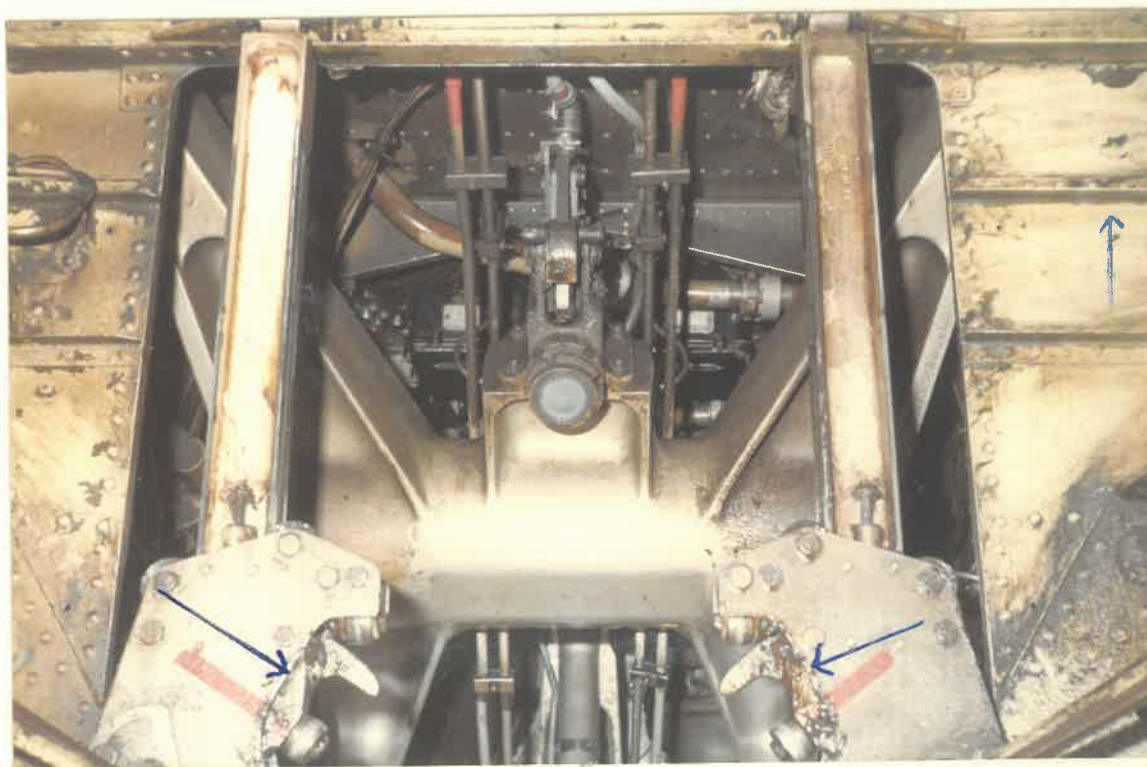
APP.  
D-10

LEFT MAIN GEAR UP LOCKS IN OPEN POSITION

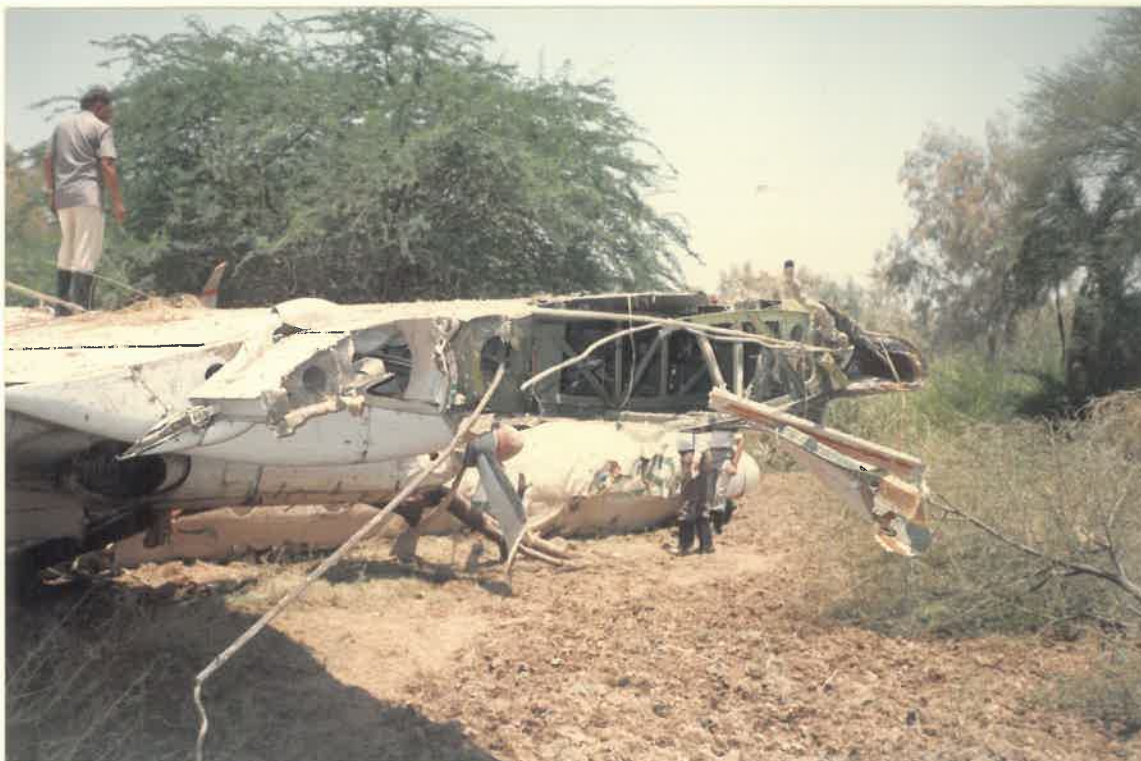
D-11

- 17.5. Shortly after the initial ground impact the starboard outer wing struck a tree which caused extensive damage to the starboard outer wing which eventually broke after hitting two trees and was thrown forward along the path of the aircraft and finally came to rest just short of a point where main aircraft wreckage came to a

RIGHT WING BROKEN FROM MID SECTION

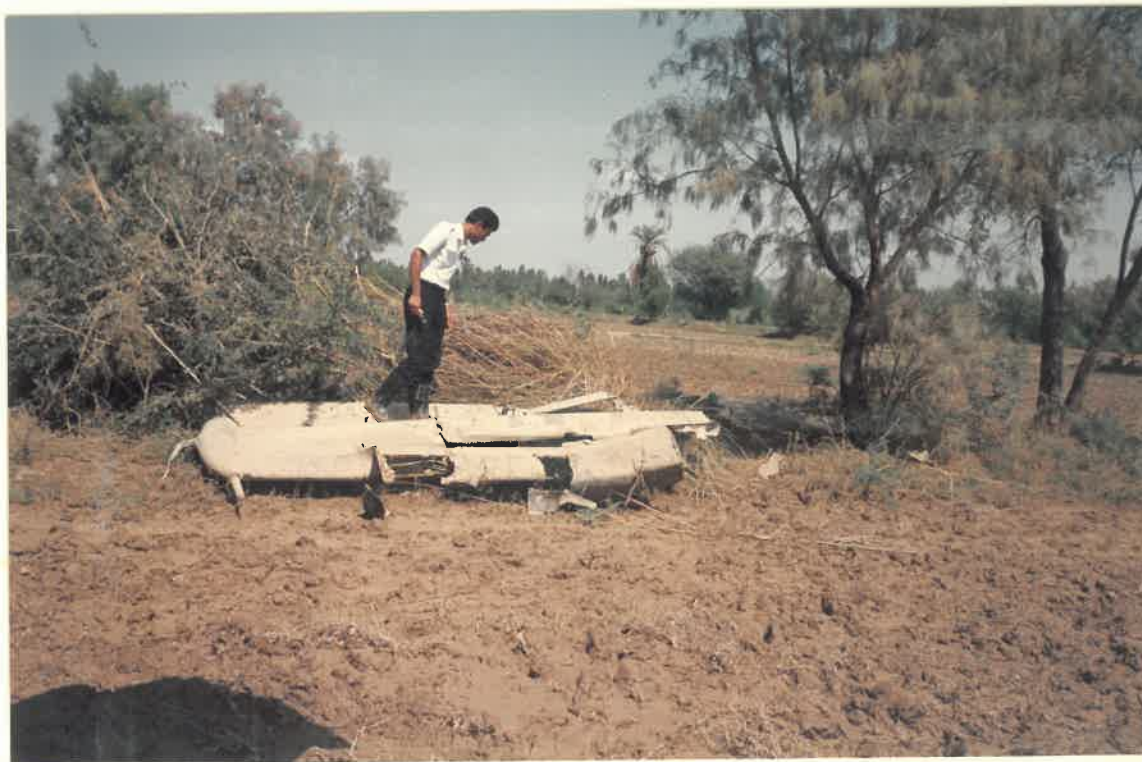
APP. D-12

RIGHT OUT BOARD WING PORTION

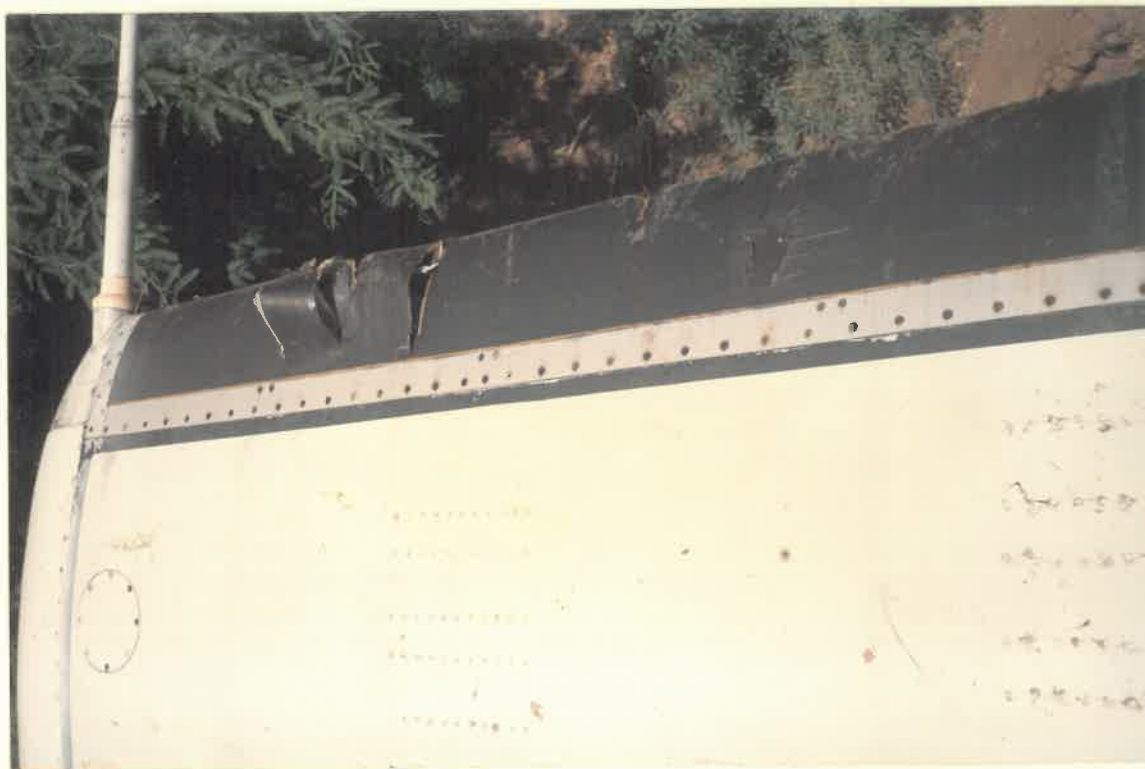
D-13

LEFT OUTER WING L.E. HIT TREES BEFORE CRASH LANDING

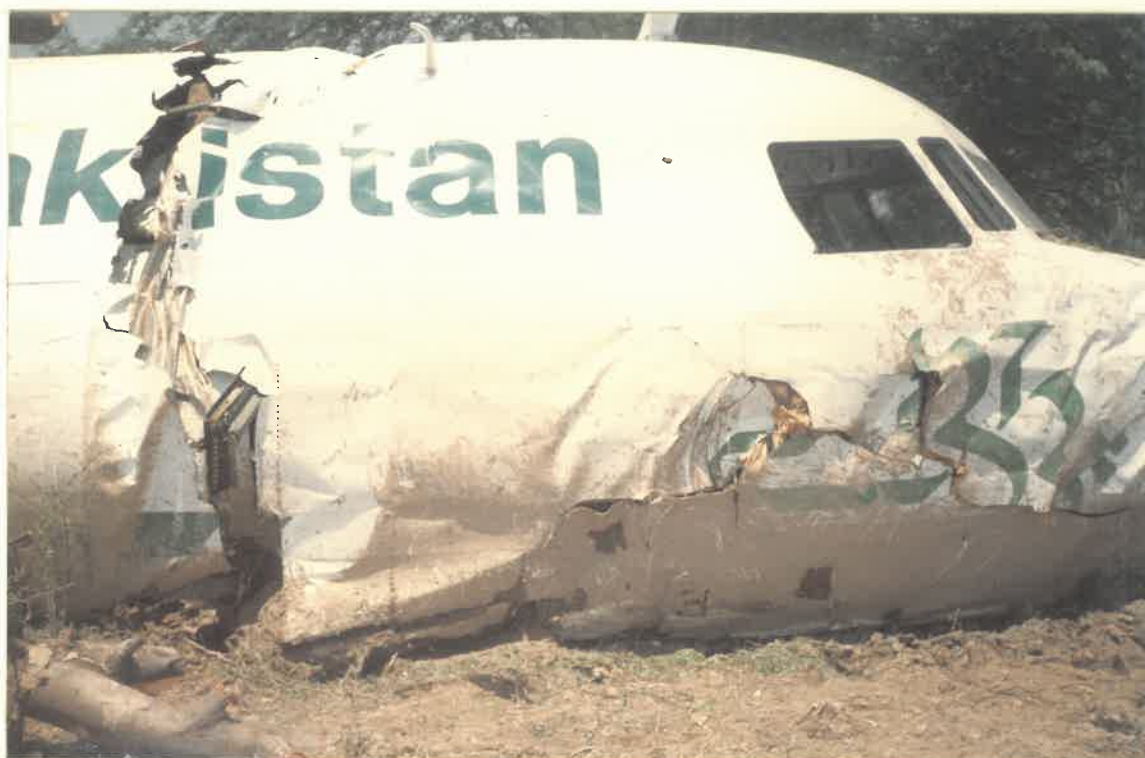
APP. D-14

- 18.3. The fuselage nose section had buckled and both the nose landing gear doors and operating linkages were damaged and detached from the structure. The cabin floor structure found in raised up position at crash beam attachments. The galley structure was

AIRCRAFT NOSE SECTION AREA DAMAGED

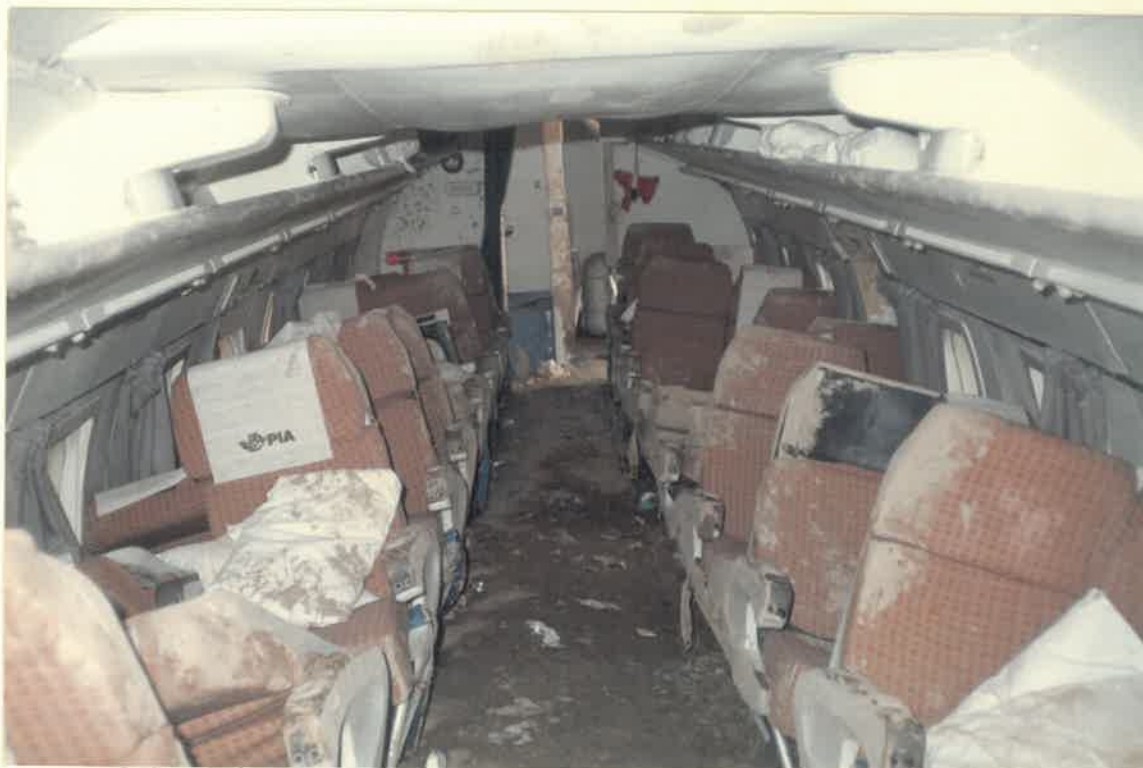
APP. D-15

PASSENGER CABIN AND SEATS DAMAGED

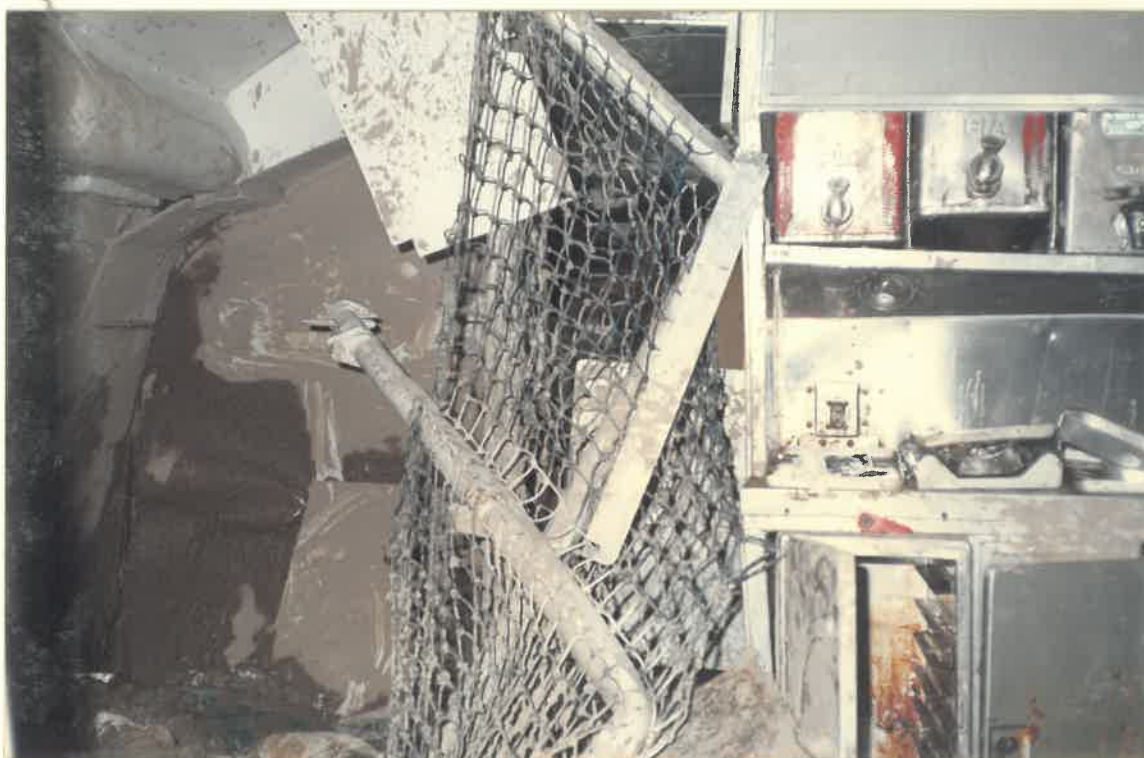
APP. D-16

AIRCRAFT GALLEY AND LUGGAGE AREA

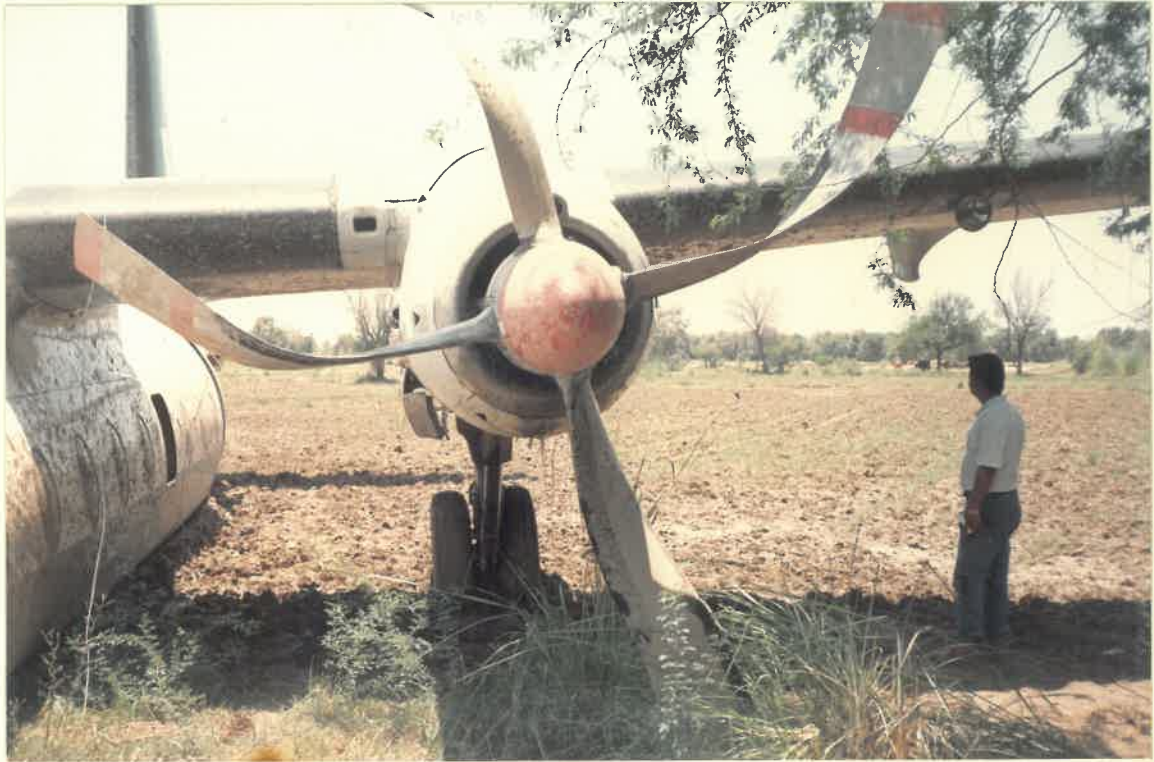
D-17

- 18.4. Both the engines were complete with propellers still attached to the engines. All blades of port propeller were found in forward bending position near the tips in a manner suggesting that propeller had some power at the time it contacted the ground. All blades had twisted and were found at different pitch angles. The starboard propeller had hit a big tree before the aircraft had come to a stop. This caused uneven bending and twisting of blades in different directions. Both the engines were removed from the crashed F.27 aircraft and were sent to PIA Engine Overhaul Shop for strip examination of engines, Propeller Control Units, Pitch Locks and Fuel Control Units. The detailed reports are placed at Appendix "O".

PORT ENGINE PROPELLER TIPS SHOWING FORWARD BENDING

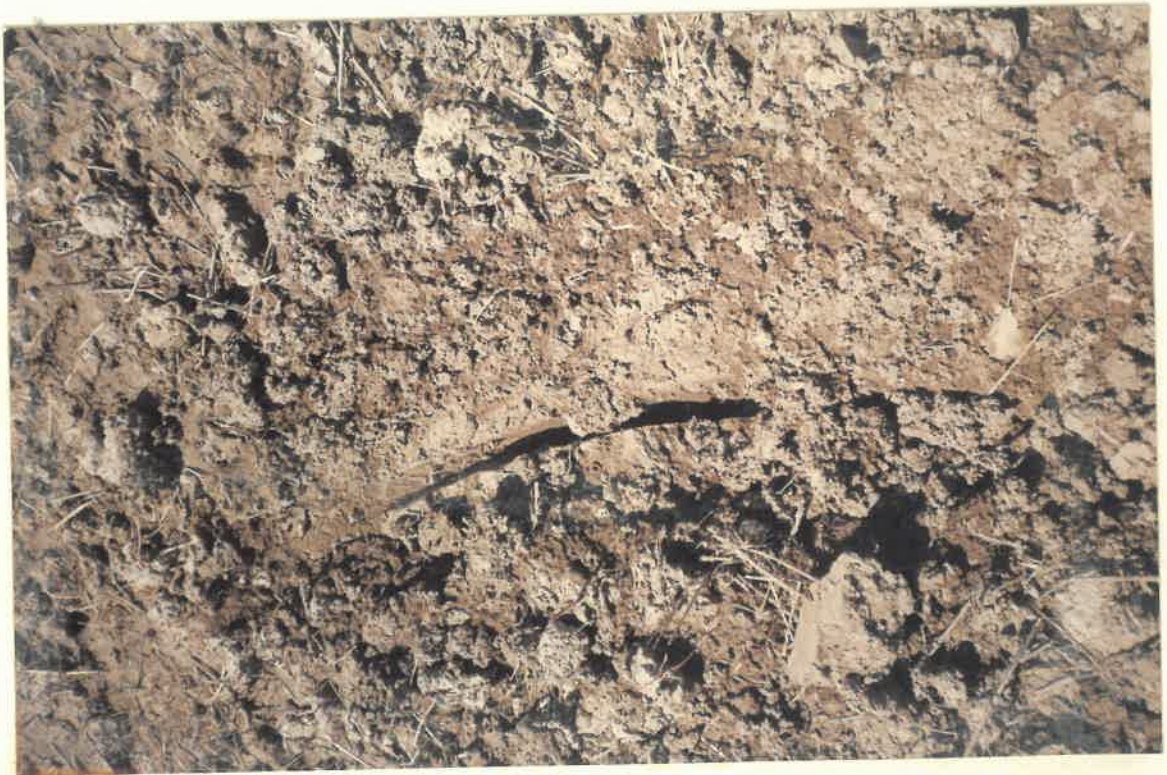
APP. D-18

- 18.8. The port propeller blade made contact with ground immediately after initial impact of the aircraft. The distance between the first and second slash mark was 3 feet 5 inches. the aircraft had impacted the ground at an estimated ground speed of at least 100-110 knots. This estimation is based on the fact that the aircraft had not impacted the ground in a stalled condition. The stalling speed of F.27 aircraft with 0 degree flap and 39000 lbs weight is 91 knots and Threshold speed with 0 degree flap for same weight configuration is 120 kts. The aircraft was skidding on its belly in a muddy field and travelled 500 feet. The aircraft had hit a big tree at fairly high speed before it came to a final stop. The Captain stated that he closed No.2 Engine when aircraft hit the two trees just before initial ground impact. At this moment the aircraft was in the process of go around and speed should be around 120 Kts minimum. The aircraft impacted the ground in less than one second after No.2 Engine throttle was closed. Therefore, the speed at initial impact is estimated to be around 110 Kts. As per calculations placed at Appendix "Q" the No.1 Engine RPM is 8784 at the time of impact. No.2 Engine propeller contacted the ground about one second after No.1 Engine propeller contacted the ground. Therefore, the speed of aircraft had also reduced to below 100 Kts or so. The slash marks of No.2 Engine propeller were not very

SLASH MARK MADE BY PORT PROP  
AT INITIAL IMPACT OF AIRCRAFT

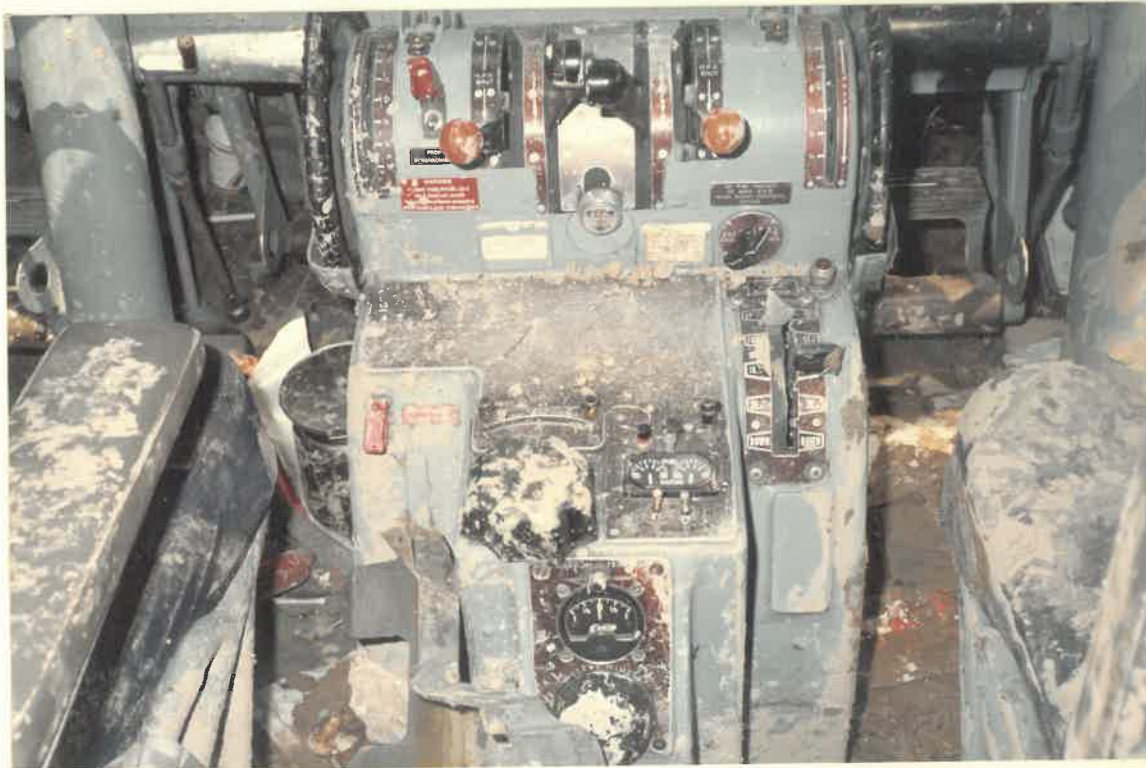
D-19

COCKPIT CONTROL LEVERS POSITION

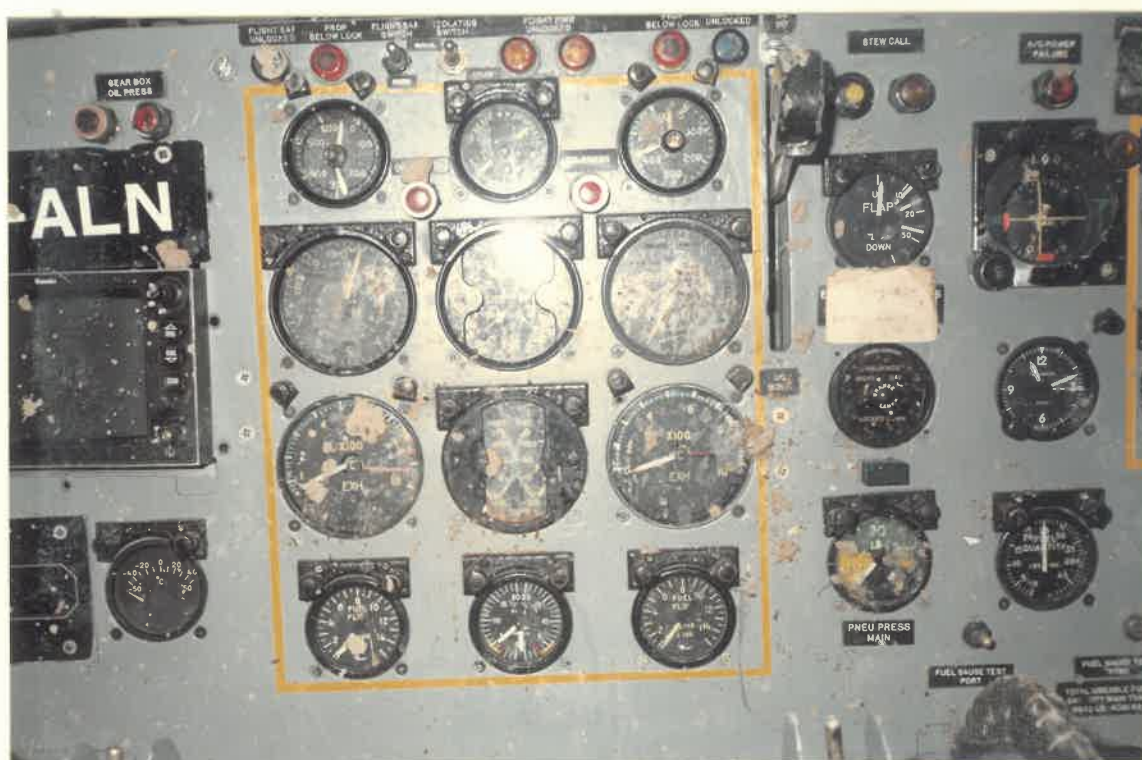
APP. D-26

FLAP INDICATOR SHOWING "UP"
