## ***AIRCRAFT SERIOUS INCIDENT 17/2006***

# ***FINAL REPORT ON THE INCIDENT INVOLVING PAKISTAN CAA BEECHCRAFT SUPER KING AIR 200, REGISTRATION AP-CAA ON LANDING AT SHARJAH INTERNATIONAL AIRPORT, UNITED ARAB EMIRATES ON 26<sup>th</sup> NOVEMBER, 2006***

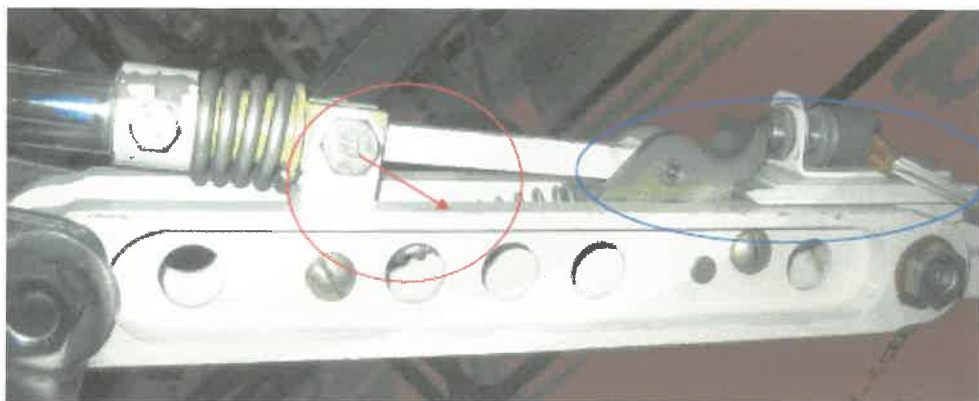
### 1.17.3 Example of an assembled LG drag brace in a down and locked position.

Link bolt arc (red circle/arrow), upper hook and down-lock plate (blue circle)

HBC has examined other landing gear components that were subjected to the forces of a landing gear collapse. Witness marks on those gears were similar and reveal the following occurred when the landing gear drag brace was not rigged to on-center to over-center:

- The extended actuator nut will separate
- The link (50) will be driven forward and the bolt attaching the actuator nut will contact the upper drag brace interior sides (24a)
- The link (47) will be wrapped around the bolt attaching the actuator nut
- One end of the guide (43) (the black end attached to the downlock hook) will be bent and separated from the downlock hook
- The lower drag brace (24) will fold, bending the downlock plate in a downward arc, if the downlock hook was engaging the downlock hook mouth. Note: If the downlock plate was not engaging the downlock hook mouth when the lower drag brace (24) folds, the downlock plate will not be bent.
- When the lower drag brace folds, it will swing around onto the lower side of the upper drag brace and contact/separate the lower arm of the downlock hook.

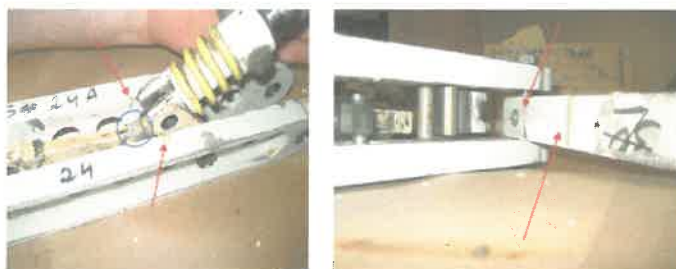
1.17.4 The following is a view of the actuator nut, link, guide, and link rod re-assembled. Note the witness marks pointed out and the separated lower arm of the downlock hook.

Marks on Brace from link bolt, link curl    Marks on lower brace from hook/hook bolt

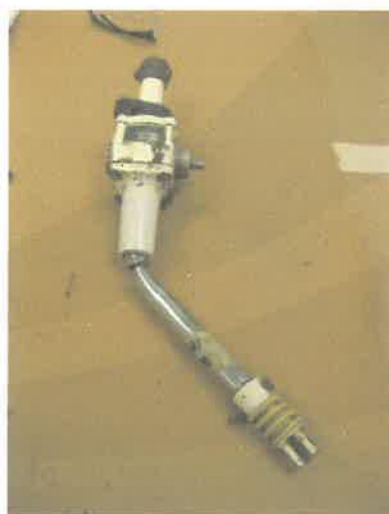
1.17.5 The following is a view of the actuator and the separated actuator nut spread-out:

The actuator nut separations were viewed under magnification by HBC. No evidence of fatigue on the fractured surfaces was found.

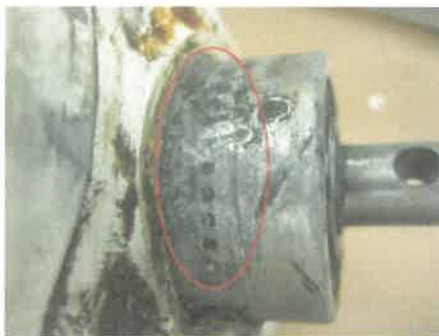
1.17.6 Close examination of the inboard actuator support revealed the following:

Ball bearing marks on actuator support surface.

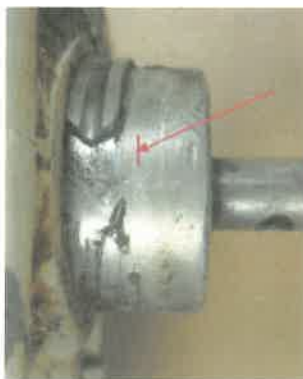
Marks showing inner bearing movement.

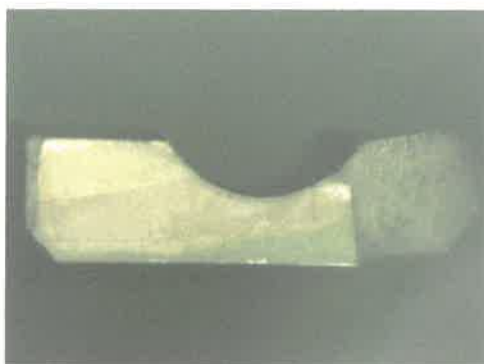
Inner race end A

1.17.7.1 The separated bearing race on the inboard actuator support was removed and viewed under magnification by HBC. Evidence of fatigue cracking was present on the two separated ends of the bearing race. The following photographs were taken of the bearing race ends:

The results of the component examination conducted by HBC suggested the landing gear collapsed when the landing gear actuator nut was about full extension. The loss of the inner race would cause the actuator to loose extension and retraction rigging alignment, and, as a consequence, the drag brace rigging would be lost. The loss of the bearing support (rigging alignment) had occurred an unknown time before the incident flight. The actuator inboard support surface gouging from bearing balls and the inner race movement suggested multiple landing gear extension and retractions had occurred since the loss of the bearing support. An out of rig actuator may not be capable of commanding the landing gear to a down-and-locked position and the drag brace to an on-center to over-center position.
