## **FINAL INVESTIGATION REPORT**

### **SERIOUS INCIDENT – SERENE AIR FLIGHT ER 522 BOEING 737-800, REG. NO. AP-BNB AT JINNAH INTERNATIONAL AIRPORT KARACHI ON 02-03-2022**

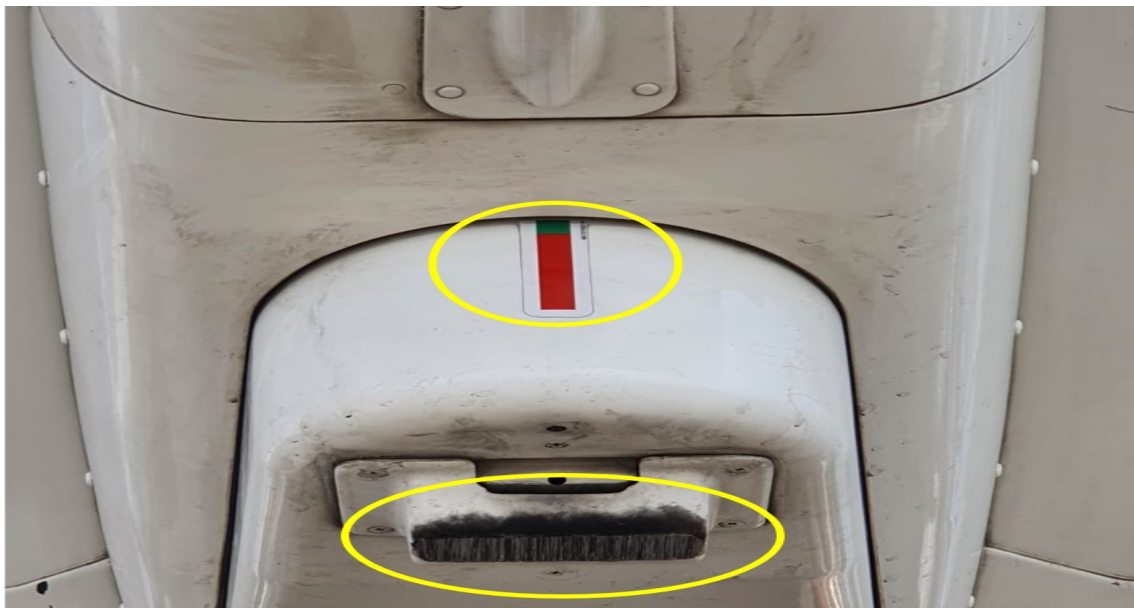
Figure 1 Tail Boot Scratch Marks

1.3.1. Tail cover scratched, with green cartridge visible. There was no other damage to the aircraft observed.

- 3.1.9. During post flight inspection, the tail skid cover was found to be scratched with the green cartridge fully visible.
- 3.1.10. DFDR analysis revealed a high pitch rate of 4.2°/s with corresponding maximum pitch angle of 9.5° at the point of lift off.

1.3.2. There was no maintenance carried out and aircraft was released for flying.

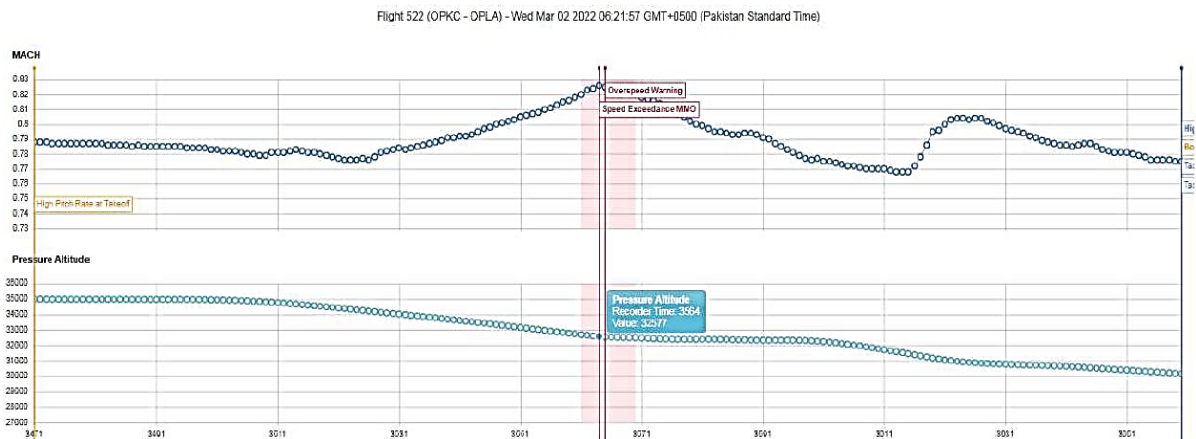
Figure 2 DFDR Data – Mach No. & Pressure Altitude

1.11.2. **Over Speed Event** – DFDR analysis also showed an over speed warning for the aircraft during descent from flight level (FL) 350. During descent, as the aircraft crossed FL330, the speed of the aircraft started to increase from M 0.82 till a maximum of M 0.826 after which it started to reduce. The Maximum Mach Operating (MMO) warning triggered as speed was reducing through M 0.825. This was an isolated incident during the flight following which no further exceedances were recorded.

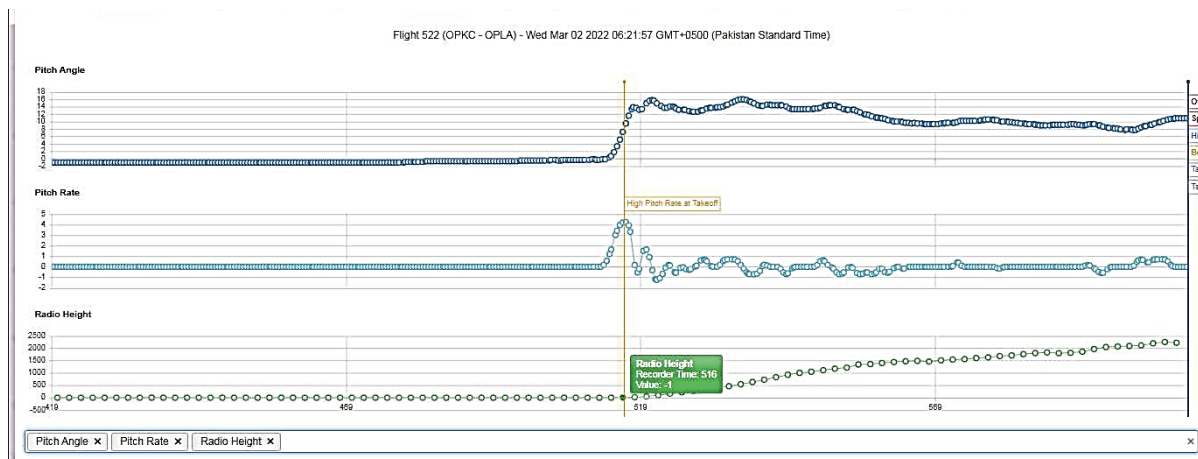
Figure 6 DFDR Data – Take-off Data: Pitch Angle, Pitch Rate & Radio Height

2.1.4. **Take-Off Rotation** – Analysis of DFDR data at the time of take-off indicates a high pitch angle as well as a high rate of pitch up upon take-off rotation.

2.1.5. As per the data recorded, the rate of pitch up increased constantly as the aircraft approached lift off speed. At the moment of lift off when Weight On Wheels (WOW) on MLG was removed, the rate of pitch peaks out at 4.2°/s which is higher than normal rate of 2-3°/s. Correspondingly, the pitch angle also increases constantly reaching a maximum of 9.5° at lift off point.

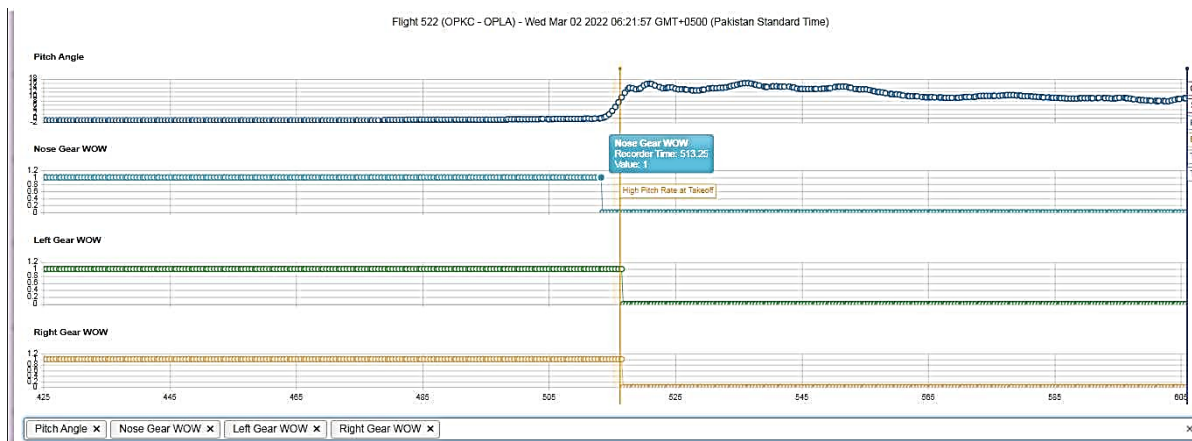
Figure 9 DFDR Data – Take-off Data: Pitch Angle, NLG WOW & MLGs WOW

2.1.10. **Abnormal Runway Contact (ARC)** – DFDR data analysis reveals that although the pitch attitude ( $9.5^{\circ}$ ) at the moment of lift off was higher than normal, but as per FCOM, still not so much as to result in a tail strike. The additional factor of slight downslope of the departure R/W is a contributory factor which served to increase the effective pitch angle. The effective pitch angle comes out to be  $9.59^{\circ} \sim 9.6^{\circ}$  ( $9.5^{\circ}$  aircraft pitch +  $0.09^{\circ}$  R/W slope); however, it is still lesser than the pitch angle specified for a tail strike. The decisive factor is the high rate of pitch while rotating the nose for take-off. The normal rate of rotation for take-off is  $2-3^{\circ}/s$  which ensures that the aircraft gets airborne while ensuring sufficient clearance of the tail from the R/W surface. However, the higher pitch rate of  $4.2^{\circ}/s$  resulted in reduced clearance from the ground at the time of lift off. While the pitch rate was not high enough to actually result in a tail strike, it was sufficiently high to cause the tail skid to just scrape the R/W surface at the time of lift off.

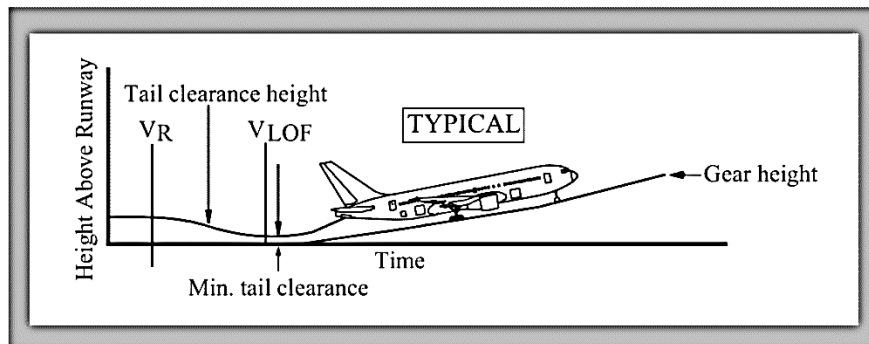
Figure 13 Boeing 737 FCOM

2.1.8. As per FCOM, the maximum pitch attitude for lift off is  $8.5^{\circ}$  which provides the minimum tail clearance of 13 inches (in) / 33 centimeter (cm) while the pitch attitude for a tail strike to occur during take-off is  $11^{\circ}$ . However, these limits apply when a pitch up rate of  $2-3^{\circ}/s$  is followed for take-off rotation. The FCOM also implies the possibility of a tail strike in case the rate of pitch is higher than normal.
