CIVIL AVIATION AUTHORITY

ACCIDENT TO EDHI AIR AMBULANCE

PIPER SENECA II REGISTRATION # AP-BFM

ON 20<sup>th</sup> SEPTEMBER 2002

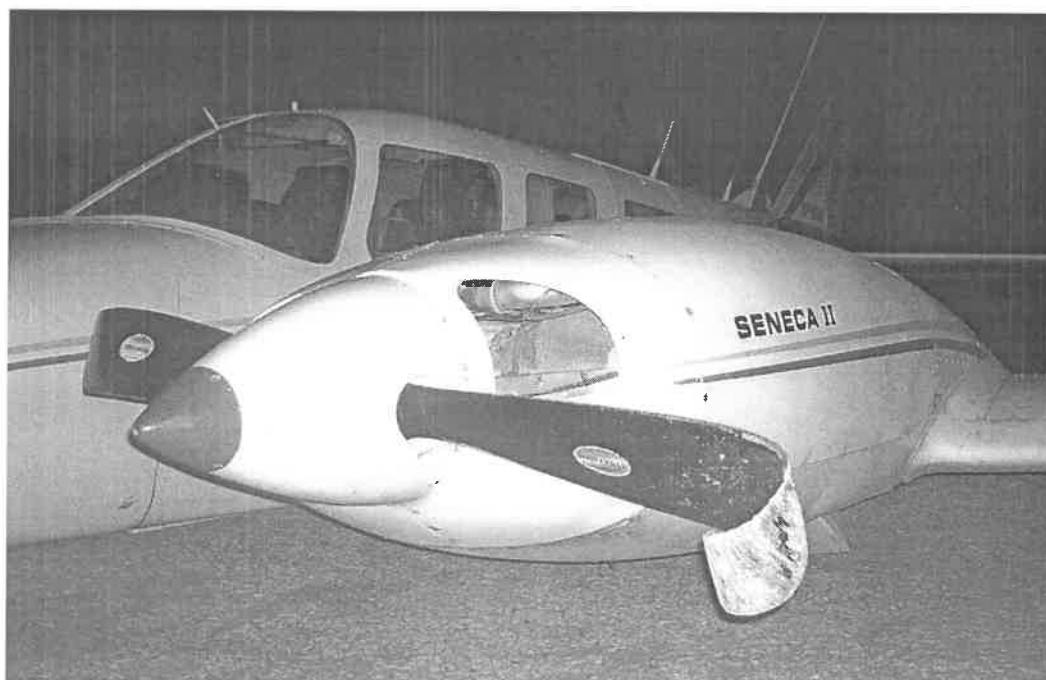
Appendix 'M1'

- 3.3 Damage to Aircraft Both propellers impacted the ground with engines running and were bent (Appendix'M1'). The under fuselage reinforcement channels, wing attachment bolt heads, antennae and cowlings were damaged as a result of impact with runway surface.

Damage to Propeller

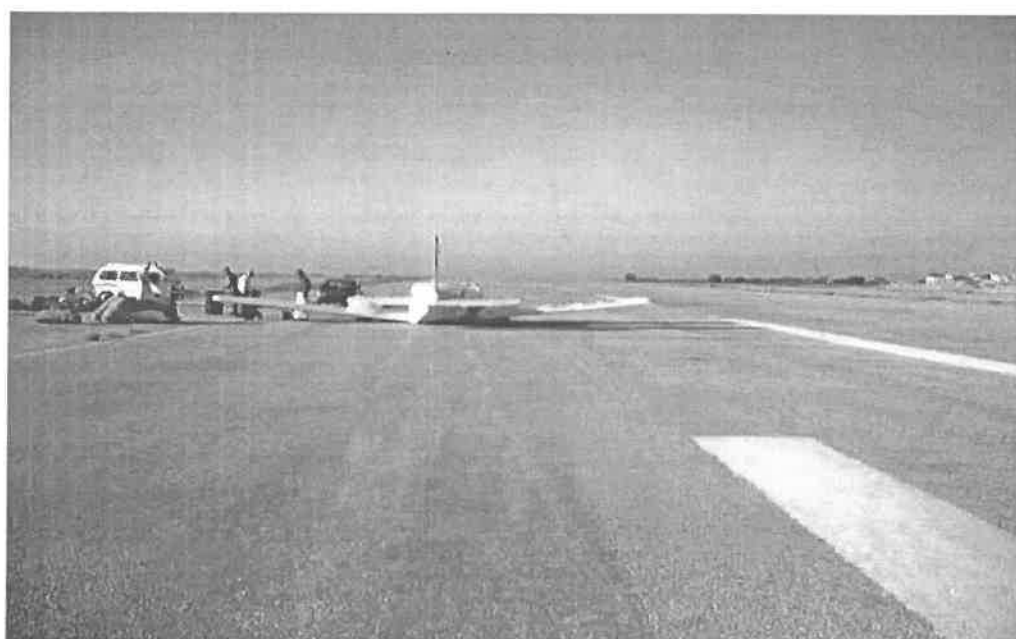
Appendix 'M2'

- 3.15.1 The aircraft came to a stop 1691 feet from threshold of Runway 20 and about 27 feet to the left of centerline (Appendix'M2'). The first impact mark was at a distance of 664 feet from threshold of Runway 20 and 13 feet to the right of center line. Initially it was a single line and then became a wide scrape mark of approximately the same width as that of the aircraft fuselage. The impact marks were continuous from the point of initial impact to the point where the aircraft came to stop. The left propeller came in contact with the runway after 16 feet of the first impact and the right propeller after 61 feet. At the point of first contact of propeller the main impact mark was a single line. Distance between first two blade cut-marks for the left propeller was 2 ft. 9 in. and for the right propeller 2 ft. 2 in. Except for about 10 feet rubber scrapes mark, all impact marks were made by metal to concrete contact. The impact marks on the aircraft were mostly restricted to fuselage under surface and propellers. The left tyre and wheel hub showed slight scraping marks on the left side. There were no marks on any of the main landing gear doors.

Aircraft Final Position

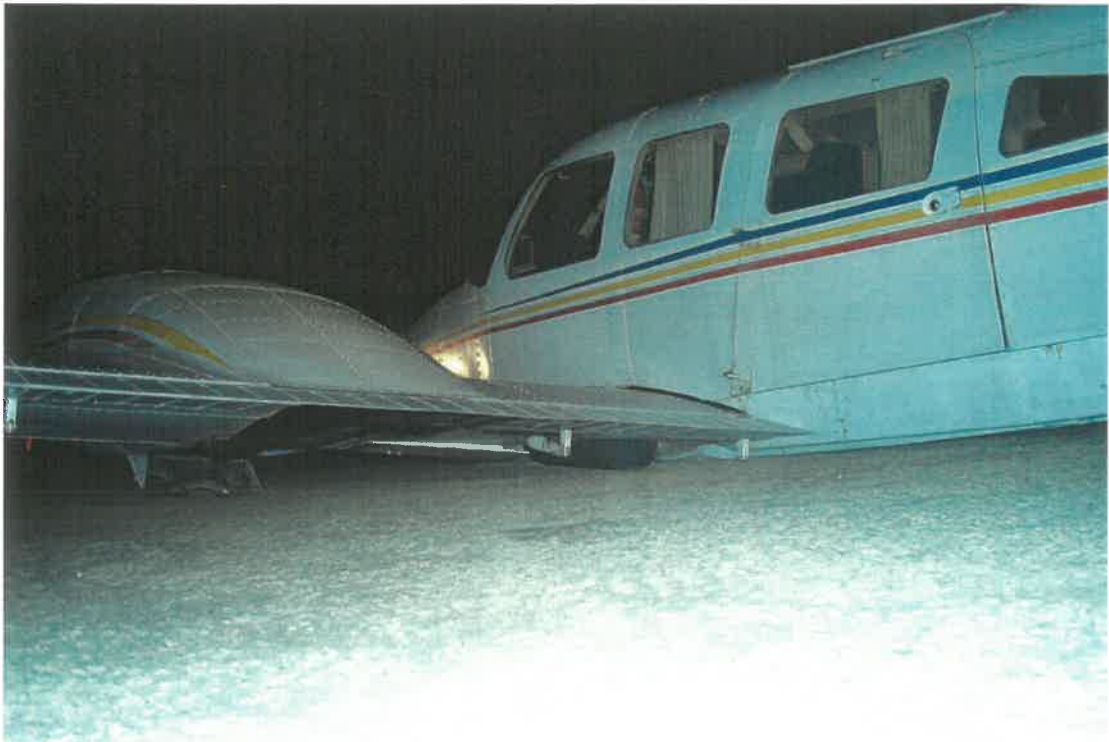
Appendix 'M3"

- 3.15.2 The main gears were found in retracted position and the flaps were up (Appendix'M3'). The footstep on the right wing trailing edge was bent under load and the fuselage was resting flat on its undersurface (Appendix'M4').

Gear and Flap Position

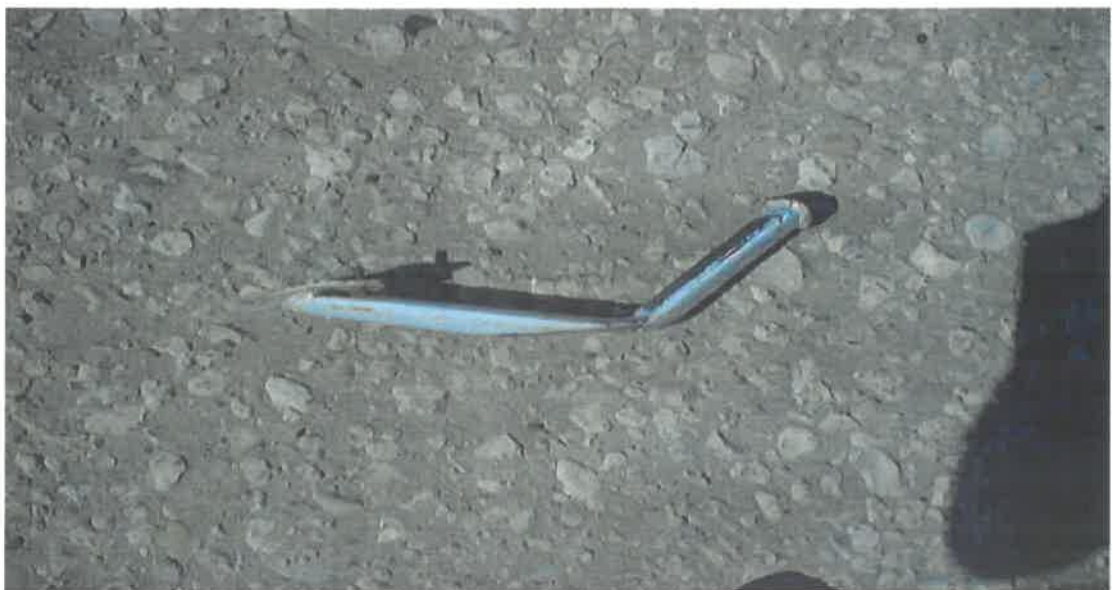
Appendix'M4'

Foot Rest

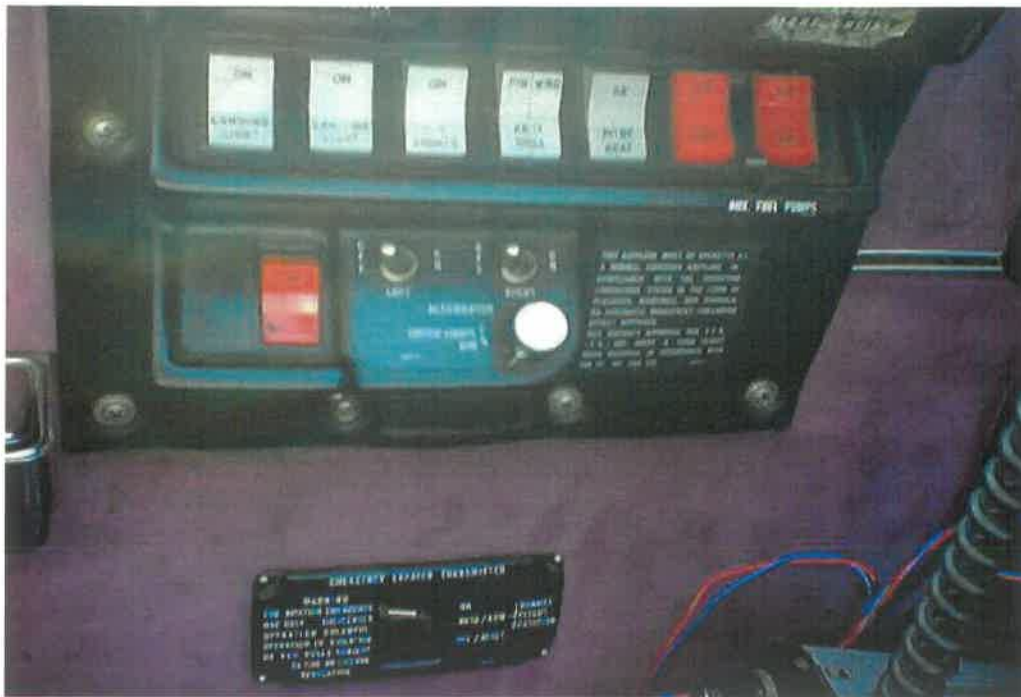
## Appendix'M5'

3.15.3 All electrical switches in the cockpit were found in OFF position (Appendix'M5') and all circuit breakers were IN (Appendix'M6). The landing gear lever was found in DOWN position (Appendix'M7'). Throttle, propeller and mixture control levers were fully back (Appendix'M8'). The flap lever was in retracted position (Appendix'M9').

Electrical Switches

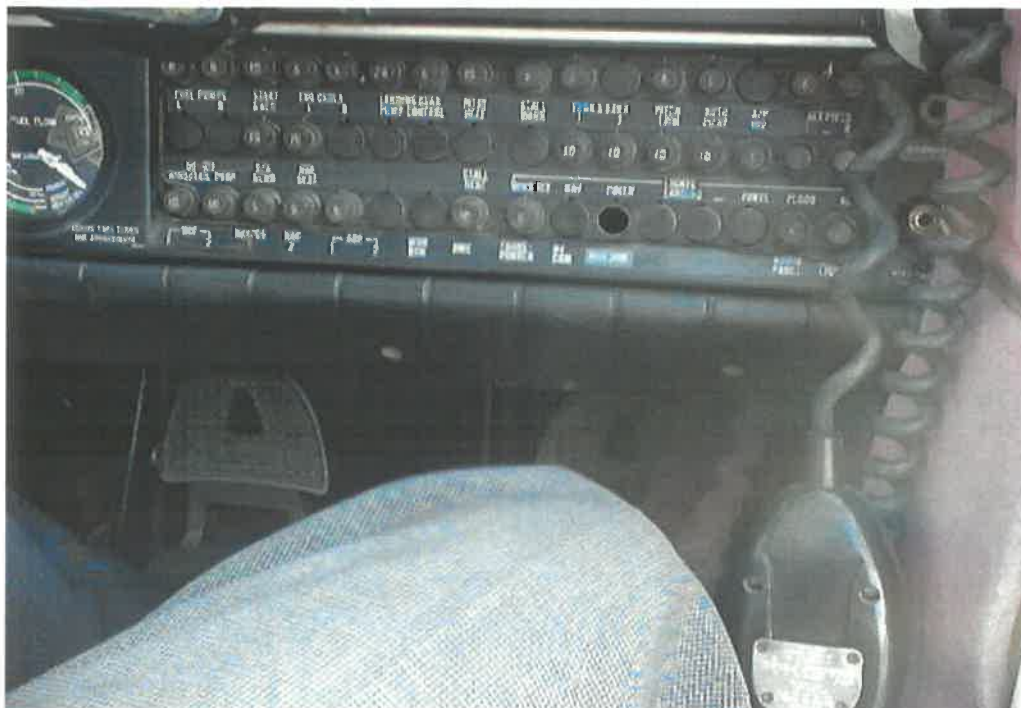
## Appendix 'M6'

Circuit Breakers

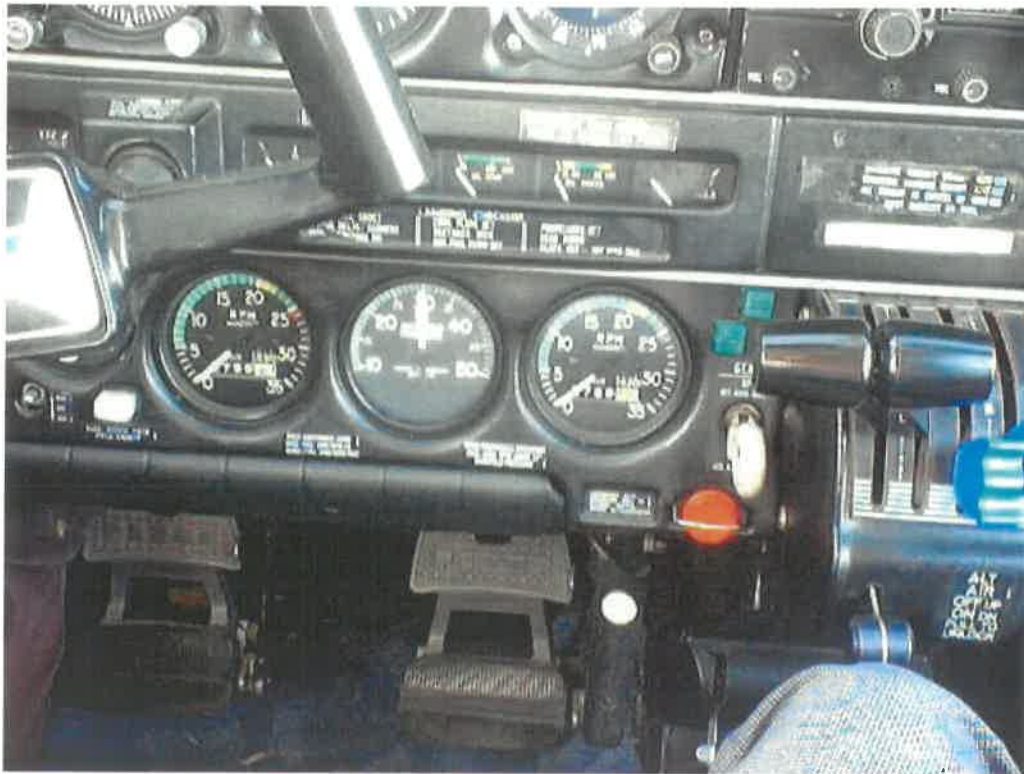
Appendix 'M7'

Landing gear Switch

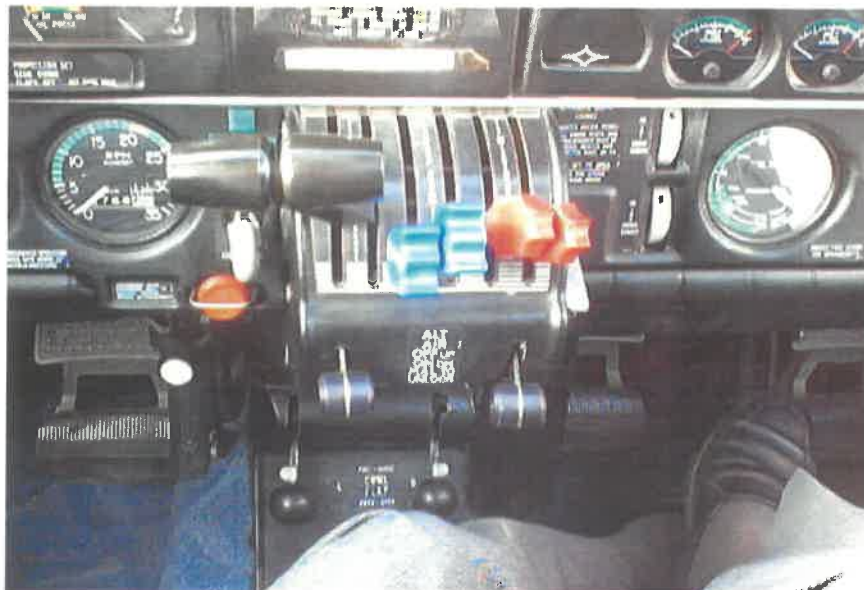
Appendix 'M8'

Engine Controls

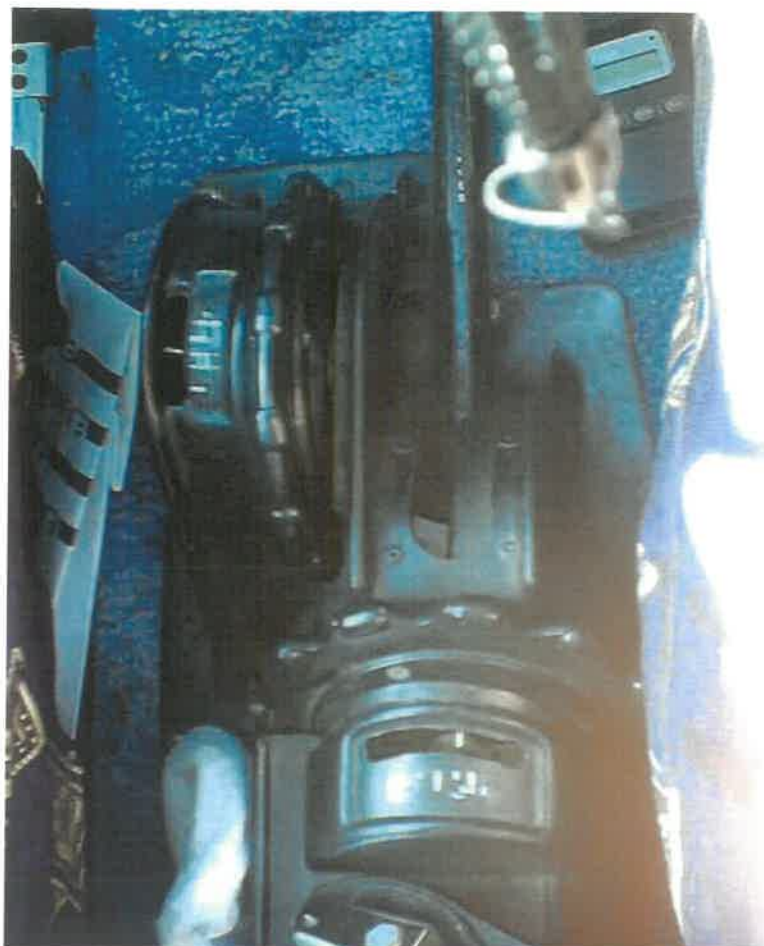
Appendix'M9'

Flap Lever

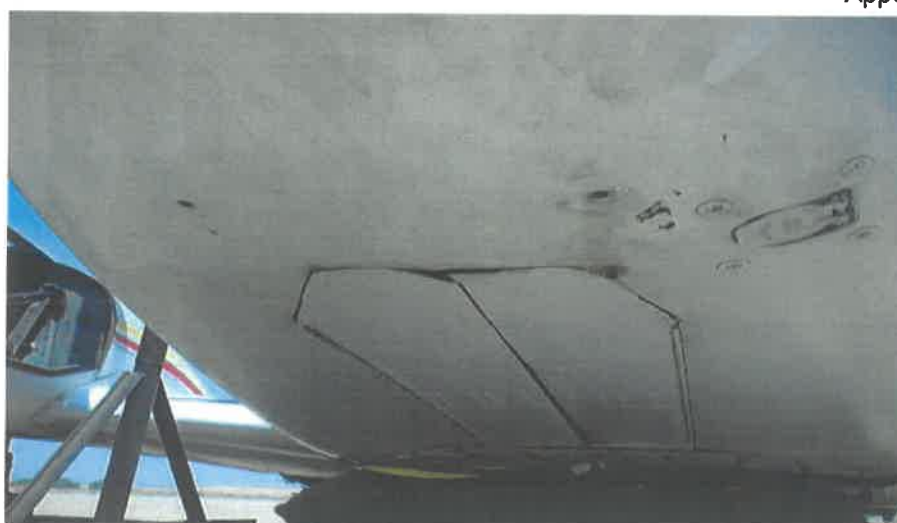
Appendix'M10'

Nose Gear Doors
