# FINAL INVESTIGATION REPORT

SERIOUS INCIDENT OF M/S PIAC FLIGHT NO. PK451  
(SECTOR ISB – SKD) A-320 AIRCRAFT REG NO. AP-BLA  
AT BBIAP, ISLAMABAD ON 08<sup>TH</sup> AUGUST, 2016

## FINAL REPORT

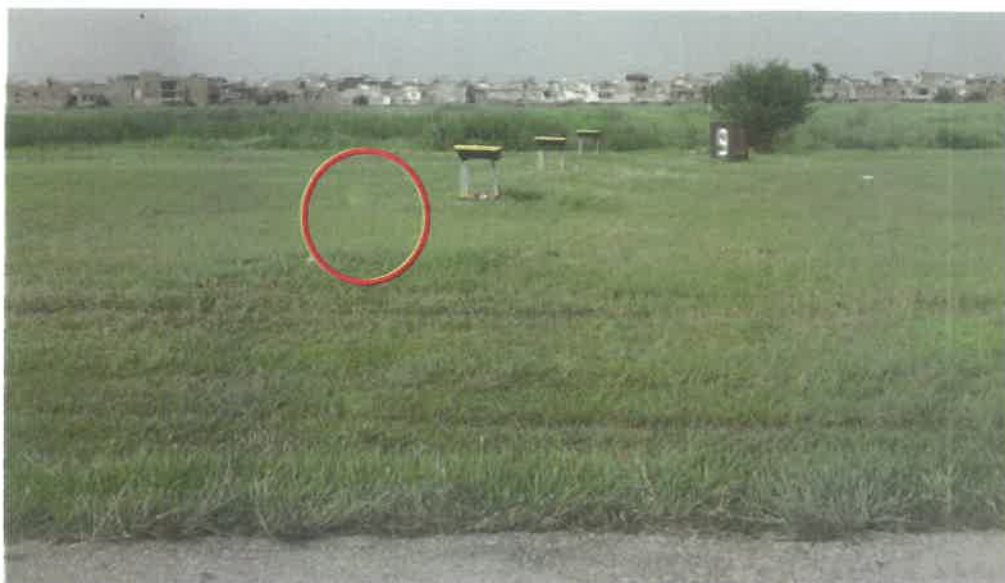
- 1.2 **Injuries to Persons.** There were no injuries to any person during the incident.
- 1.3 **Damage to Aircraft.** No. 2 engine received substantial damage due to hitting / ingestion of PAPI light. There was no other damage to the aircraft.

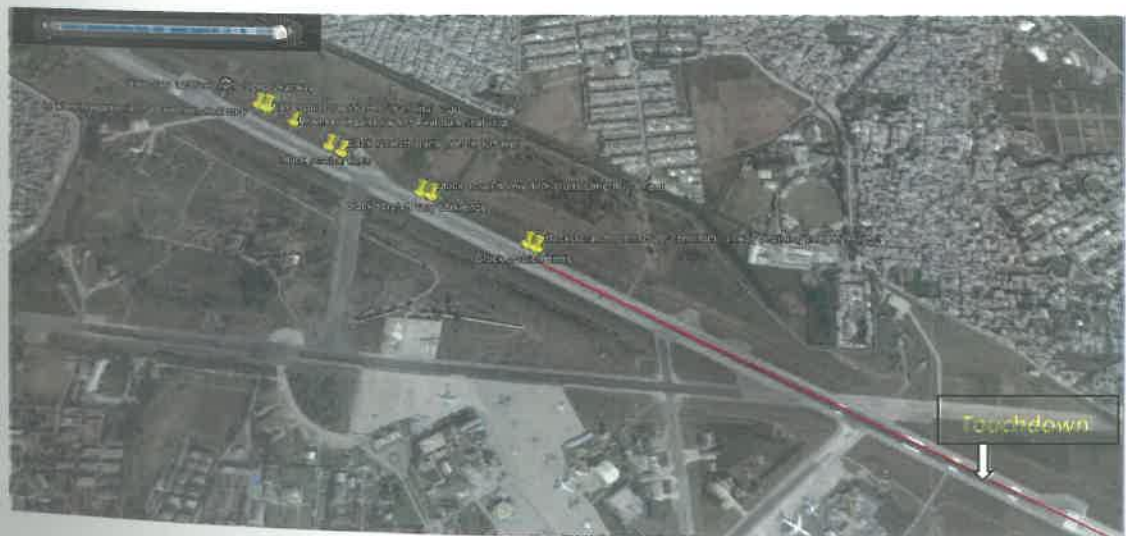
Pictorial view of landing roll

- 2.1.14 While landing on runway 30 at BBIAP, the touchdown was made at 146 kts Ground Speed (GS). After touchdown, and down to 93 kts GS, maximum thrust reversers were used without pedal braking. When the aircraft had slowed down below 93 kts and in the latter half of landing roll, pedal braking was done three times. Although both pedals were pressed simultaneously and equally but significant differential pressure got transmitted to wheels resulting in asymmetrical braking (refer technical investigation for details). This asymmetrical braking resulted in aircraft drifting towards right side, ultimately departing the runway at approximately 50 kts of ground speed, 8500 ft down the runway and hitting No. 2 engine with one of the PAPI lights. The pictorial view of entire landing roll and blow up of braking portion is appended below:

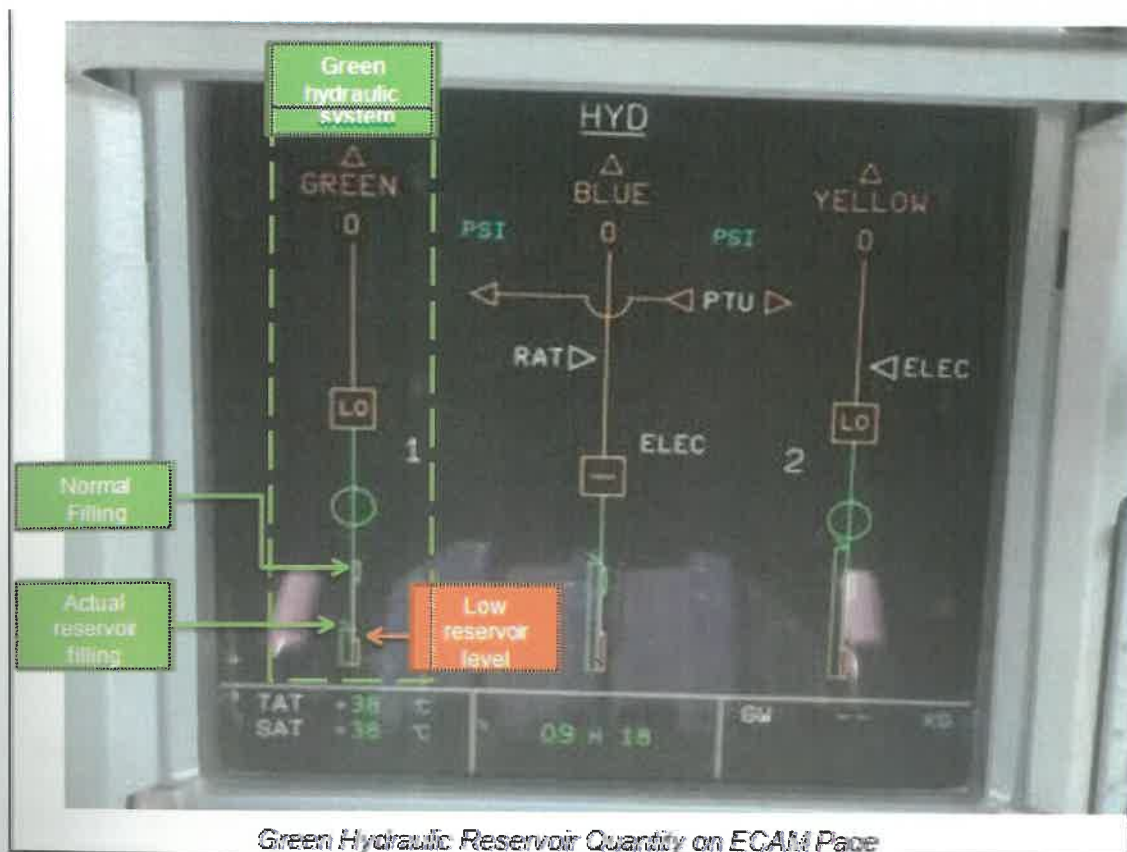
- 2.2.2 After the in-flight event, photo of the ECAM Hydraulic SD page also shows that the green reservoir quantity is green, therefore above the low level warning level (otherwise the indication would have been amber). However, there was clearly a low green hydraulic reservoir quantity, just above the warning level, as illustrated on the picture below:
