## **FINAL INVESTIGATION REPORT**

### **SERIOUS INCIDENT LANDING ON WRONG RUNWAY**

**SAUDI AIRLINES FLIGHT SVA-724 BOEING 777-368 (ER)  
REG NO HZ-AK21 AT IIAP, ISLAMABAD ON 14-10-2024**

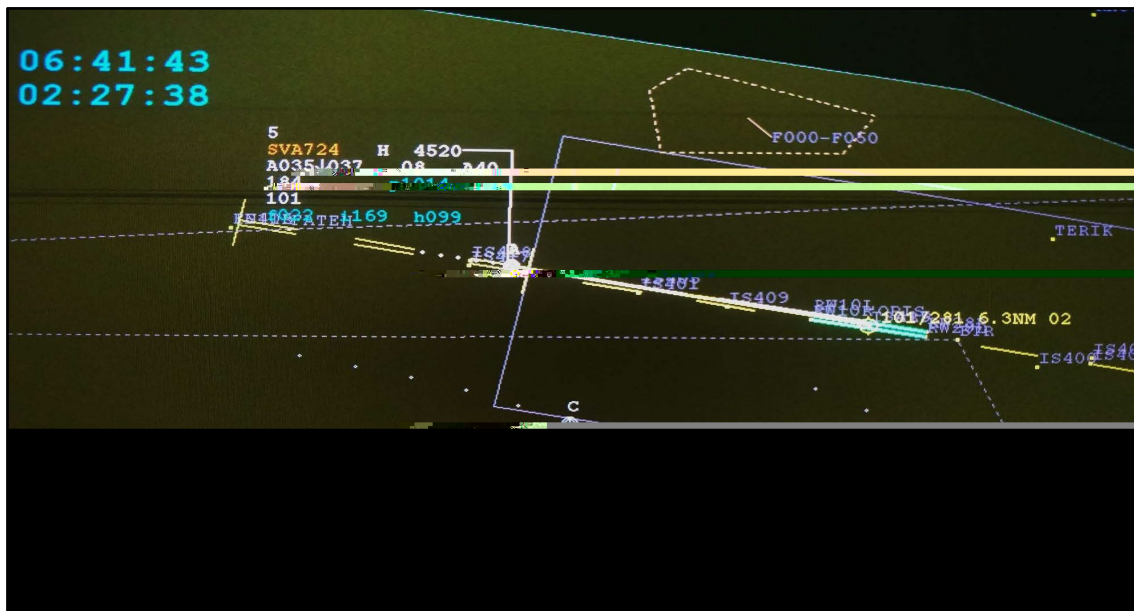
*Clear to land RW 10R*  
but the read back by **SVA-724** only  
**stated RW 10 without mentioning Left (L) or Right (R).**
