# **FINAL INVESTIGATION REPORT**

**SERIOUS INCIDENT OF PIAC FLIGHT PK-390 (KARACHI TO SUKKUR)  
ATR72-500 REG NO AP-BKY ENGINE SHUTDOWN ON LINE UP AT  
JIAP KARACHI ON 4 SEPTEMBER 2017**

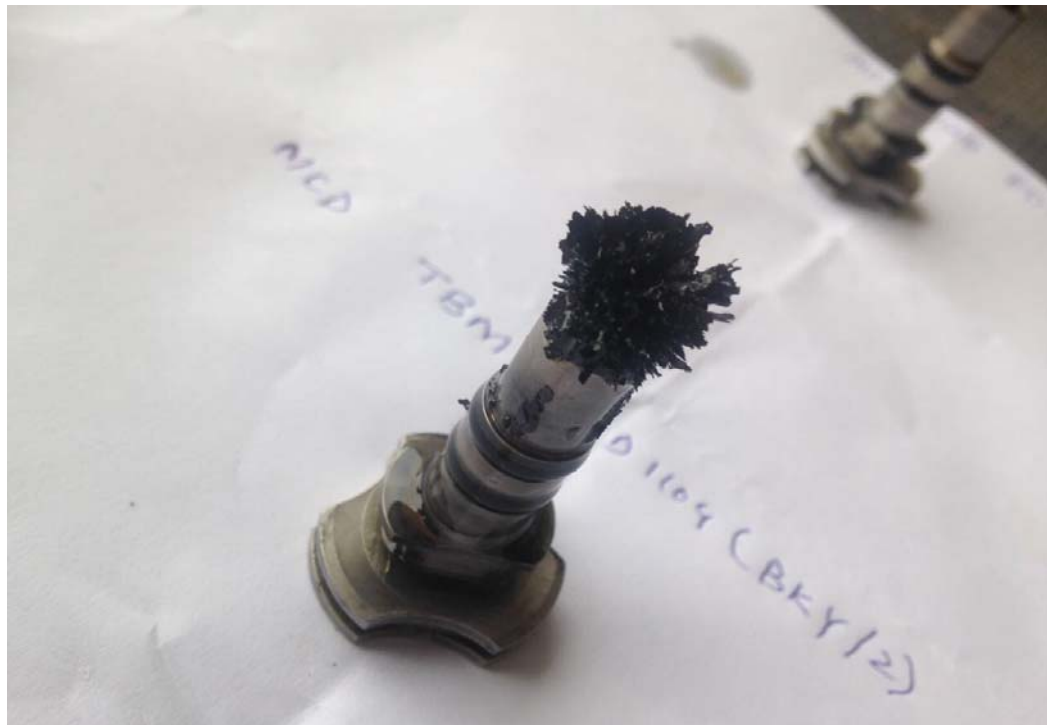
- 2.1.3 The aircraft recent history revealed that on 03 September 2017 (on the night prior to this occurrence), a defect of "Pressure Filter by-pass Indicator Popped Out" was reported. This by-pass indicator is provided in the assembly of Oil filter and it pops out if the filter element gets clogged.

- 2.1.4 This previously reported defect of "Pressure Filter by-pass Indicator Popped Out" was cleared by replacing the filter element. In this maintenance activity, instructions given in the maintenance manual PW MM 72-0-05 fault isolation-2, Table-101, Fig-111 weren't adhered and missed out an essentially required activity of inspecting the Metal Chip Detector (MCD).

- 2.1.5 PIAC in its preliminary report acknowledged this omission.
- 2.1.6 The aircraft was released to service with the aforementioned un-safe airworthiness status. Consequently, the engine failed after taxi out.

- 4.1 The OEM (Pratt & Whitney, Canada) is recommended to accelerate their efforts for identifying the intrinsic reason(s) leading to failure of No 2 bearing and make required improvement(s) with an aim to improve the engine reliability / safety.
- 4.2 PIAC is required to carry out refresher training of its maintenance engineers and technicians with a special emphasis on adequate troubleshooting of the reported defects as per guidelines given in the maintenance manuals.
