GROUND ACCIDENT BETWEEN PIA CATERING VAN NO. 429  
AND B-720, REG. NO. AP-AXM ON 011284 AT 1315 HRS.  
AT ISLAMABAD AIRPORT

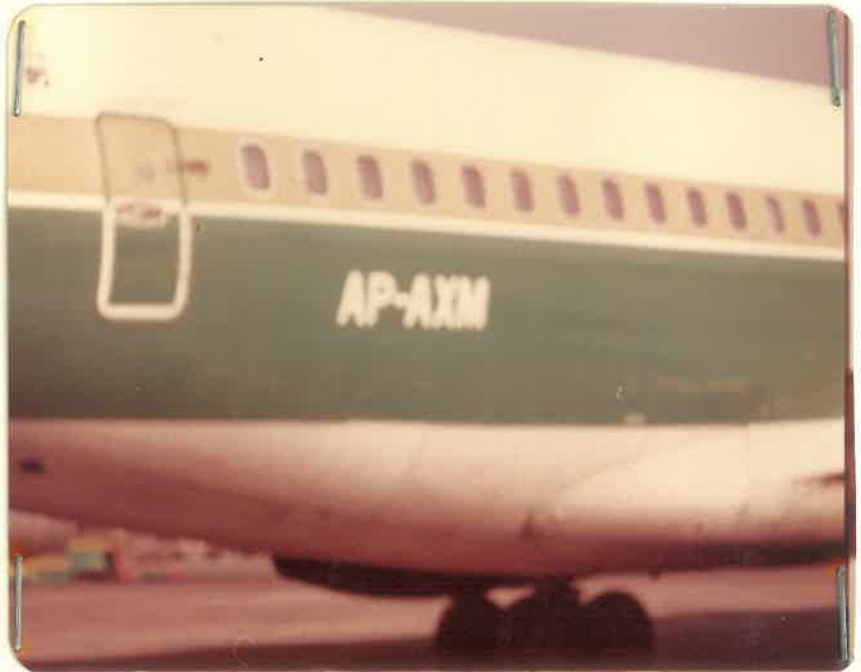
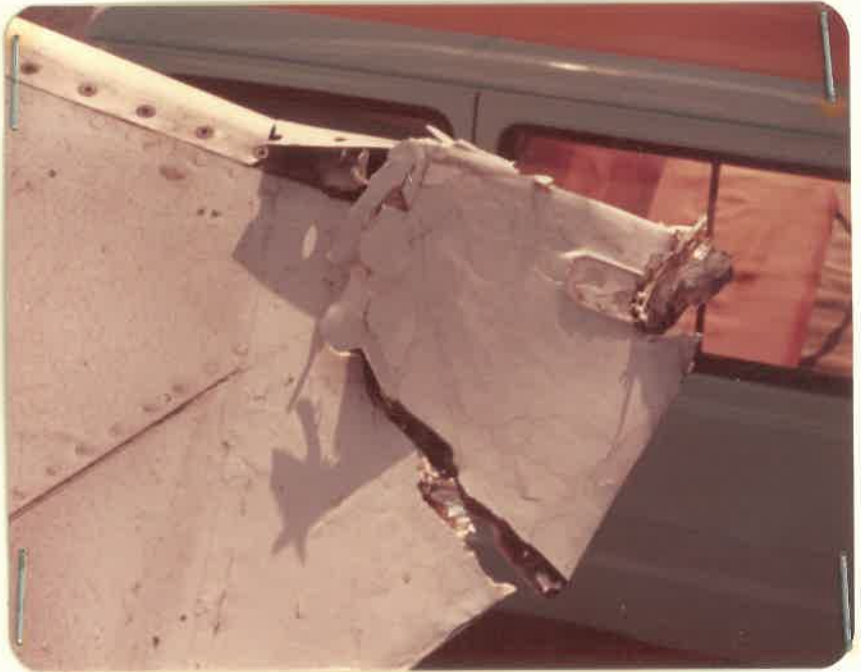
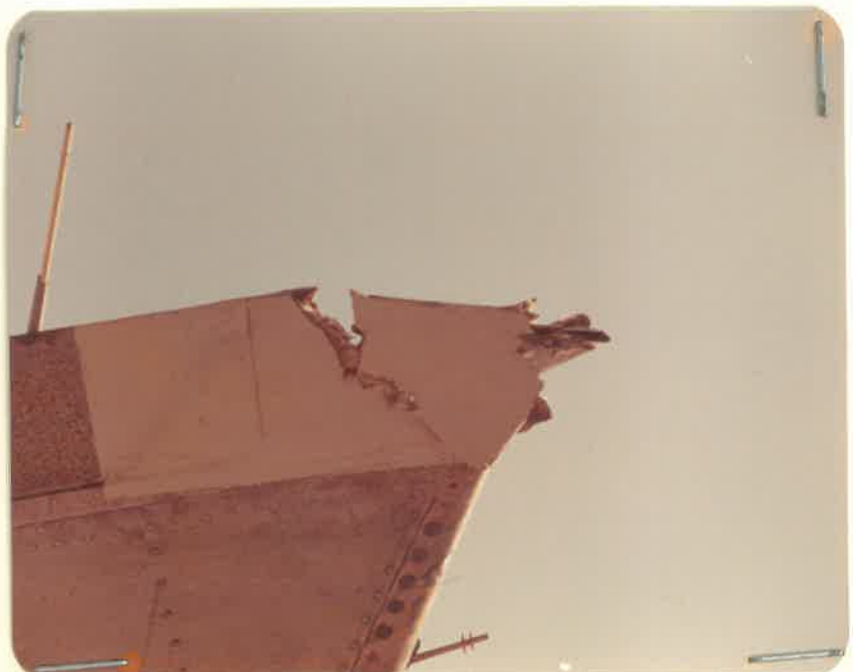
- 5-1 The following damage was noted after the aircraft was stripped:-
- 5-1-1 On inspection found R.H.S. wing tip trailing edge honey comb piece about (11x10") damaged and skin cracked about 3" smas.
- 5-1-2 Hole drilled and damaged honey comb reinforced with alloy sheets area checked for secondary damage and damaged area

PHOTOGRAPHS SHOWING  
DAMAGE TO A/C AP-AXM

temporarily repaired & protected as per repair manual.

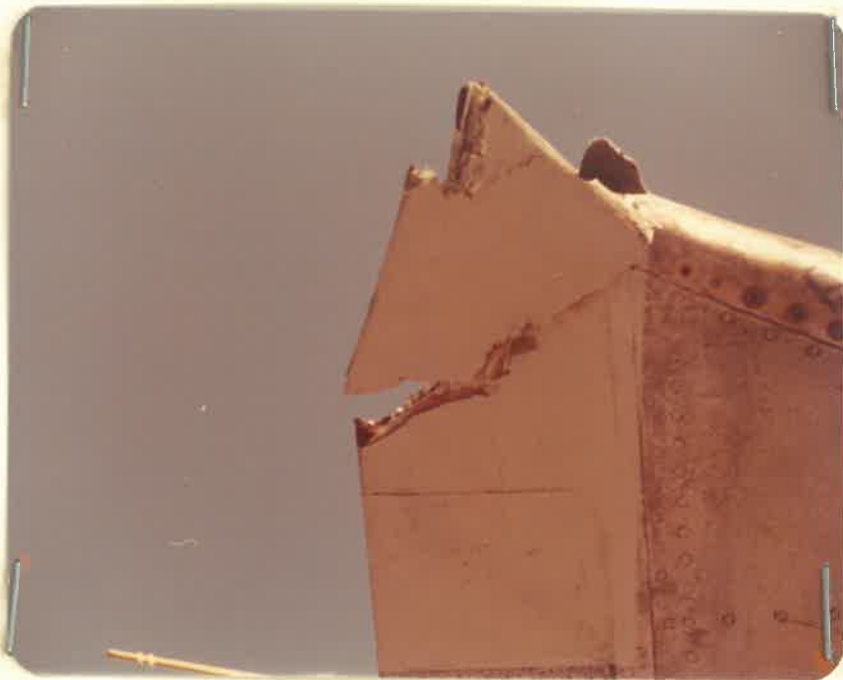
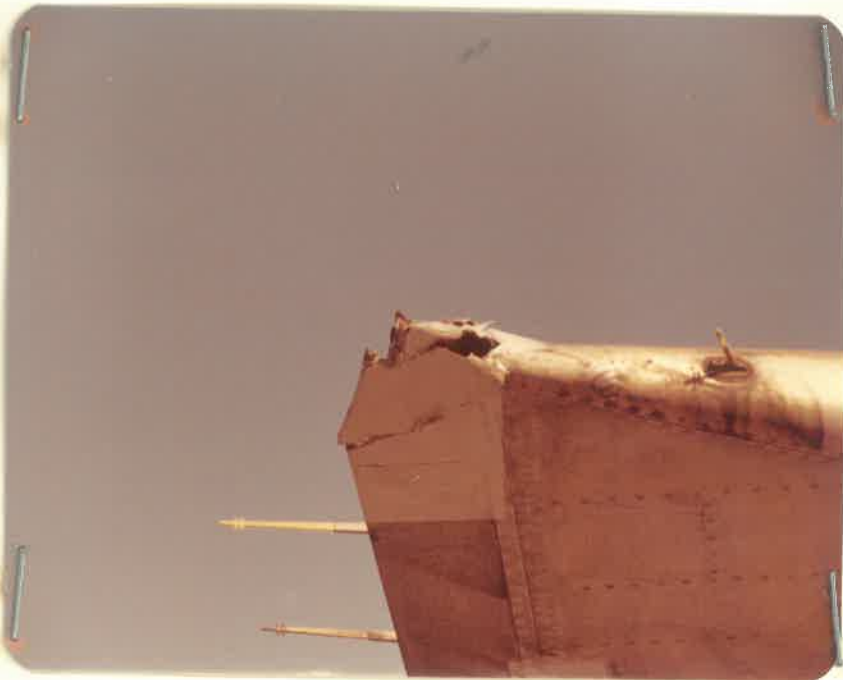
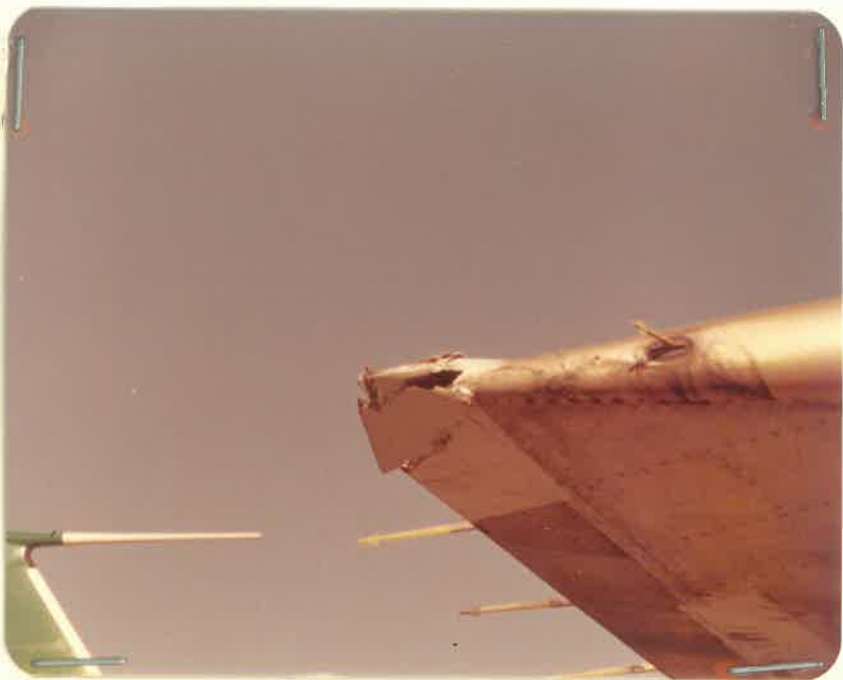
VARIOUS VIEWS

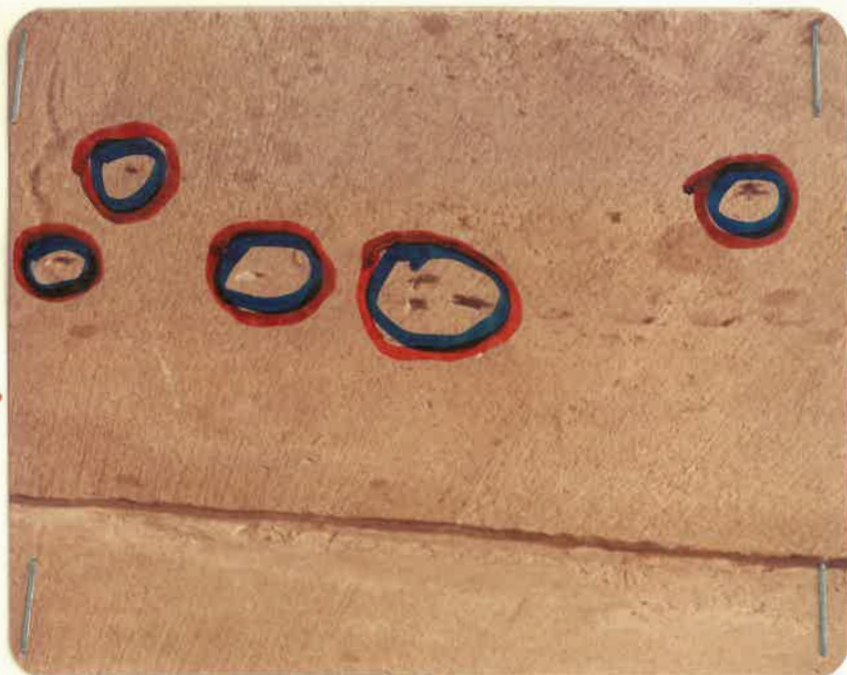
PIECES OF  
DAMAGED  
PORTION OF  
AIRCRAFT

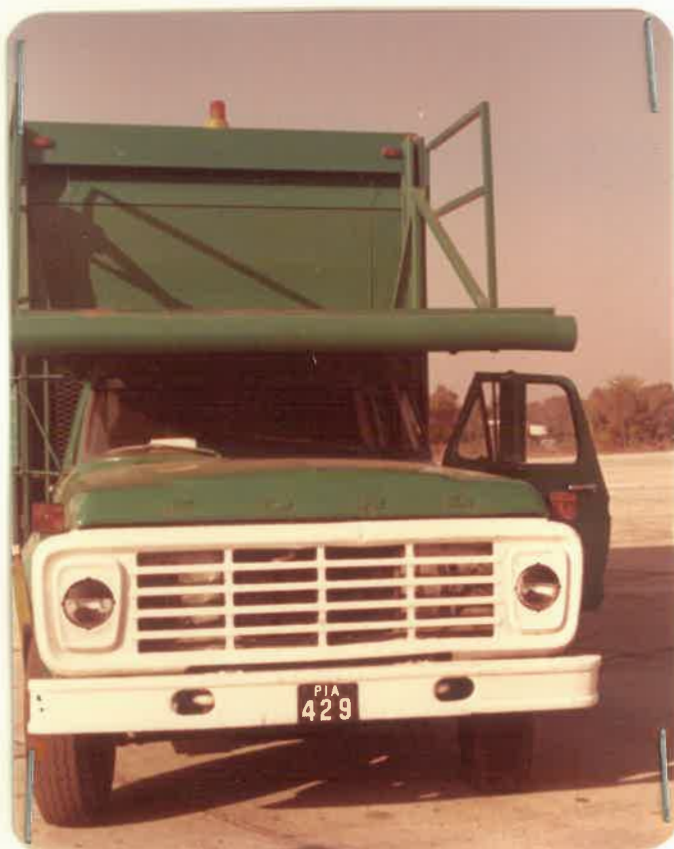
CATERING  
VAN P.I.A.  
429

6-1 The catering van No. 429 did not sustain any damage only a small part of the paint peeled off at the point of impact.

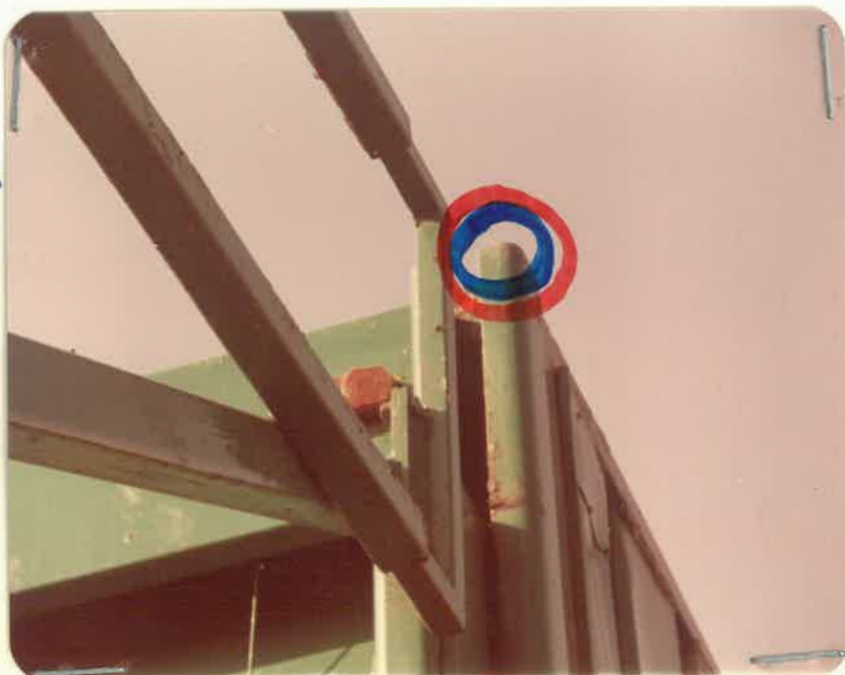
21-1-2 Mr. Ali Ahmed, Driver moved the vehicle and during this process, the top left hand corner of the catering van No. 429 hit the right hand side wing tip trailing edge, as he could not see the left hand top portion of vehicle from his driving seat.

INDICATING  
THE POINT  
WHERE IT  
HIT A/C
