## FINAL INVESTIGATION REPORT

**SERIOUS INCIDENT OF TCAS – RA REPORTED BY  
AIRBLUE FLIGHT ABQ 211 AIRBUS 320 AIRCRAFT  
REG. NO. VN-A650 (ON WET LEASE) AT  
ISLAMABAD ON 03-04-2018**

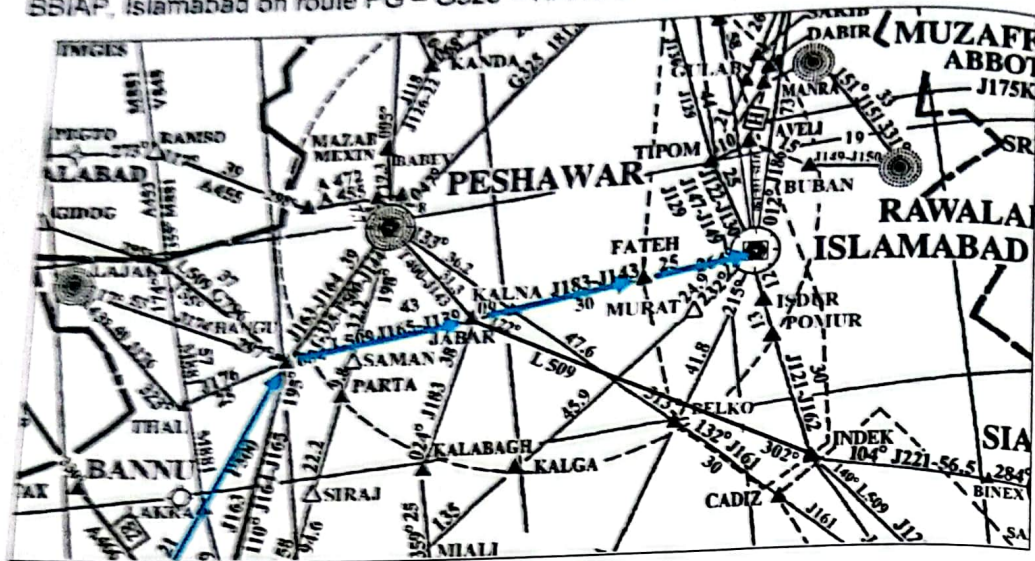
Figure 1 ABQ 211 Route plan

1.1.1. On 3<sup>rd</sup> April 2018, Airblue flight ABQ 211, Airbus 320 aircraft, Reg. No. VN-A650 was operating from Dubai International Airport, Dubai to BBIAP, Islamabad on route PG – G325 – HANGU – J139 – FATEH – OPRN.

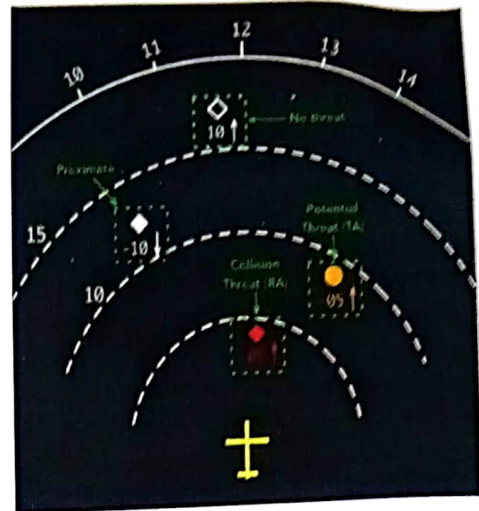
Figure 9 Traffic Display

1.18.3. **Traffic Display Symbology** – On the TCAS traffic display both colour and shape are used to assist the pilot in interpreting the displayed information.

1.18.3.1. Own-aircraft is depicted as a white or yellow aircraft-like symbol. Targets are displayed by different symbols, according to their threat status

1.18.3.2. Hollow white diamond – for other traffic. (No threat).

1.18.3.3. Solid white diamond – for proximate traffic.

1.18.3.4. Solid yellow or amber circle – for intruders (i.e. aircraft which trigger a TA).

1.18.3.5. Solid red square – for threats (i.e. aircraft which trigger an RA).
