## **FINAL INVESTIGATION REPORT**

### **SERIOUS INCIDENT OF TCAS – RA REPORTED BY EMIRATES FLIGHT UAE 637, BOEING 777-31H(ER) AIRCRAFT, REG. NO. A6-ENO, ON 19-09-2019**

Date: 10 November, 2023

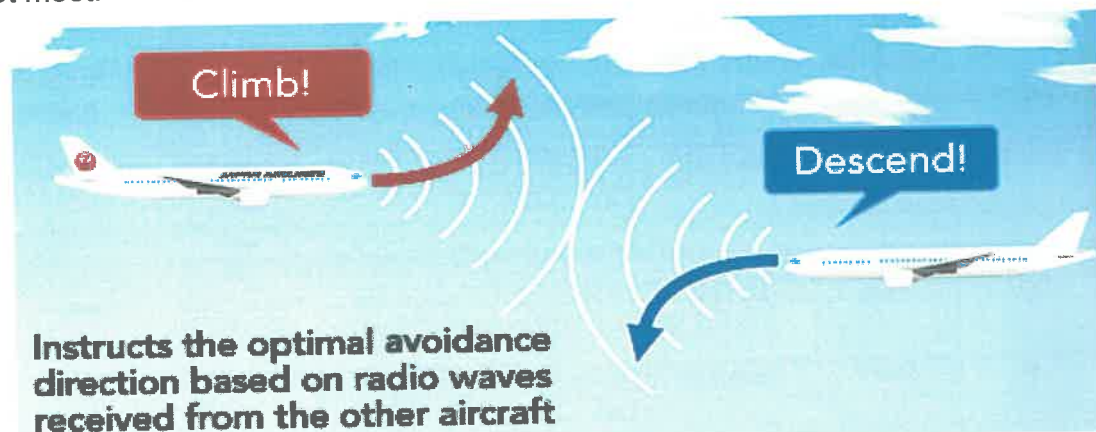
Figure 2 TCAS Working Principle

1.16.1. **TCAS Working Principle** – TCAS stands for Traffic Collision Avoidance System, and its purpose is to minimize the risk of mid-air collisions between aircraft. Working independently from Air Traffic Control, TCAS uses nearby aircraft's transponder signals to alert pilots to the danger of mid-air collisions. In detecting the other aircraft's transponder signals, it can foresee the potential collisions based on speeds and altitude of planes passing through the airspace in question. If TCAS detects a potential collision, it will automatically notify each of the affected aircraft. In this instance, it will automatically initiate a mutual avoidance manoeuvre. This involves the system informing the crews of the aircraft in question both audibly and visibly to either climb or descend in a manner that ensures that, when their paths cross, they do not meet.
