**PAKISTAN CIVIL AVIATION AUTHORITY**  
**(SAFETY & INVESTIGATION BOARD)**

**SERIOUS INCIDENT TO GULF STREAM-1 OF  
M/S. KING AIR SERVICES (SOUTH AFRICA) REG. NO.  
ZS-NHW ON 14 MARCH 2007  
AT  
ISLAMABAD INTERNATIONAL AIRPORT**

## FINAL REPORT

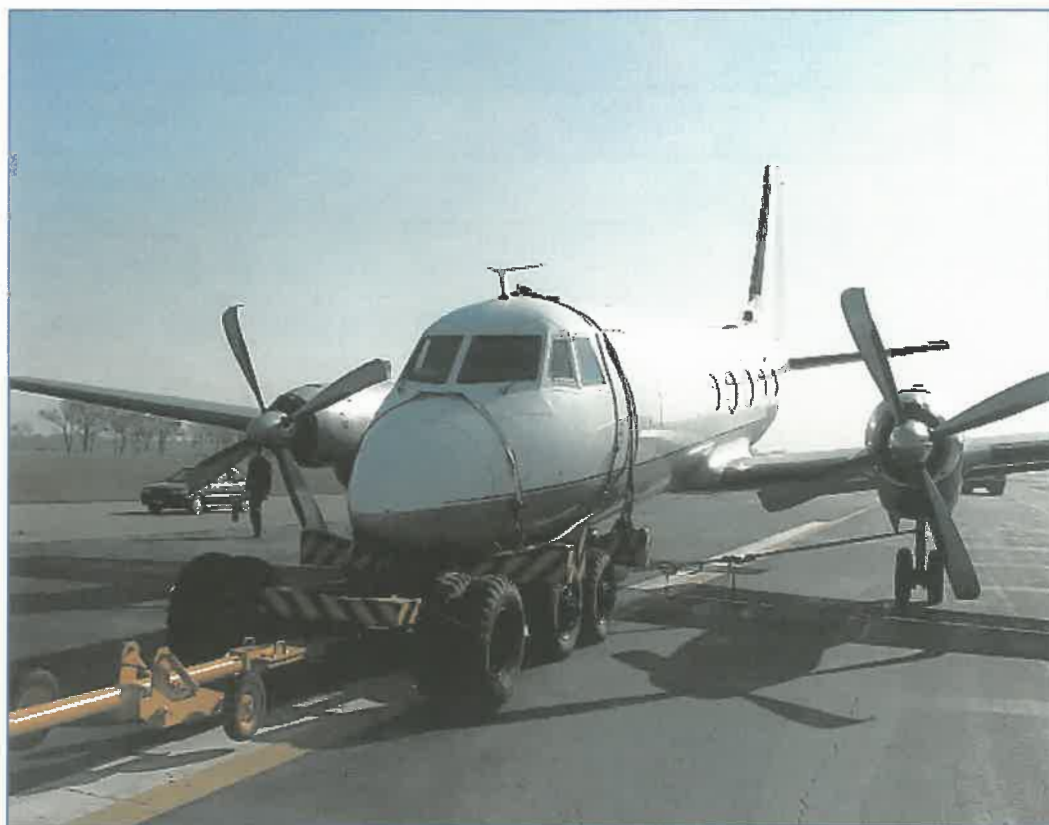
**SYNOPSIS:** On 14 March 2007 a non scheduled cargo flight, aircraft Gulf Stream-I, operated by Air King South Africa landed on Islamabad runway with nose landing gear (NLG) in retracted position. The aircraft was on a chartered flight from Muscat to Islamabad (**Appendix 'B'**). The notification of serious incident as per ICAO Annexure 13 was issued (**Appendix 'C'**). The NLG could not be extended despite of all efforts by aircrew and was confirmed in retracted position by ATC. Aircraft sustained damage to its both propellers and nose dome. However, no injury to any person or damage to ground equipment occurred. CAA and PAF authorities extended emergency and rescue facilities in excellent manner. The investigations revealed damages to NLG doors and control rods due to vibrations and rubbing during nose gear up landing. The exact cause of failure of normal NLG could not be determined due to non availability of hydraulic components facility in Pakistan. The emergency handle was also found jammed in its position. The aircraft operator M/s. King Air Services is not responding to extend any help either for component testing or for aircraft recovery. In these circumstances the aircraft will be auctioned to recover the charges to be paid to PAF for parking and recovery from runway. (**See Photograph K-1**).

1.3. **Damage to Aircraft:** Nose area structure and propellers were bent due to ground rubbing while in rotation (**See Photographs K-2 and K-10**). The movie of aircraft while landing is attached to the report in electronic version.

3.4 Aircraft nose, propellers and forward fuselage were damaged. Nose gear landing doors, link rods and hinges were damaged/broken bent severely.
