# FINAL INVESTIGATION REPORT

SERIOUS INCIDENT OF PIAC FLIGHT PK-363  
(SECTOR ISB – UET), B737-300 AIRCRAFT REG # AP-BFT  
AT QUETTA ON 08<sup>TH</sup> MARCH, 2013

### SERIOUS INCIDENT OF M/S. PIAC FLIGHT PK-363 (SECTOR ISB – UET) B737-300 AIRCRAFT REG # AP-BFT AT QUETTA ON 08<sup>TH</sup> MARCH, 2013

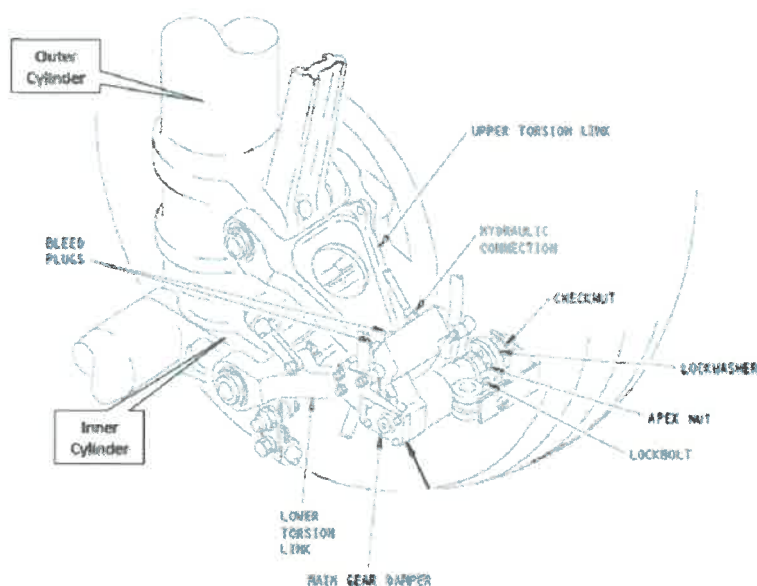
Torsion Links and Shimmy Damper Assembly

- 2.8 The axle of the wheels is mounted on the inner cylinder. The torsion links and shimmy damper assembly prevents pivot of the inner cylinder inside the outer cylinder (torsional movement). The torsional vibrations are prevented by the shimmy damper.
