Civil Aviation Authority  
Safety Investigation Board  
(SIB)

## Investigation Report of Boeing 737-340 Aircraft Pressurization Failure

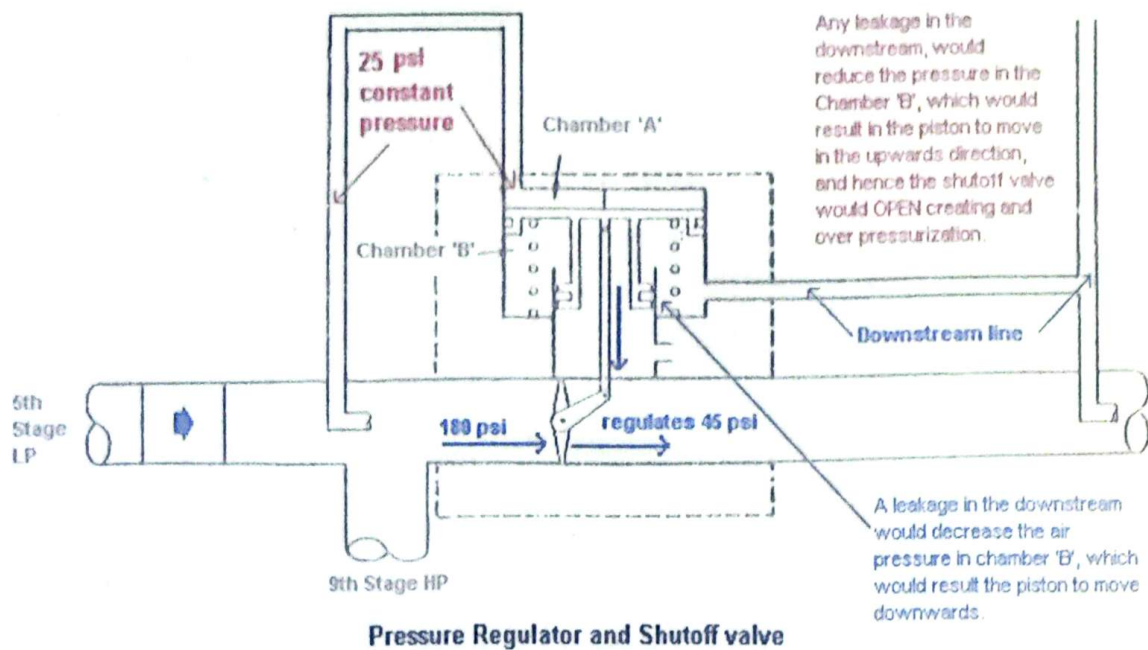
- 8.6 *Pressure Regulator / Shutoff Valve (PR/SOV):* A regulated pressure of 25 psi is supplied to the chamber 'A' to overcome the spring force which further opens the butterfly valve. Downstream pressure applied to the actuator chamber 'B' modulates the butterfly valve towards closed until chamber 'A' is balanced by chamber 'B' pressure plus the spring force. This occurs at a downstream pressure of 45 plus minus 4 psi. The butterfly valve

automatically compensates for the upstream fluctuations or downstream flow demand. The latching solenoid controls bleed air flow from the engine by directing pneumatic pressure to chamber 'A' to open the butterfly valve or venting the chamber 'A' to the atmosphere to close the butterfly valve (Refer figure below).

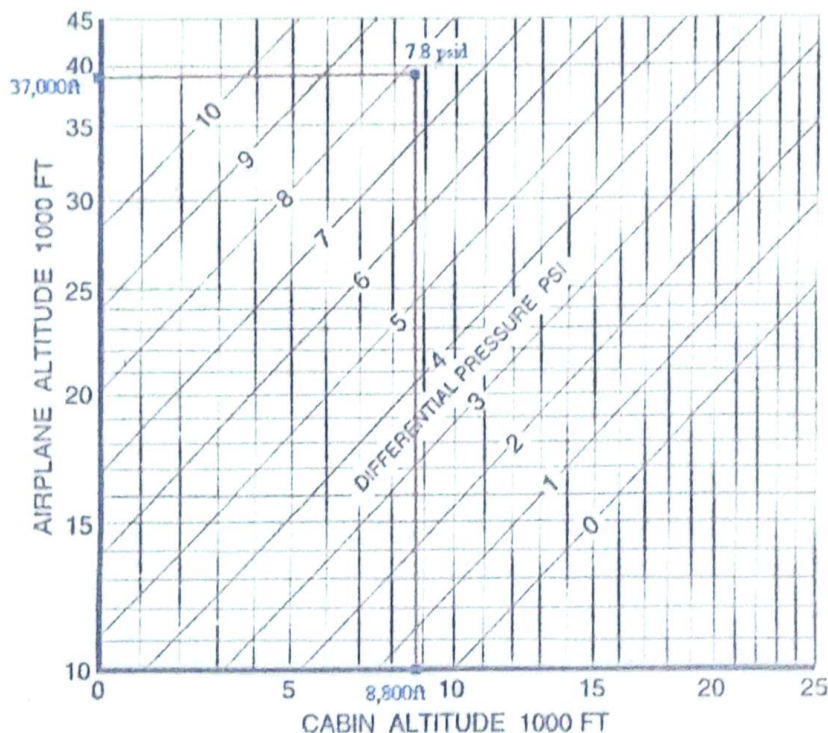
- 9.13 The aircraft operating ceiling is 37,000 ft as per Boeing 737 operation manual (Appendix 'W'). The aircraft fuselage structure is designed for operating at a cabin pressure of 7.8 psid with a maximum of 7.9 psid. A dual differential pressure system controls cabin dual differential pressure to 7.5 psi for flights at altitude of less than FL 280 and 7.8 psi for flights above FL 280. Since the aircraft was flying at 37,000 ft, therefore cabin pressure would be 7.8 psi. Referring to the airplane altitude versus cabin altitude graph, the cabin altitude at FL 370 with 7.8 psi comes to approx 8800 ft, well within limits. Keeping in view the age of the aircraft, the rate of climb of the cabin altitude tends to be more rapid due various leaks. Hence, if the rate of climb of the cabin altitude is 2500 ft/min, then the cabin can reach a dangerous level of 16300 ft in 03 minute.
