# **FINAL INVESTIGATION REPORT**

**ACCIDENT OF SUNWAY AIR CARRIER (GEORGIA)**  
**IL-76TD AIRCRAFT REG # 4L-GNI AT KARACHI, PAKISTAN**  
**ON 27<sup>th</sup> NOVEMBER, 2010**

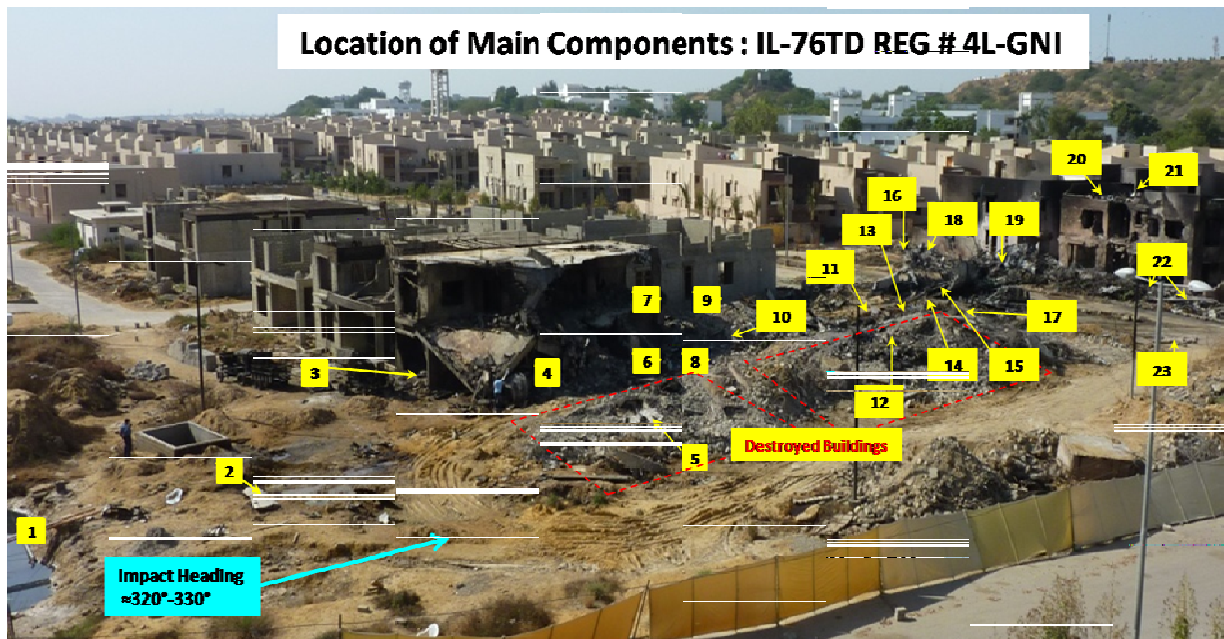
Location of engines

1.12.1. The close up photographs of major components as annotated in above picture (Location of Main Components : IL-76TD Reg # 4L-GNI) are as follows:
