**AIRCRAFT ACCIDENT INVESTIGATION REPORT**

**CRASH OF CESSNA 402B REG # AP-BFG  
IN ARABIAN SEA NEAR KARACHI  
ON 24<sup>TH</sup> FEBRUARY 2003**

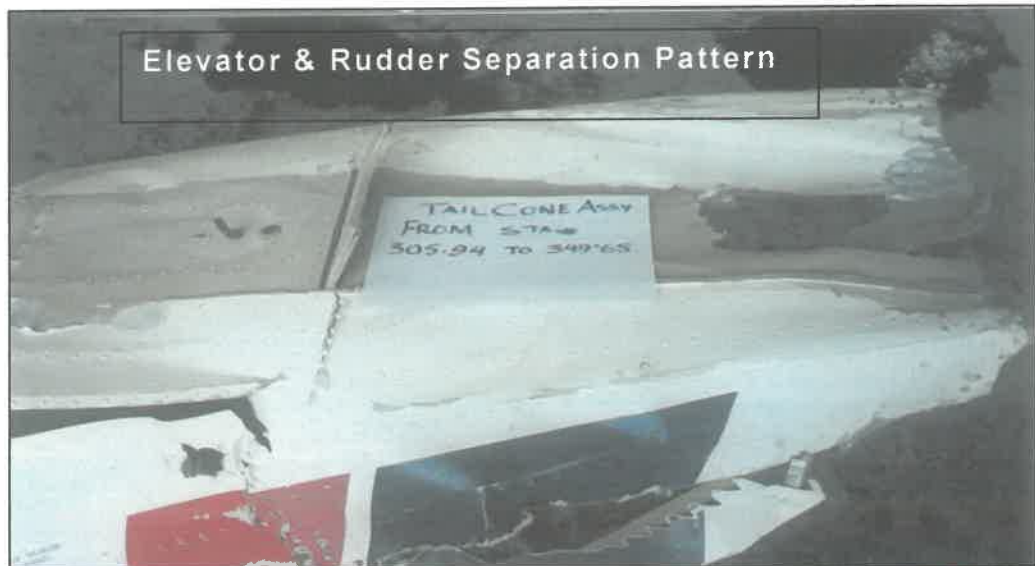
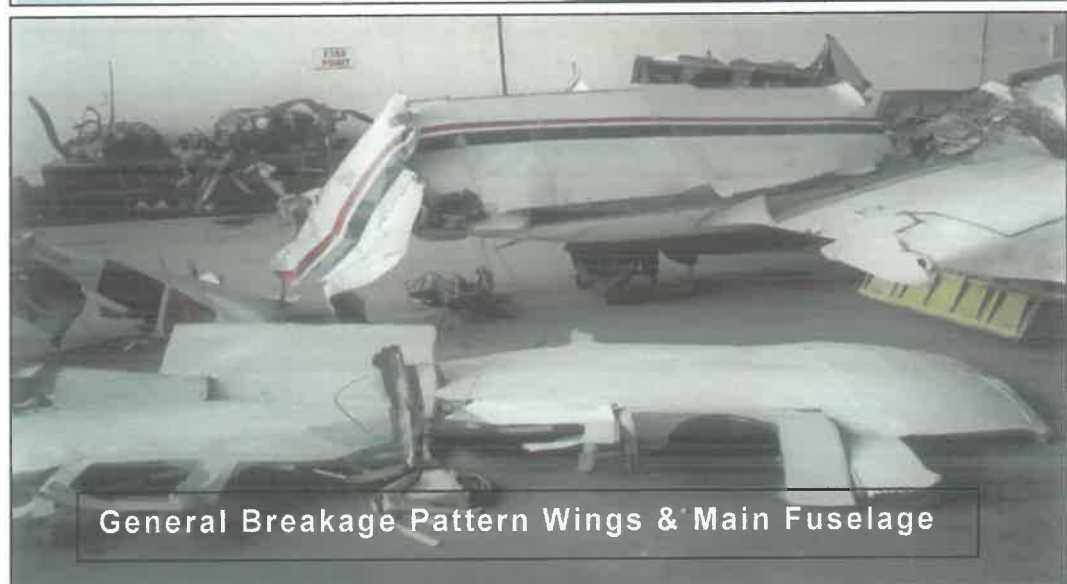
- 2.4.2 On both the propellers, one blade each was found bent in the direction of rotation and one blade was bent opposite to the direction of rotation. Third blade on both the propellers was slightly bent, indicating feathered position.

- 2.4.3 The left wing, after breaking away from fuselage during impact with water, collided with the fuselage and caused sequential damage.
  - 2.4.4 The carpet of the cabin floor was intact and clear of any burn marks etc.

- 2.4.7 Steel cables running to the tail section indicated that very strong tensile force acting from the rear of the aircraft caused their separation.

- 2.4.8 The tail cone, horizontal stabilizer, elevators and the rudder were not found.
  - 2.4.9 Examination of the wreckage did not reveal any evidence of bird strike, any penetrating metals or fire. Similar evidence was also not found on the dead bodies.

3.5.3 The damages to right wing leading edge; were caused due to impact with water. There were no cuts, smears, colour marks or dents. The wreckage parts also did not show any evidence of fire or explosion.
