# FINAL INVESTIGATION REPORT

SERIOUS INCIDENT OF M/S. PIAC FLIGHT PK-4522 (SECTOR SKD – ISB)  
ATR 42-500, AP-BHO ENGINE NO. 1 UNCOMMANDED SHUTDOWN  
ON 15<sup>TH</sup> SEPTEMBER, 2014 AT SKARDU

## FINAL REPORT

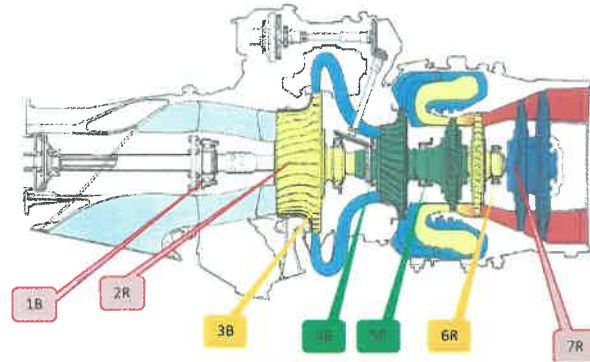
- 2.2 The following schematic shows relative position and numbers of PW127E bearings.

Engine schematic: (R and B stand for roller and ball bearing respectively)
