**CIVIL AVIATION AUTHORITY – PAKISTAN**

**SERIOUS INCIDENT TO PIA FLIGHT 786**

**B-747 REG # AP-BFV, AT ISLAMABAD**

## FINAL REPORT

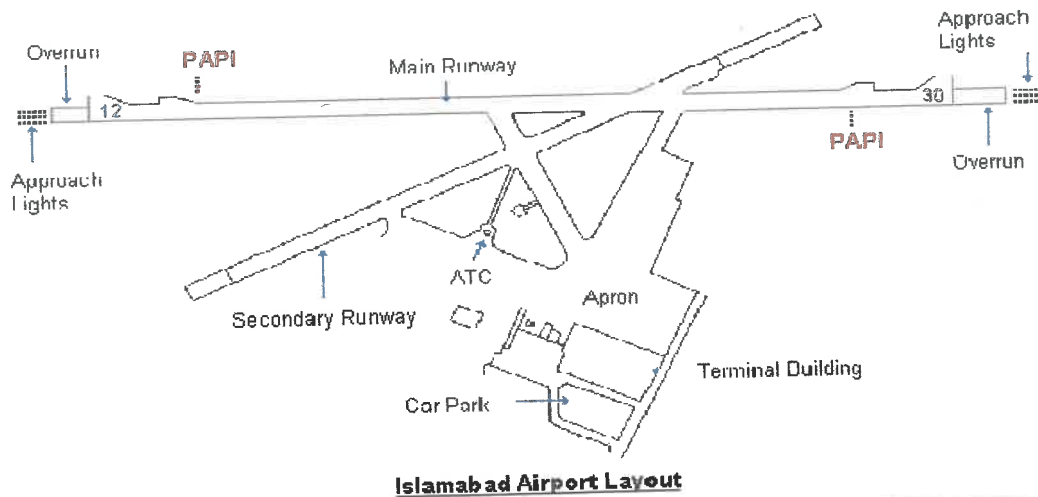
1.11.1 The aerodrome elevation of Islamabad International Airport is 1660 ft above mean sea level. This airport has two runways – secondary runway 09 / 27 (Not in use for take-off and landing) and main runway 30/12 (see figure below). Runway 30 is 11,000 ft long (excluding overrun area of both sides) and 150 ft wide. The overrun area on the 30 end is 900 ft. The main runway is made of bitumen surface and has a slope of 0.15 % from runway 12 end up to 5943 ft and has a slope of 0.5 % from the runway 30 end up to 2286 ft.
