TO INVESTIGATE INTO THE GROUND ACCIDENT IN WHICH  
TWO, TWIN OTTER AIRCRAFT REG. AP-BCG AND AP-BCH  
RESPECTIVELY WERE BADLY DAMAGED ON 5TH SEPT, 1985  
AT 0230 L.T. PARKED ON BRAVO TAXIWAY  
AT ISLAMABAD AIRPORT

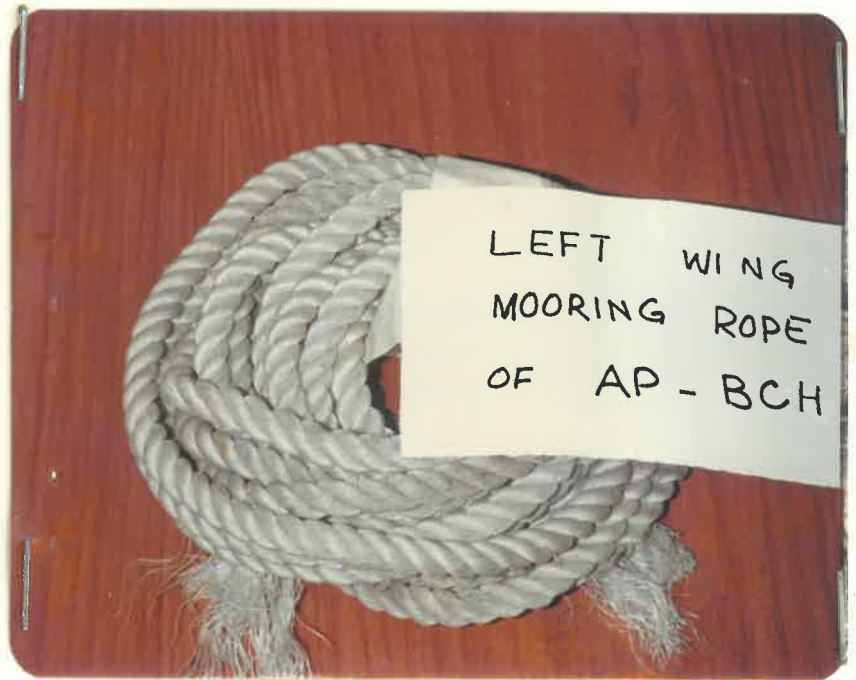
4

- 23-4-3 Un-approved Polyester rope used by PIAC on these aircraft was tested in Naval Dockyard Karachi and is found to have breaking strength of 1653 pounds comparing with the laid down breaking strength. <sup>/6288 Lbs</sup> the Polyester rope used has 1/4 strength. This is a violation of Rule 40 (1 & 2) of Civil Aviation Authority Rules 1978.

AP- BCH, MOORING ROPE

24-2 Mooring rope as given in the Maintenance Manual must be used. Breaking strength of the rope should not be less than 6288 pounds as recommended by the manufacturer's.
