INVESTIGATION REPORT INTO FLYING INCIDENT  
INVOLVING F-27 AIRCRAFT, REG. MARK AP-AUR,  
BOTH TYRES BURST ON LEFT HAND SIDE ON LANDING  
AT 0645 H ON 12TH DECEMBER, 1984 AT ISL. AIRPORT

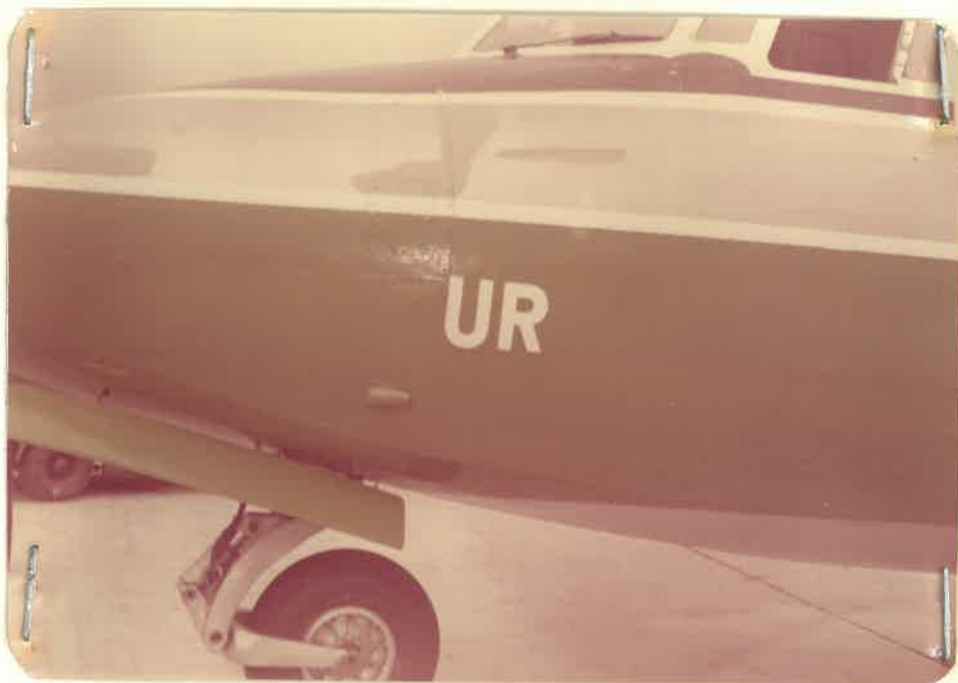
F-27 A/C.  
AP-AUR

17-3 Both the left hand tyres on port side were found burst while starboard side outer tyre were also found burst (Appendix "G").

- 22-1 The probable cause could be due to some residual pressure trapped in wheel brake assembly, resulting in locked wheel landing.
- 22-2 Shop reports on components are awaited from PIA Engineering staff at Karachi, before any final cause is established.

STBD. OUTER  
TYRE BURST
