**PAKISTAN CIVIL AVIATION AUTHORITY**  
**(SAFETY & INVESTIGATION BOARD)**

**ACCIDENT TO M/S MULTAN FLYING CLUB**  
**CESSNA – 150 AIRCRAFT**  
**REG # AP-BAS ON 01<sup>st</sup> SEPTEMBER 2012 AT**  
**MULTAN INTERNATIONAL AIRPORT, MULTAN**

## INVESTIGATION REPORT

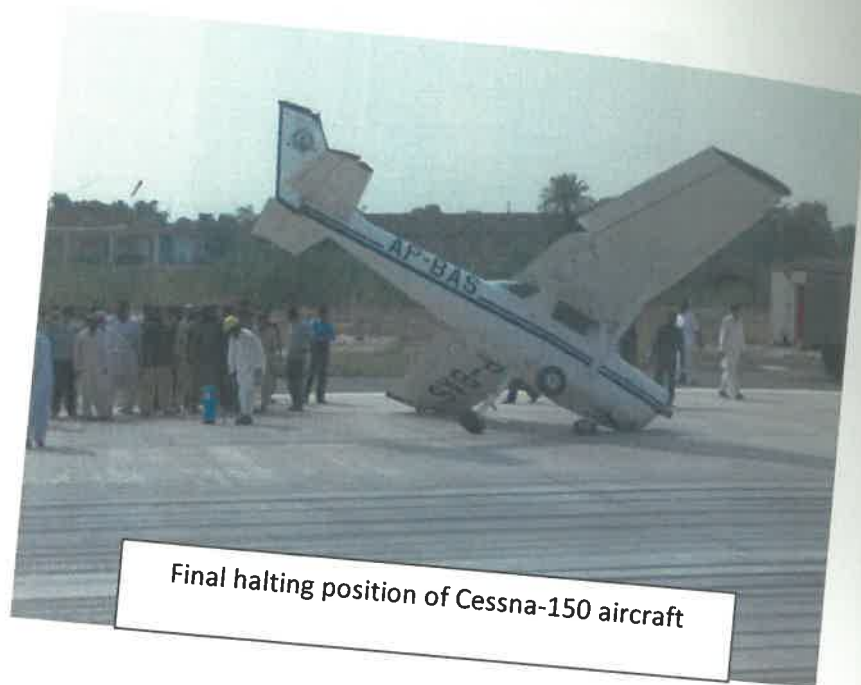
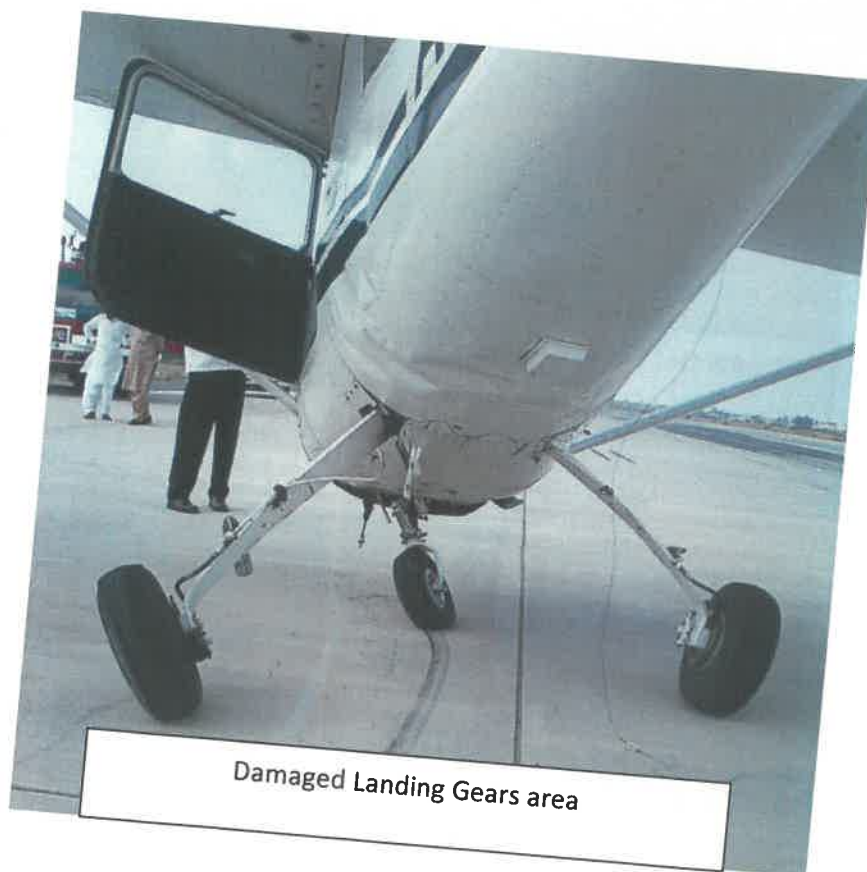
1.13 **Impact Information:** Aircraft touched down on its nose landing gear, damaging severely the nose landing gear. As a result of nose landing gear hitting the ground / runway surface first, the aircraft bounced and entered into porpoise. The aircraft experienced extreme uneven loading on landing gears which resulted in nose landing gear collapse along with extensive damage to main landing gears and buckling of fuselage behind main landing gears area . During porpoise, the left and right wing tips of the aircraft also came in contact with the ground / runway surface which resulted in damage to both the wing tips.

Damaged Propeller and Nose area
